STATEWIDE MATERIAL SITE INVENTORY

MATERIAL SITE
INSPECTION REPORT

Federal Project No. STP-000S(530)
AKSAS Project No. 76174

DALTON HIGHWAY

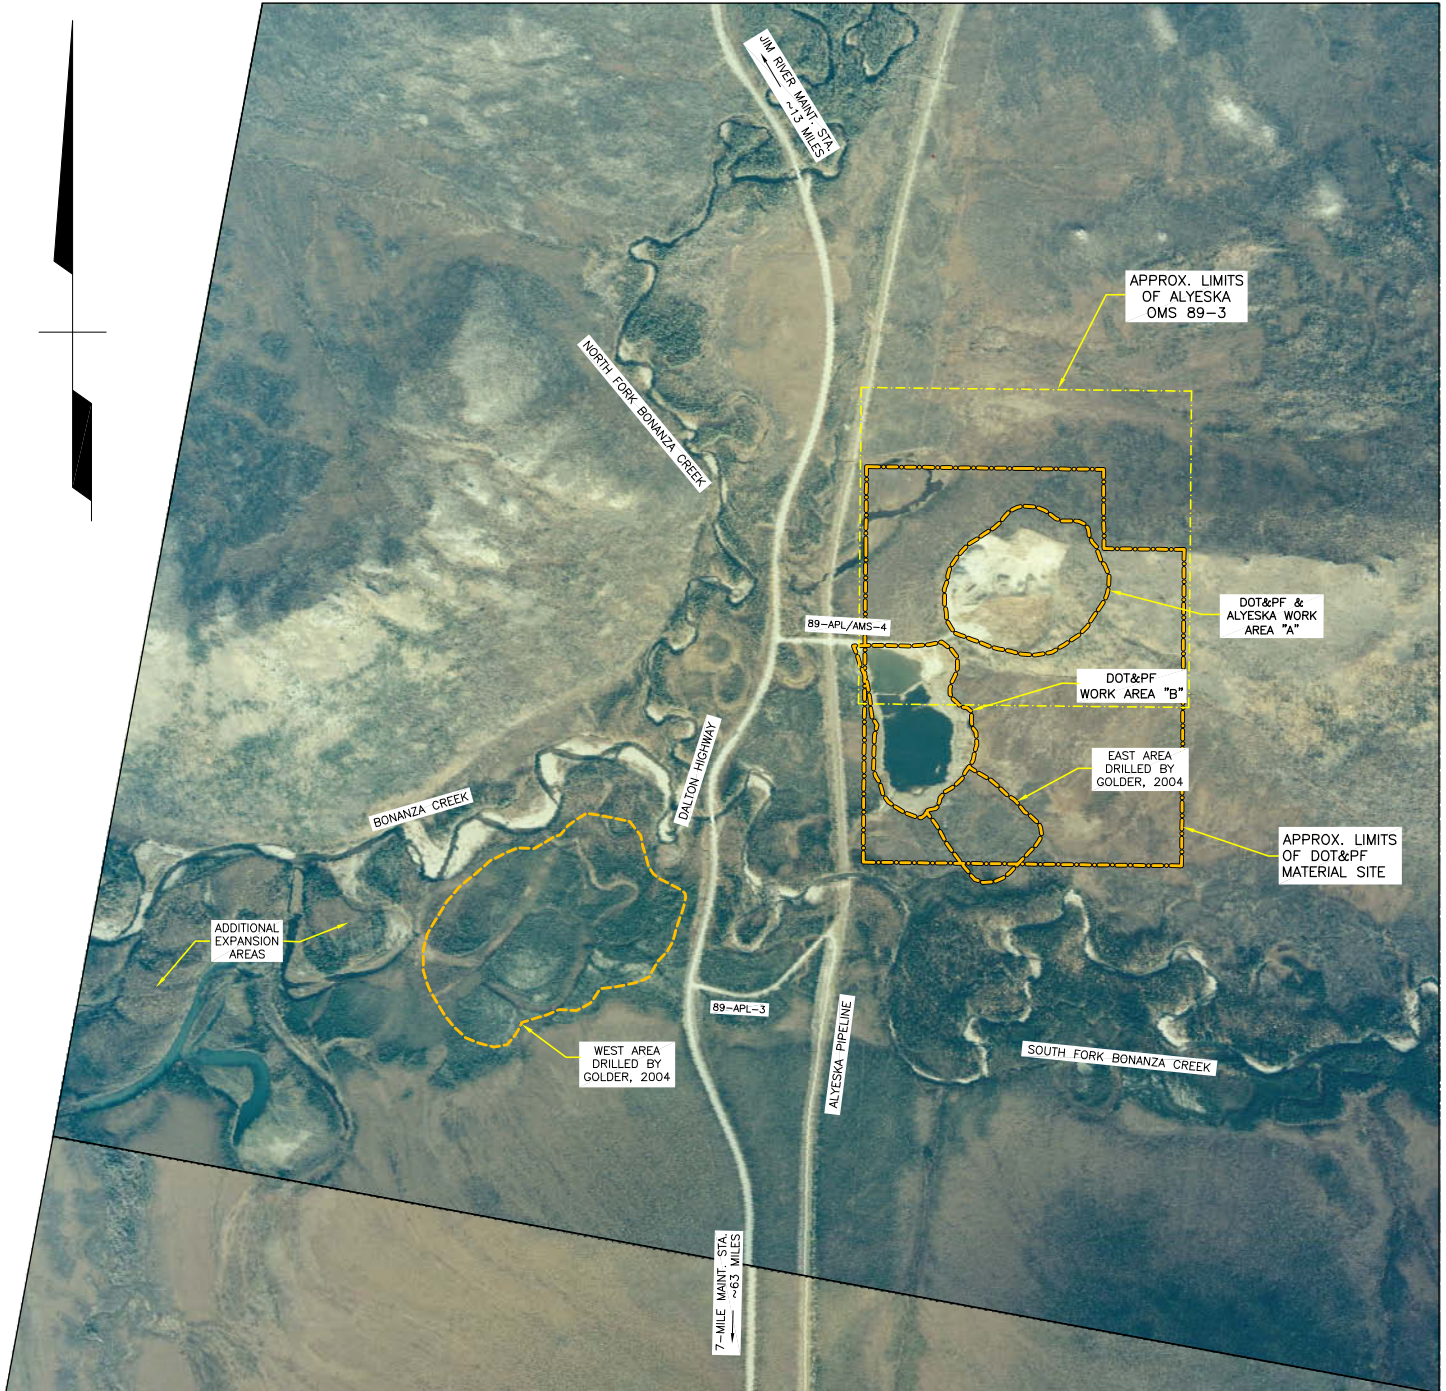
SITE MAP

BASE MAP IS 2008 AERIAL PHOTOGRAPHY. THIS IS A PLANNING DOCUMENT ONLY. THE MATERIAL SITE BOUNDARIES SHOWN ON THIS DRAWING ARE APPROXIMATE. OWNERSHIP OF THE LANDS ADJACENT TO THIS SITE ARE UNKNOWN. THE ACCESS ROW SHOULD BE VERIFIED.

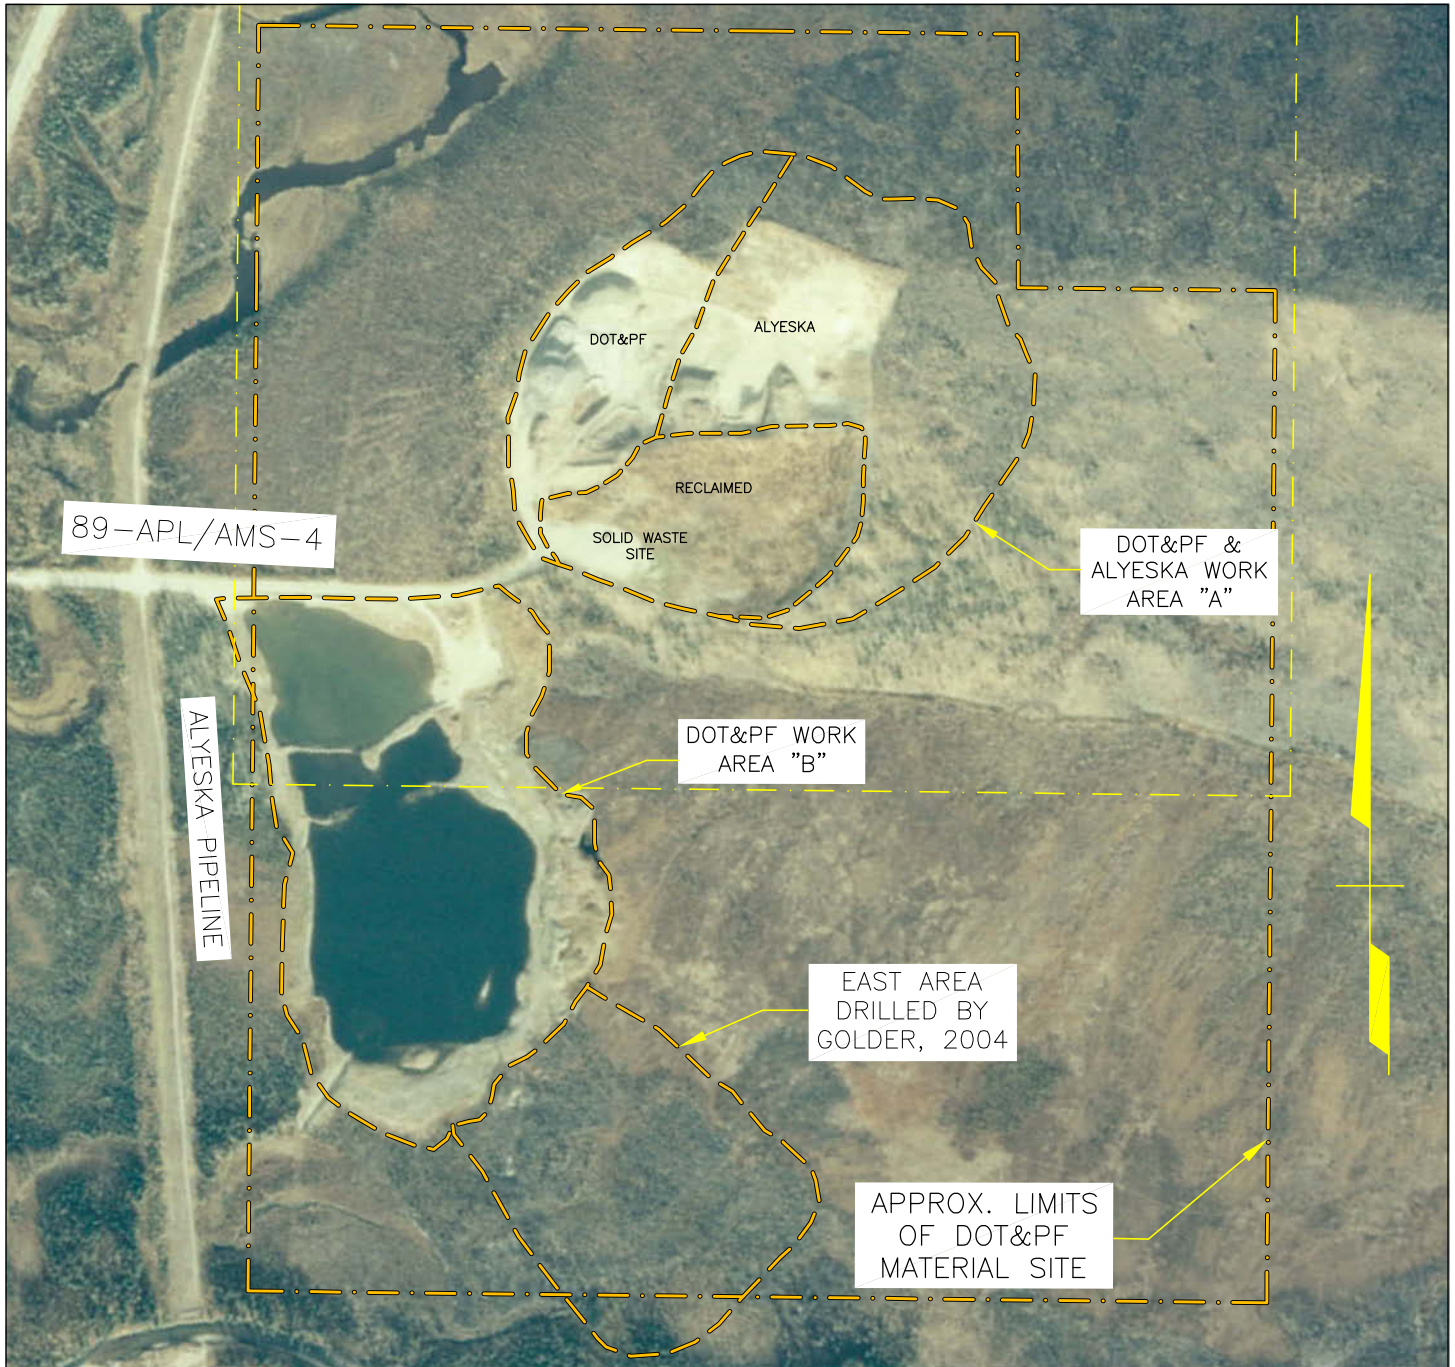
SITE MAP EAST BONANZA CREEK

BASE MAP IS 2008 AERIAL PHOTOGRAPHY.
THIS IS A PLANNING DOCUMENT ONLY. THE MATERIAL SITE BOUNDARIES SHOWN ON THIS
DRAWING ARE APPROXIMATE. OWNERSHIP OF THE LANDS ADJACENT TO THIS SITE ARE
UNKNOWN. THE ACCESS ROW SHOULD BE VERIFIED.

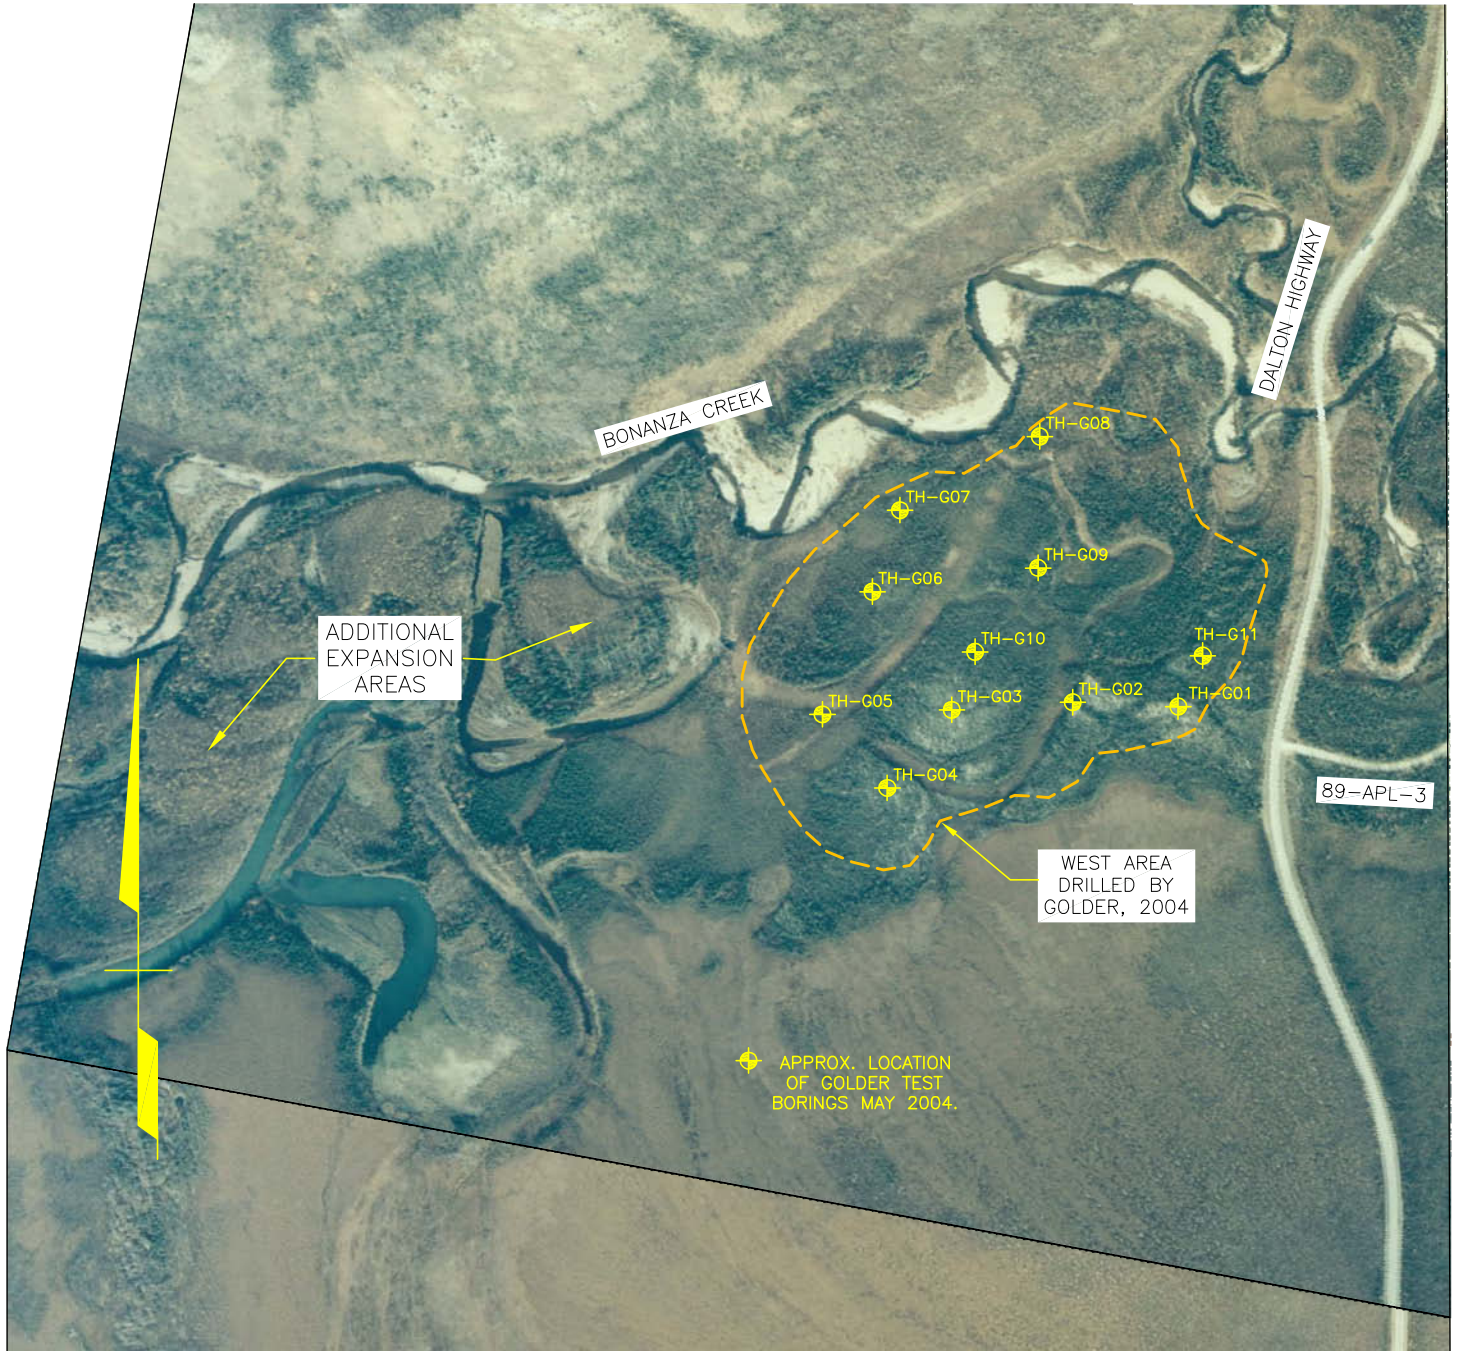
SITE MAP WEST BONANZA CREEK

BASE MAP IS 2008 AERIAL PHOTOGRAPHY.
THIS IS A PLANNING DOCUMENT ONLY. THE MATERIAL SITE BOUNDARIES SHOWN ON THIS DRAWING ARE APPROXIMATE. OWNERSHIP OF THE LANDS ADJACENT TO THIS SITE ARE UNKNOWN. THE ACCESS ROW SHOULD BE VERIFIED.

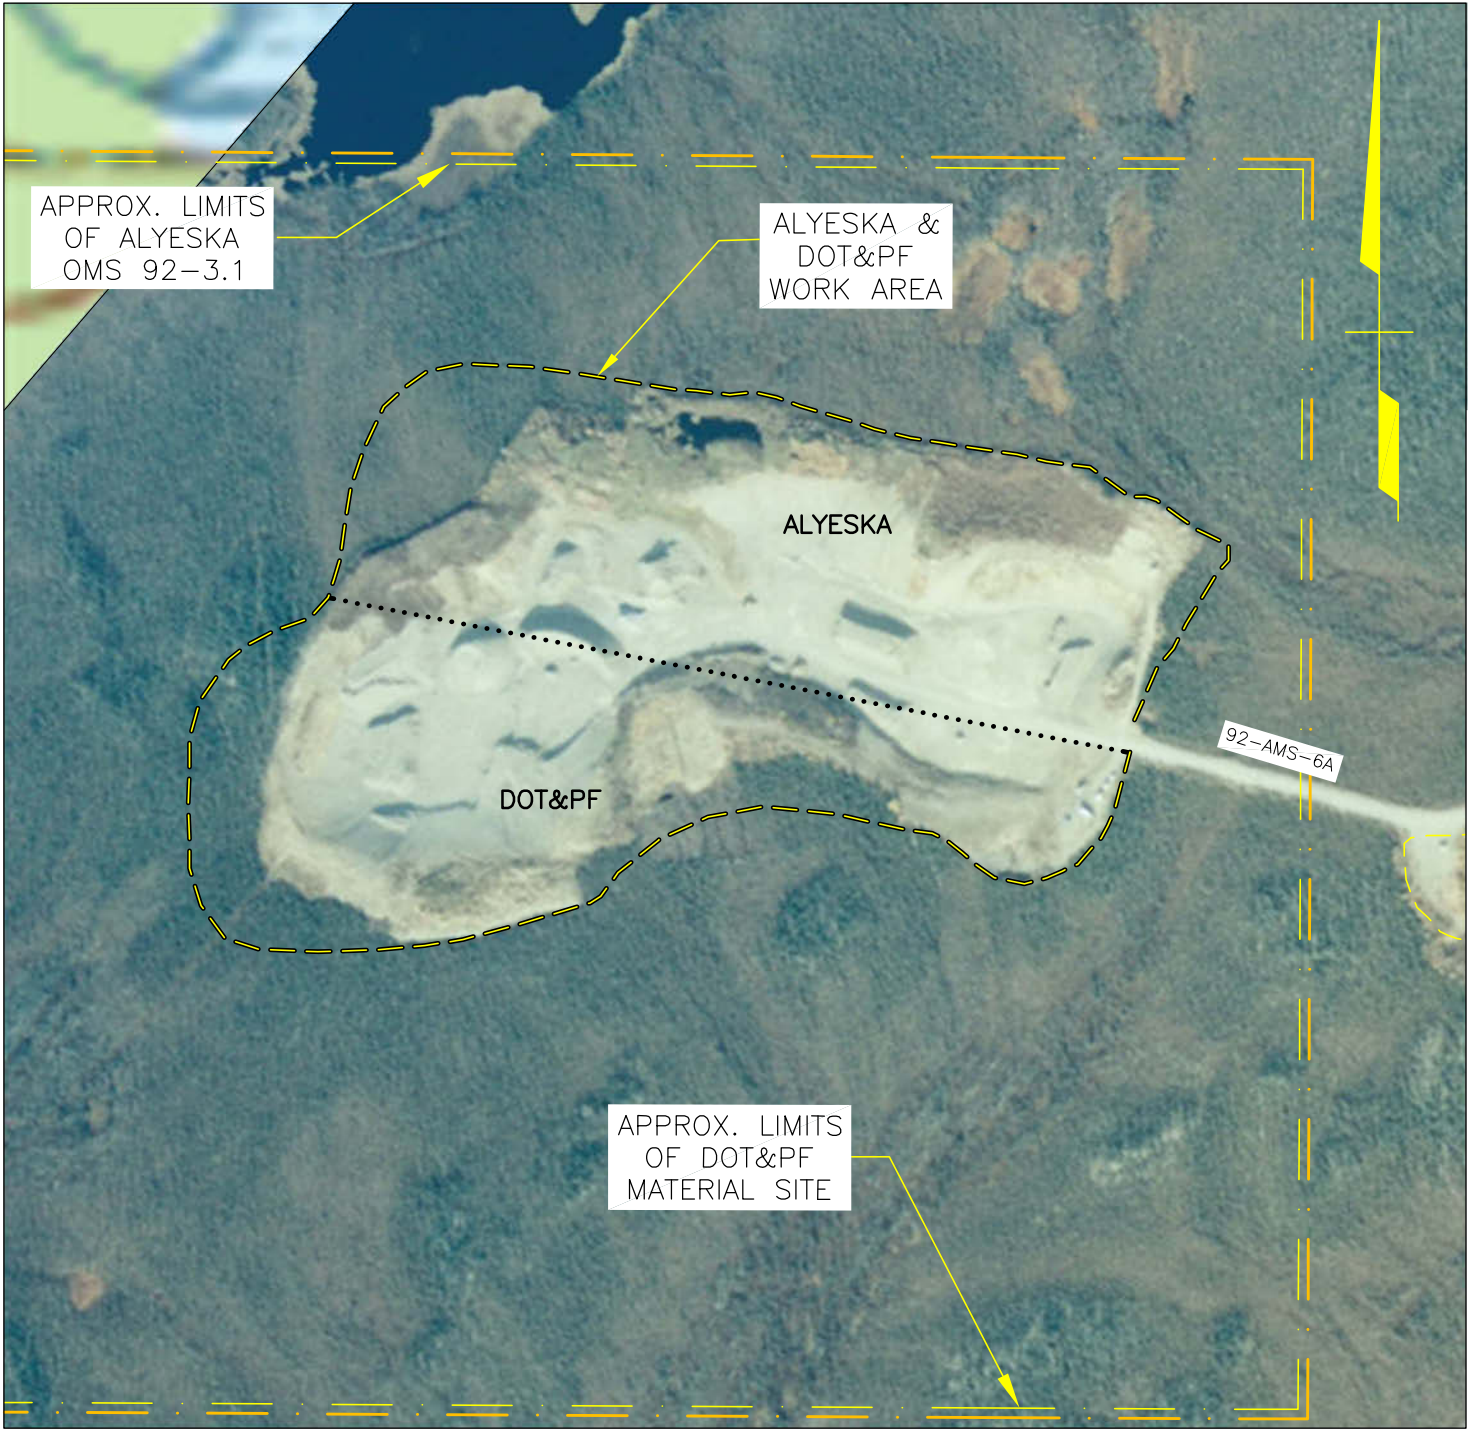
SITE MAP

BASE MAP IS 2008 AERIAL PHOTOGRAPHY.
 THIS IS A PLANNING DOCUMENT ONLY. THE MATERIAL SITE BOUNDARIES SHOWN ON THIS
 DRAWING ARE APPROXIMATE. OWNERSHIP OF THE LANDS ADJACENT TO THIS SITE ARE
 UNKNOWN. THE ACCESS ROW SHOULD BE VERIFIED.
