STATEWIDE MATERIAL SITE INVENTORY

MATERIAL SITE
INSPECTION REPORT

ALASKA HIGHWAY

MS 62-1-015-5
Mile 1281 Pit

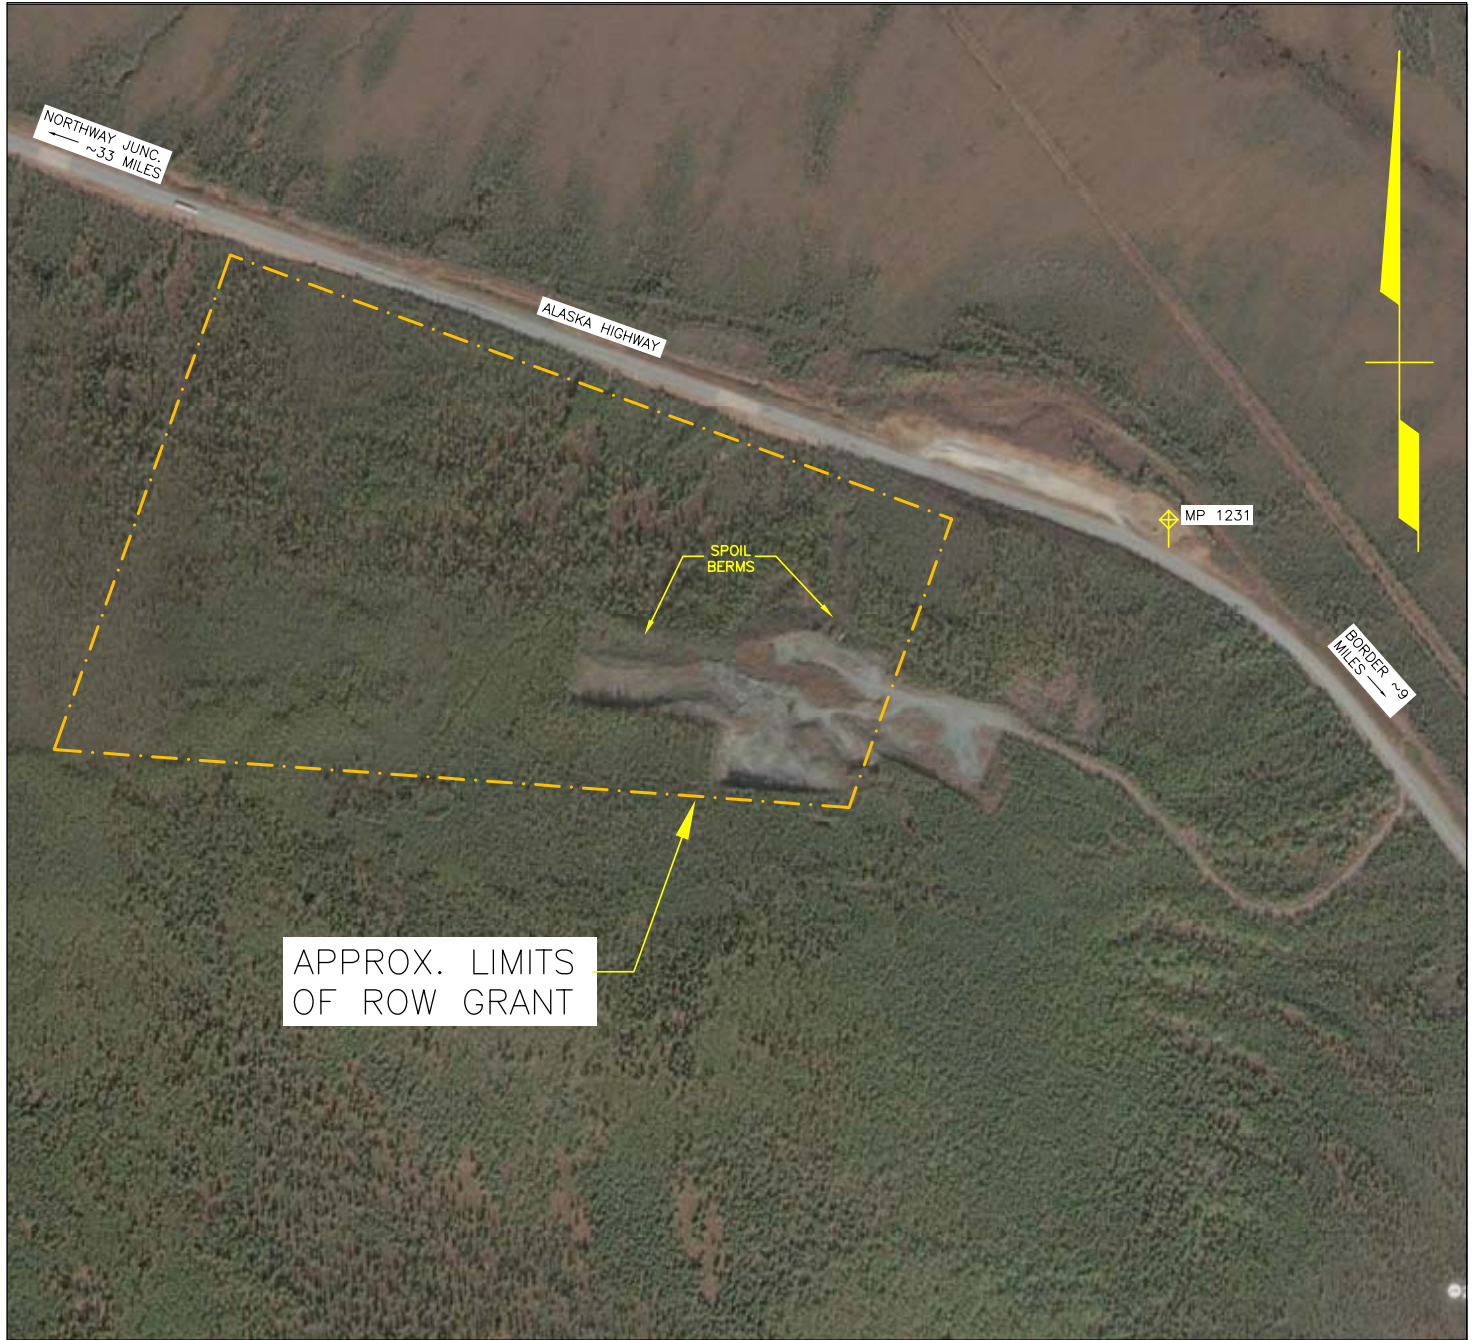
SITE MAP

The site limits on the Site Map were based on a 1994 drawing in the material site file and hand-held GPS coordinates of corners acquired during this inspection. The north-south site dimensions shown on the 1994 drawing were shorter than those from the original 1983 right-of-way plat. Thus the area of the site (~72 acres) used in this report is less than that indicated on the 1983 drawing.

BASE MAP IS 2005 SATELLITE PHOTOGRAPHY. THIS IS A PLANNING DOCUMENT ONLY. THE MATERIAL SITE BOUNDARIES SHOWN ON THIS DRAWING ARE APPROXIMATE. OWNERSHIP OF THE LANDS ADJACENT TO THIS SITE ARE UNKNOWN. THE ACCESS ROW SHOULD BE VERIFIED.

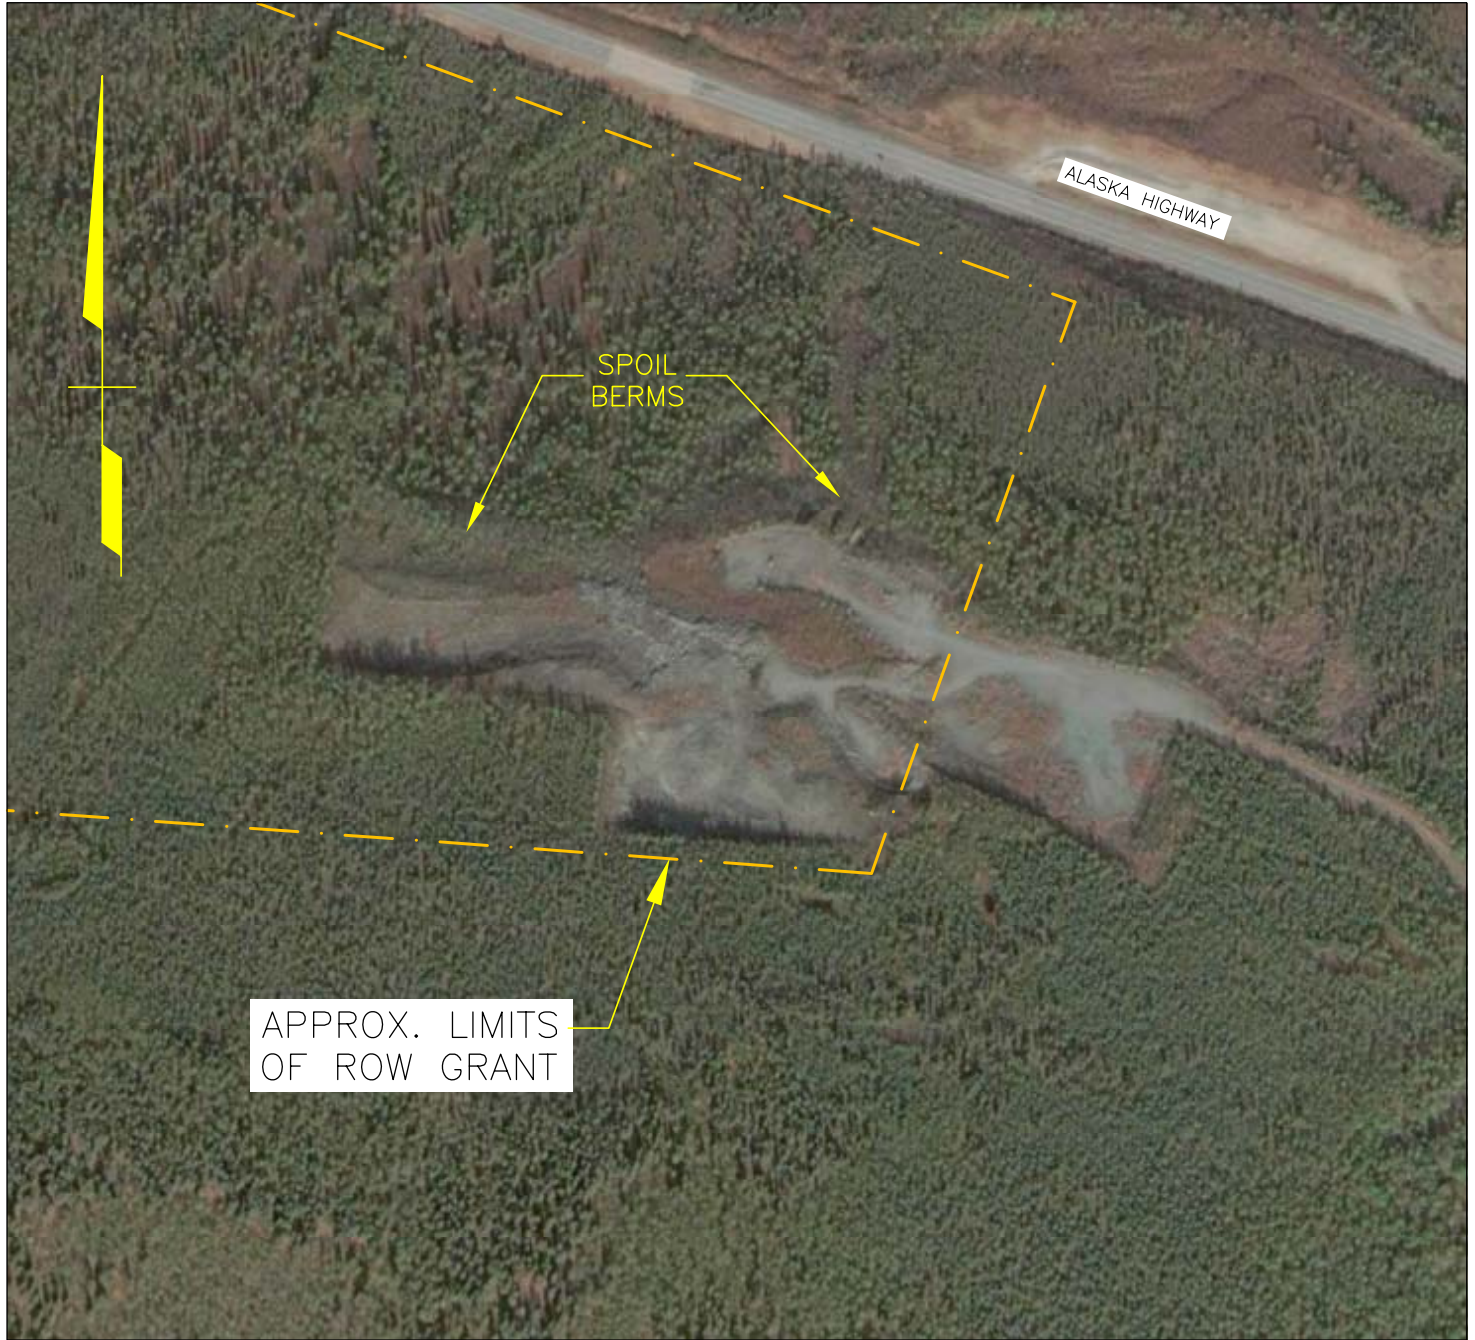
SITE MAP

BASE MAP IS 2005 SATELLITE PHOTOGRAPHY. THIS IS A PLANNING DOCUMENT ONLY. THE MATERIAL SITE BOUNDARIES SHOWN ON THIS DRAWING ARE APPROXIMATE. OWNERSHIP OF THE LANDS ADJACENT TO THIS SITE ARE UNKNOWN. THE ACCESS ROW SHOULD BE VERIFIED.

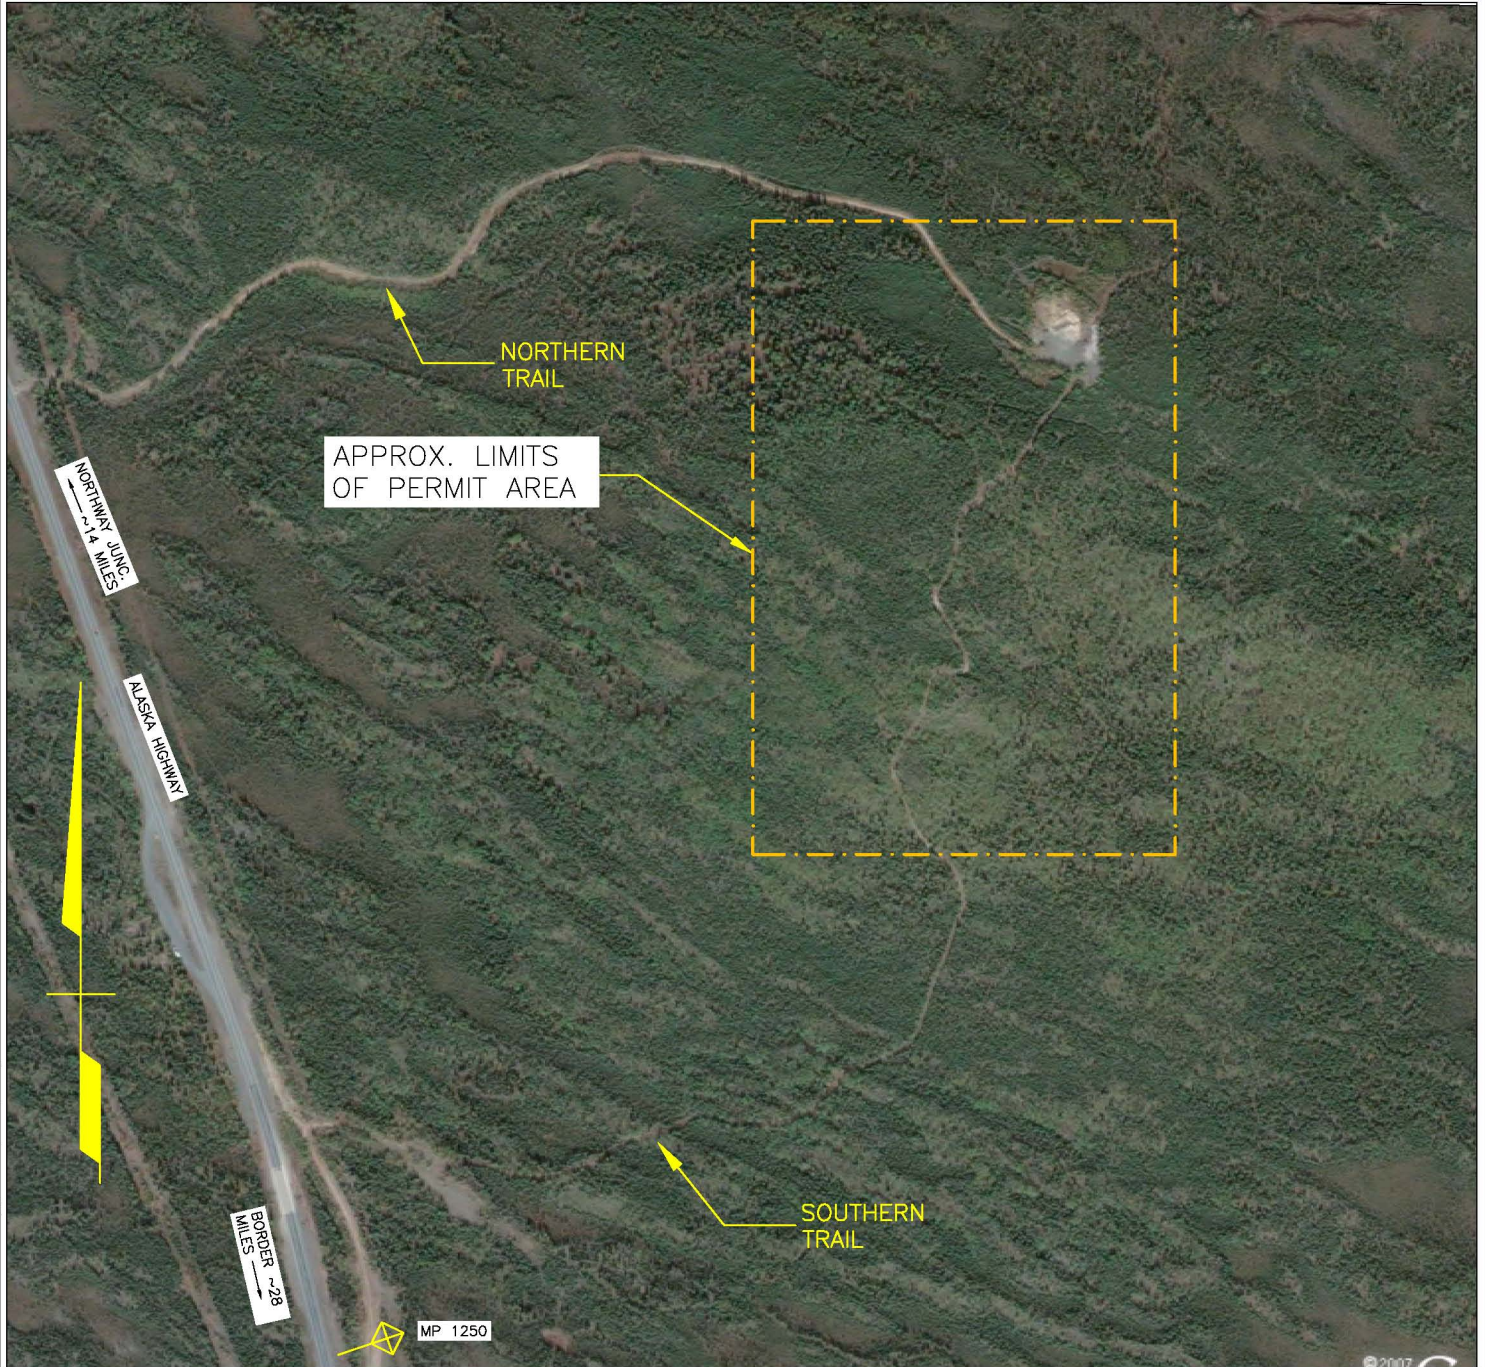
SITE MAP

BASE MAP IS 2005 SATELLITE PHOTOGRAPHY. THIS IS A PLANNING DOCUMENT ONLY. THE MATERIAL SITE BOUNDARIES SHOWN ON THIS DRAWING ARE APPROXIMATE. OWNERSHIP OF THE LANDS ADJACENT TO THIS SITE ARE UNKNOWN. THE ACCESS ROW SHOULD BE VERIFIED.

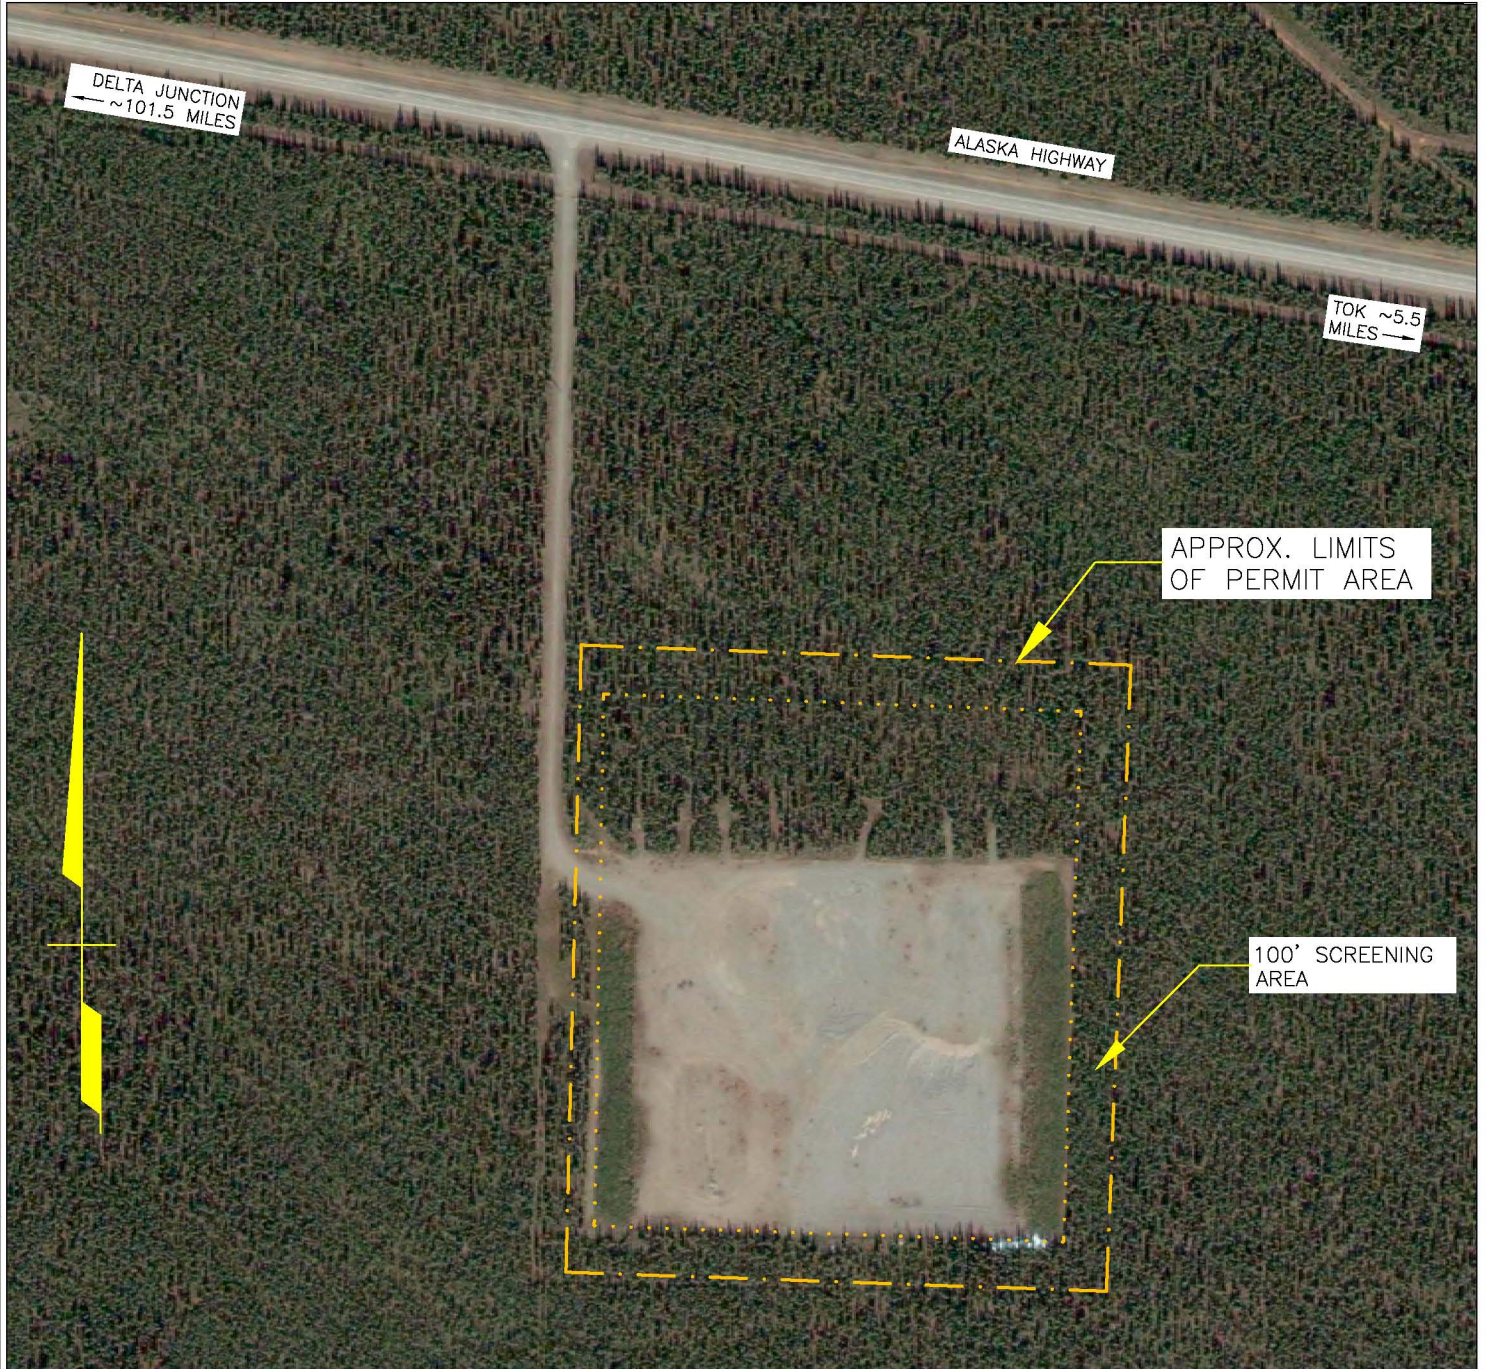
SITE MAP

BASE MAP IS 2005 SATELLITE PHOTOGRAPHY. THIS IS A PLANNING DOCUMENT ONLY. THE MATERIAL SITE BOUNDARIES SHOWN ON THIS DRAWING ARE APPROXIMATE. OWNERSHIP OF THE LANDS ADJACENT TO THIS SITE ARE UNKNOWN. THE ACCESS ROW SHOULD BE VERIFIED.
