# **Environmental Assessment**

*Unalakleet, Replacement of the Water  
Distribution System and Water Service Lines*

Village Safe Water  
The City of Unalakleet, Alaska  
May 2025

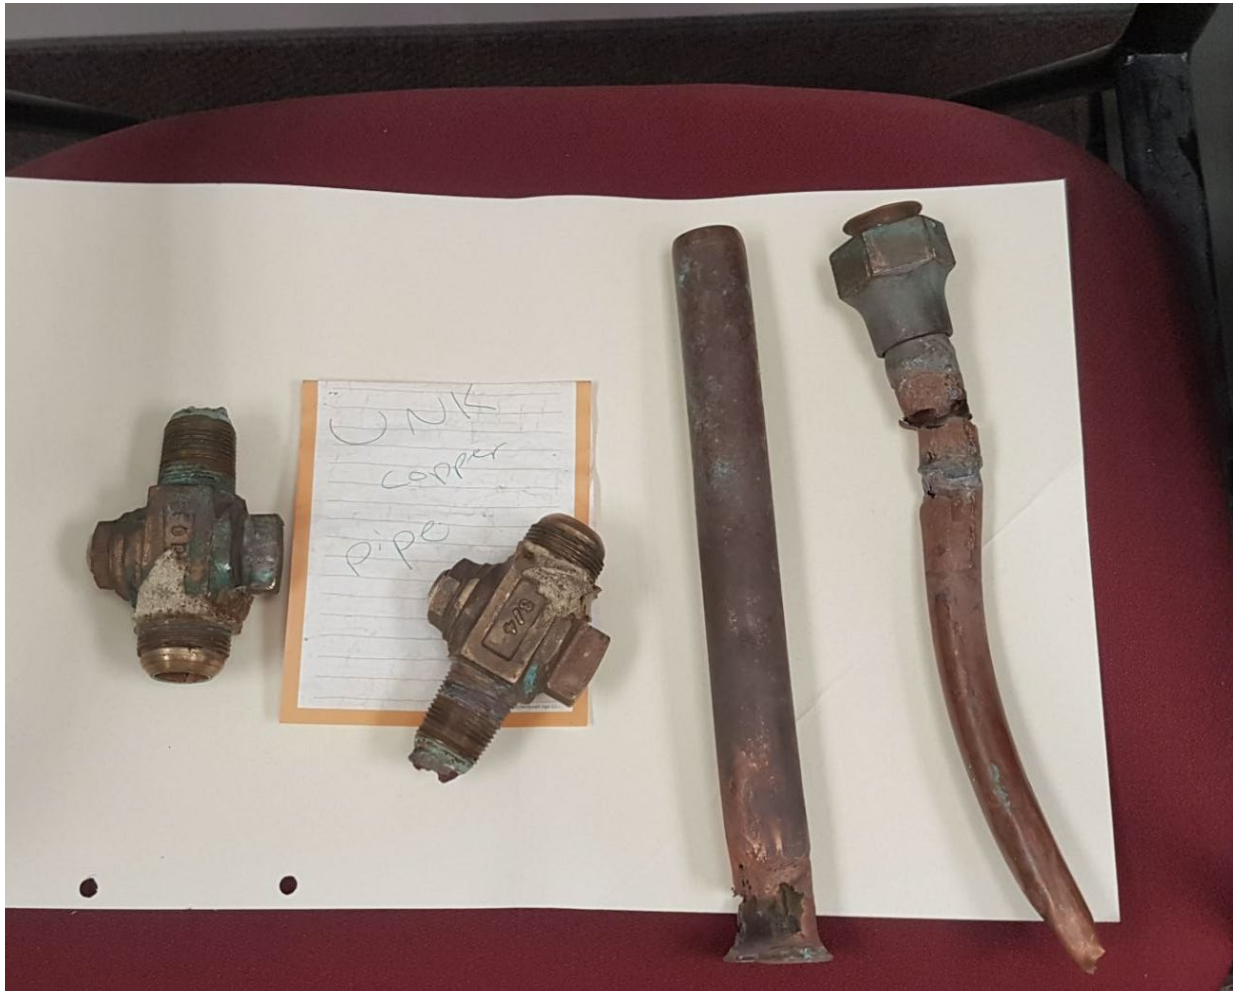
**Figure 2.2: Pitorifices and Piping Typical Failures**

Figure 2.2 shows examples of copper piping and pitorifices that were removed during a water service repair. Note the pitorifices spurs have completely corroded away from the corporation stops. The copper piping has failed around the corporation stops due to corrosion. Local operators report that this is typical of the pipes they pull out of the service lines. Operators also report that existing carrier pipe and insulations are also deteriorating.

The typical water service line consists of one-inch copper supply and return lines inside an insulated carrier pipe. The water service lines freeze-protection includes insulation, heat trace, interior circulation pump, and copper pitorifices. Due to age and corrosion, the water services lines have been experiencing an increase in leaks and freezing. When a water service fails, the old copper piping is pulled out and new high-density polyethylene (HDPE) or Cross-linked polyethylene (PEX) piping is pushed through the carrier pipe. The pulled copper piping shows signs of heavy pitting, corrosion, and pipe wall thinning. The copper pitorifices spurs are often corroded off with wall-thinning around the corporation stop. These failures reduce recirculation through the pipes and increase freezing. Copper pipe is more rigid than HDPE or PEX piping and splits when frozen. Multiple water service lines are replaced or repaired each winter.

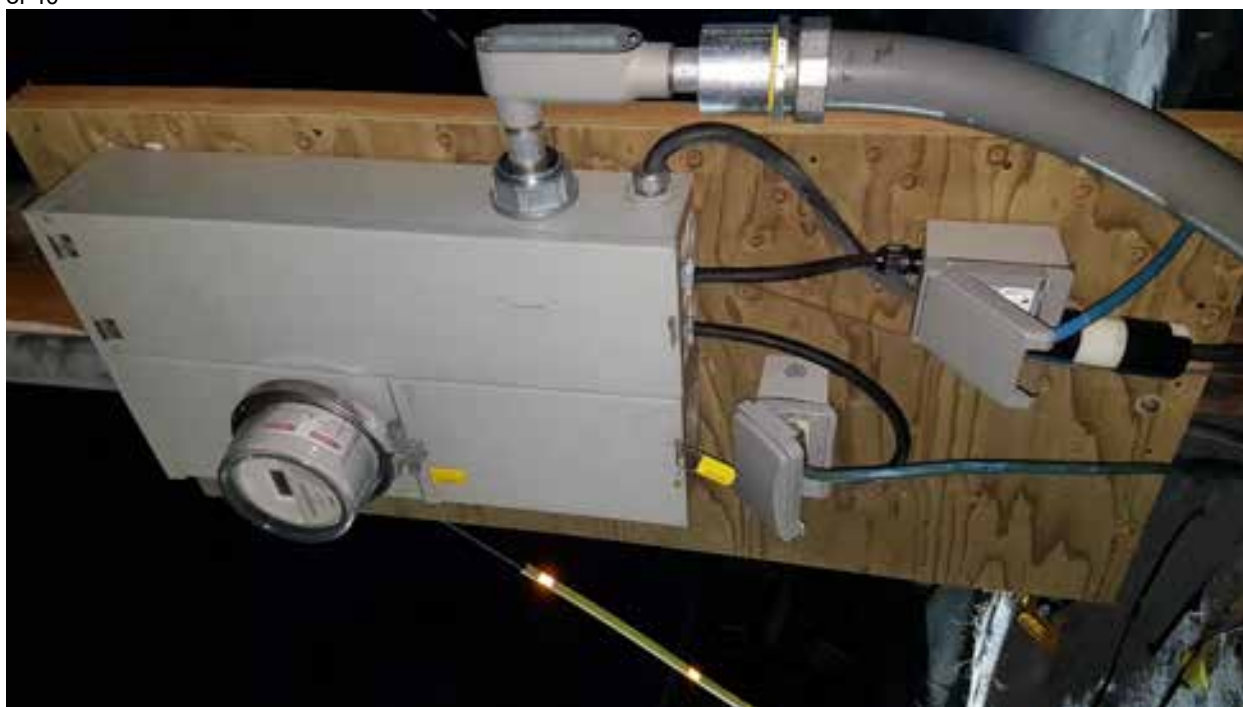
Figure 13 - 125 amp meter base needing replacement with 200 amp meter base

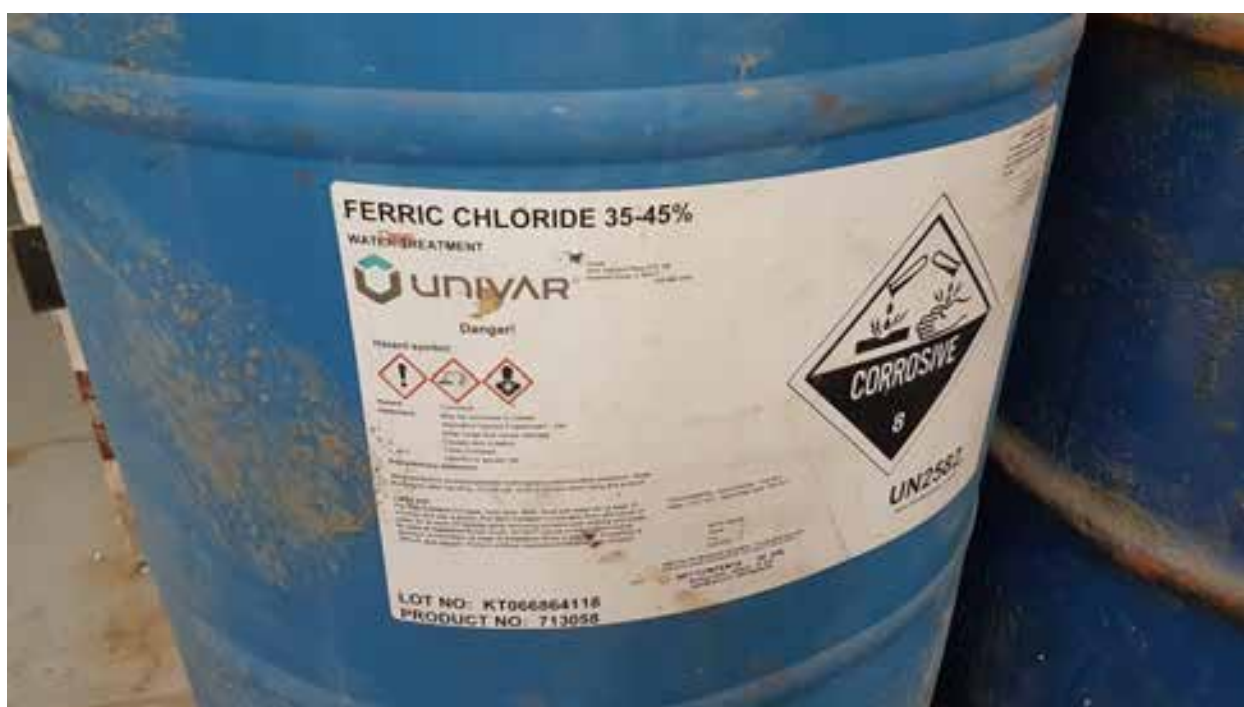
Figure 14 - Strength of Neat FeCl at plant

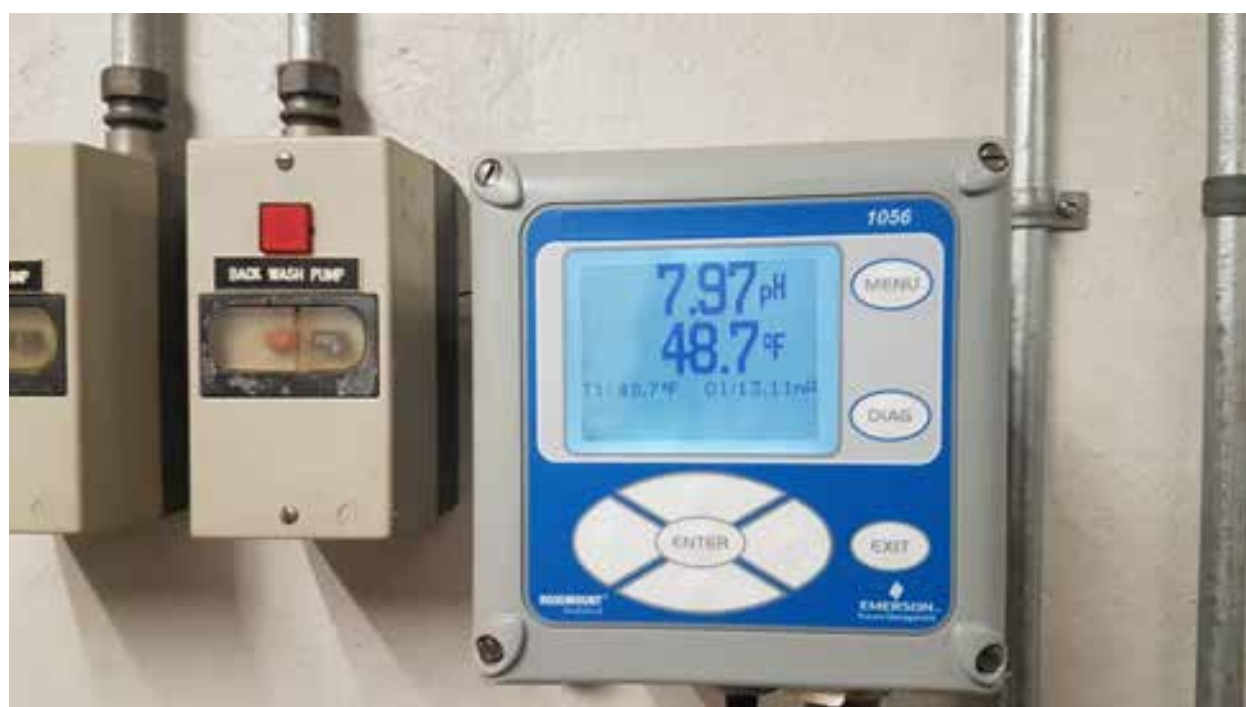
Figure 16 pH meter of treated water - Probe needs calibration – Sensor located on treated water to tank line

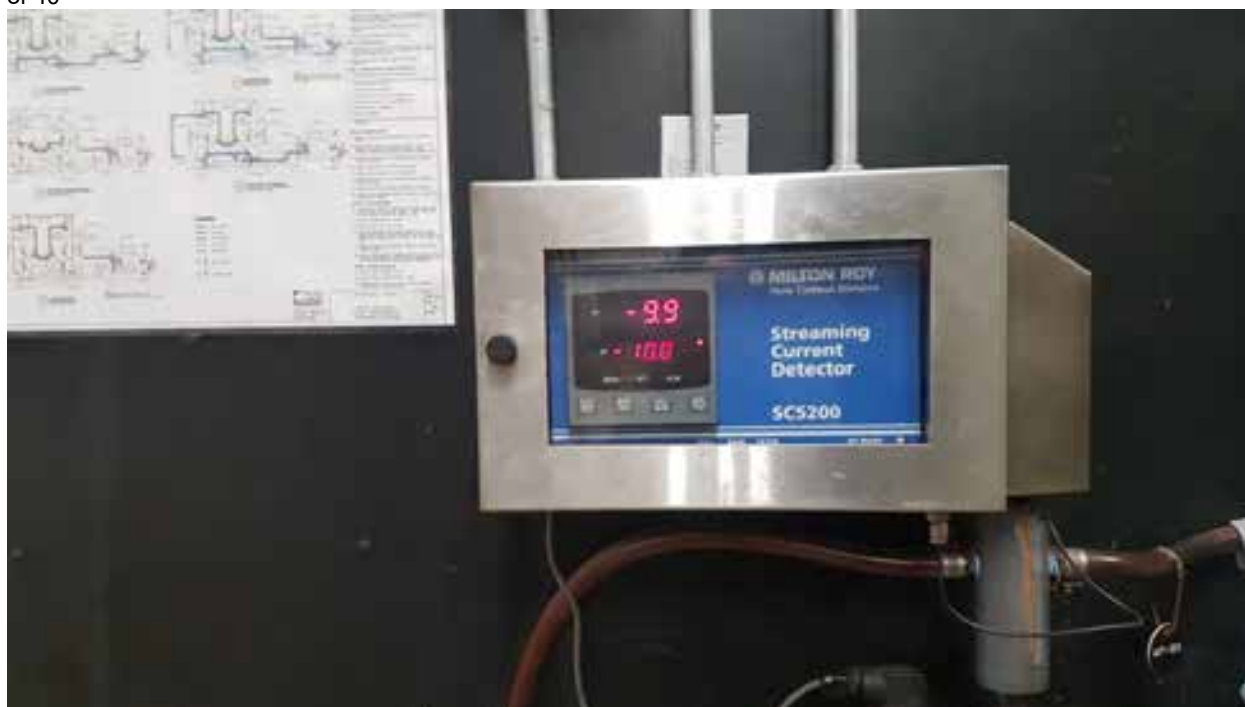
*Figure 17 - SCD showing setpoint value is met during treatment*

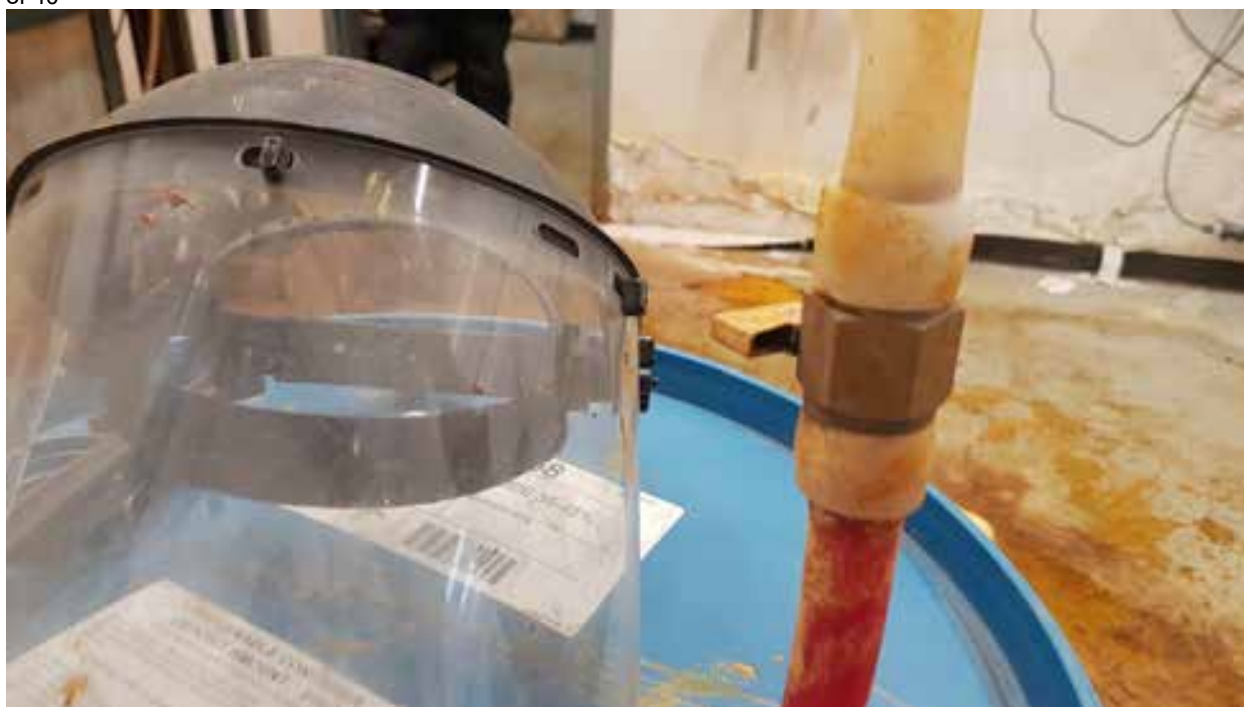
*Figure 19 Neat FeCl transfer pump is broken. Crew used temporary valve which corroded away within 20 to 30 minutes.*

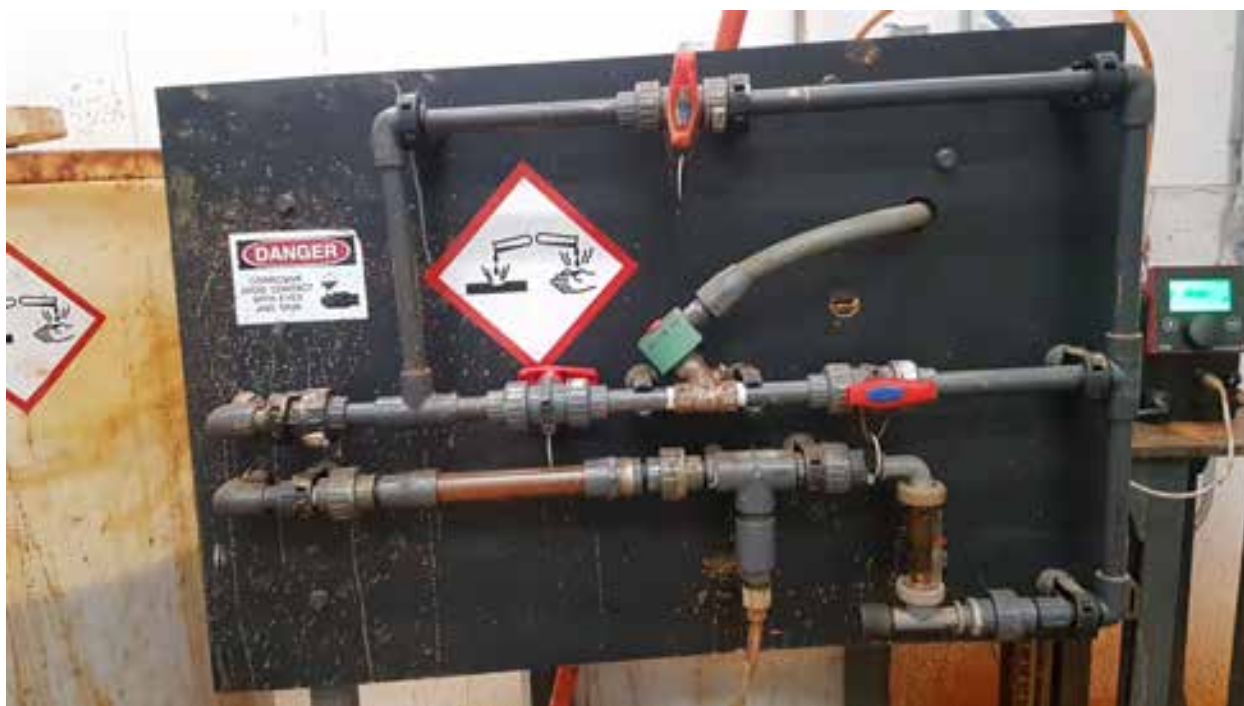
*Figure 20 FeCl Neat Tank to Stock Solution tank mixing manifold. This needs some repairs.*

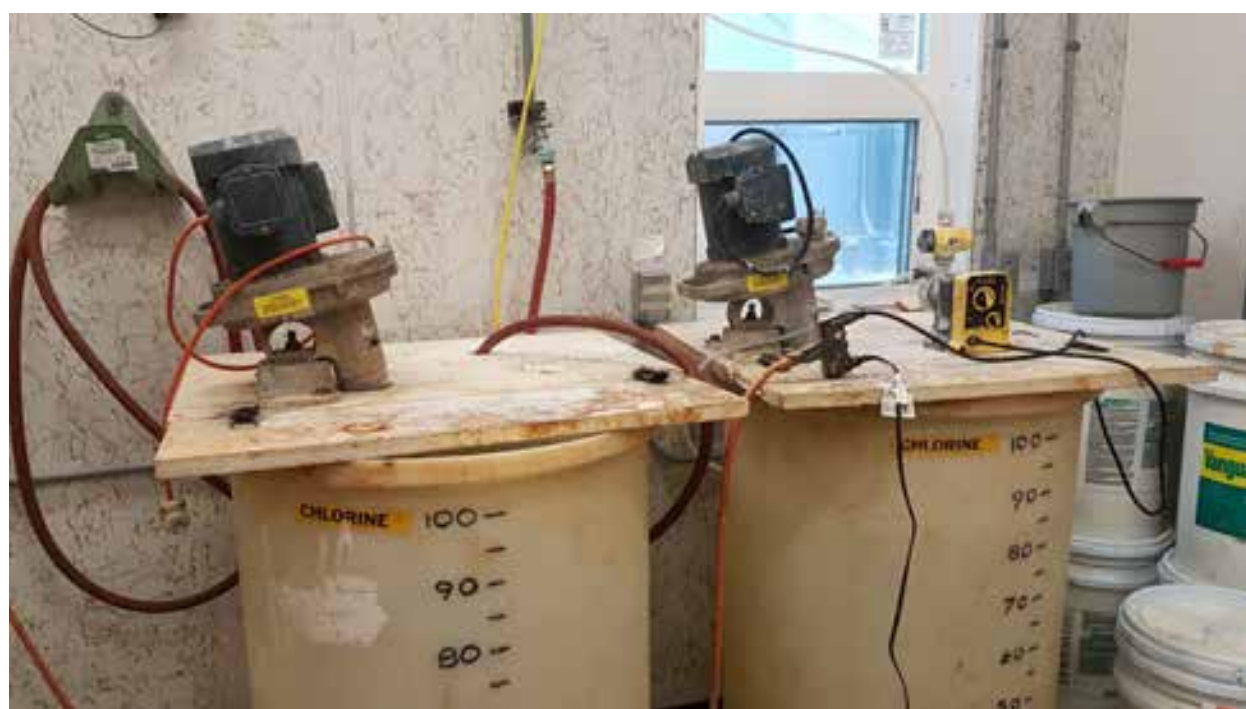
Figure 22 - Chlorine vats - Only one operational pump - Crew swaps pump between tanks as needed.

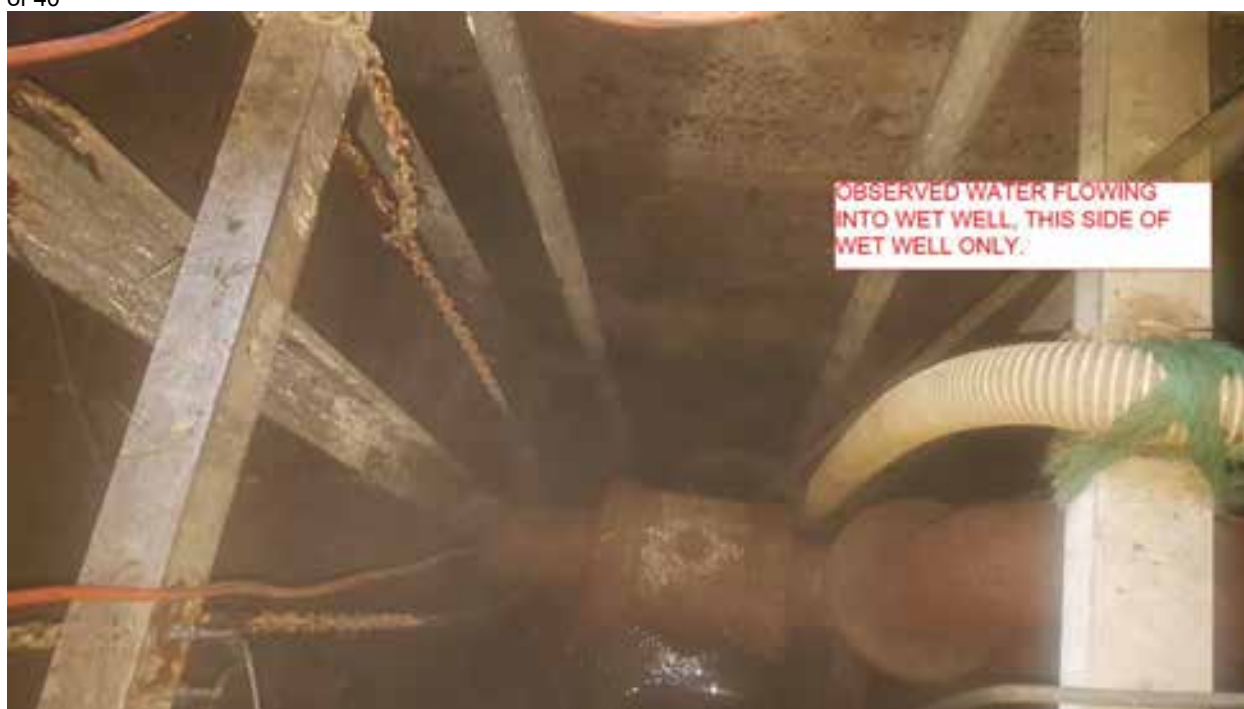
*Figure 27 - FAA Lift station - Water seeping through wet-well, especially when utilidors are flooded*

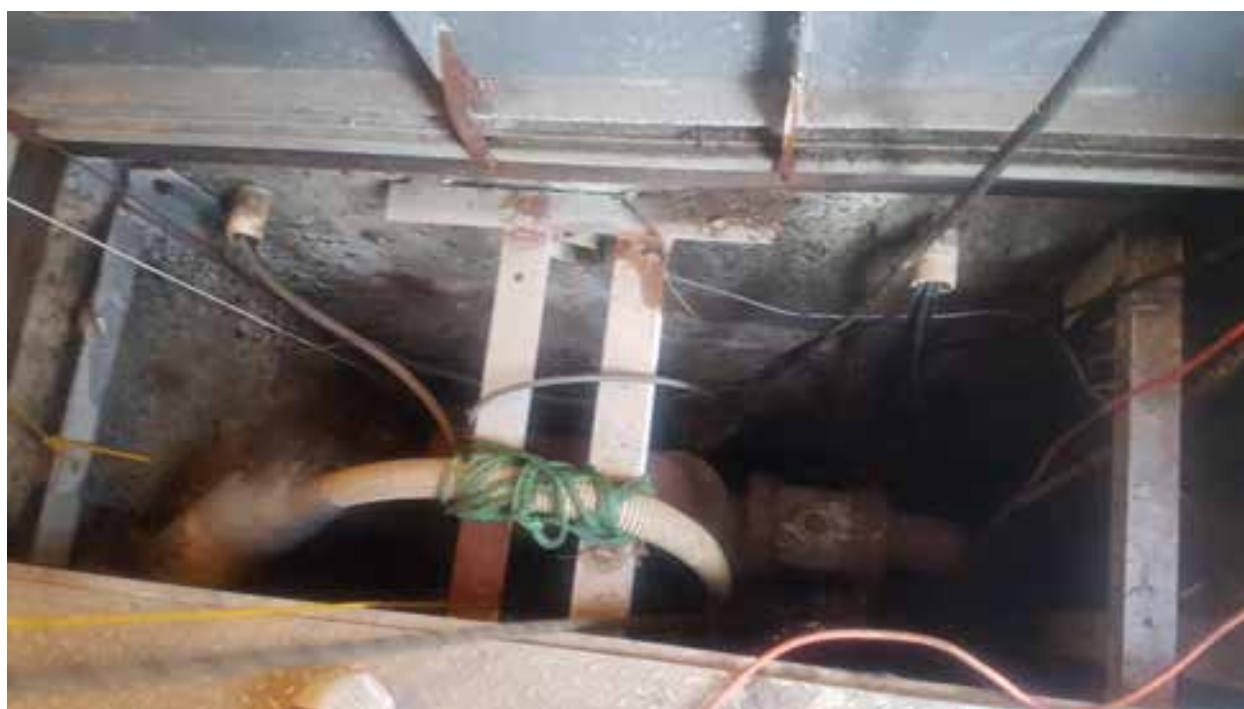
*Figure 28 - FAA Lift station - Temporary 110v pump and hose connection with temp 110v float switches.*

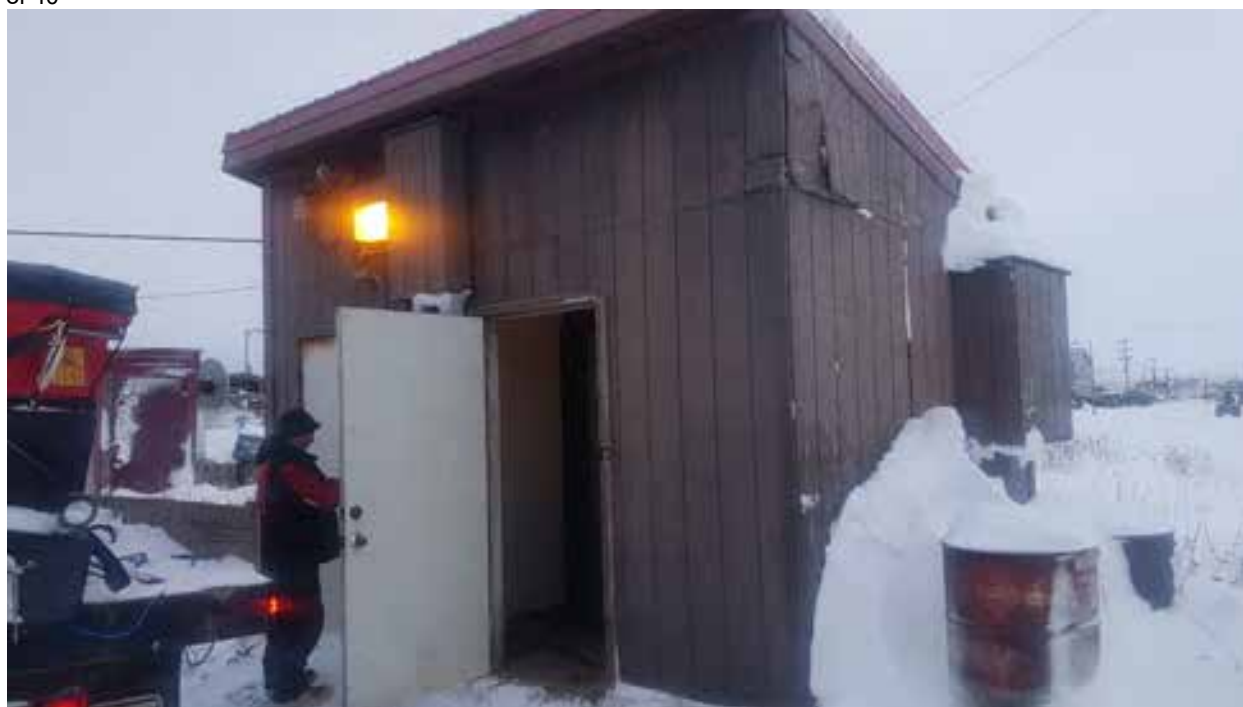
*Figure 29 - Terminal Lift Station Exterior - Note Damage on Top Right Exterior*

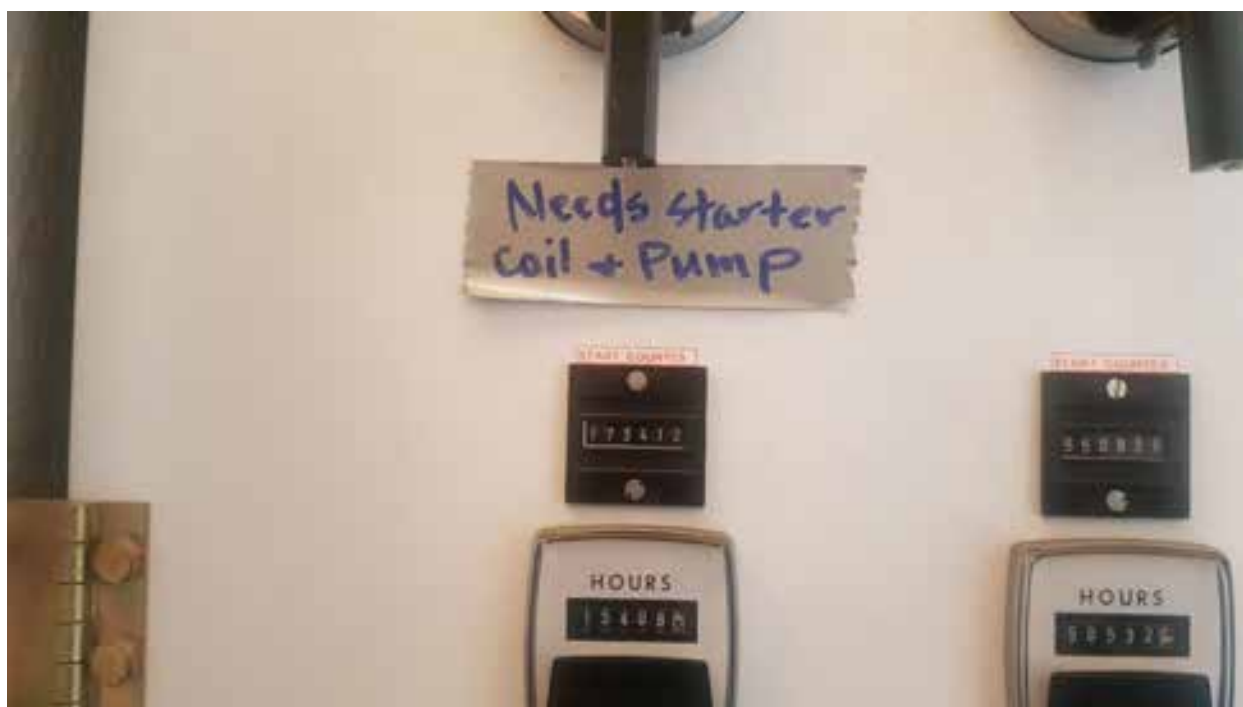
*Figure 30 - Terminal Lift Station Control Panel - Recommended parts for functionality*

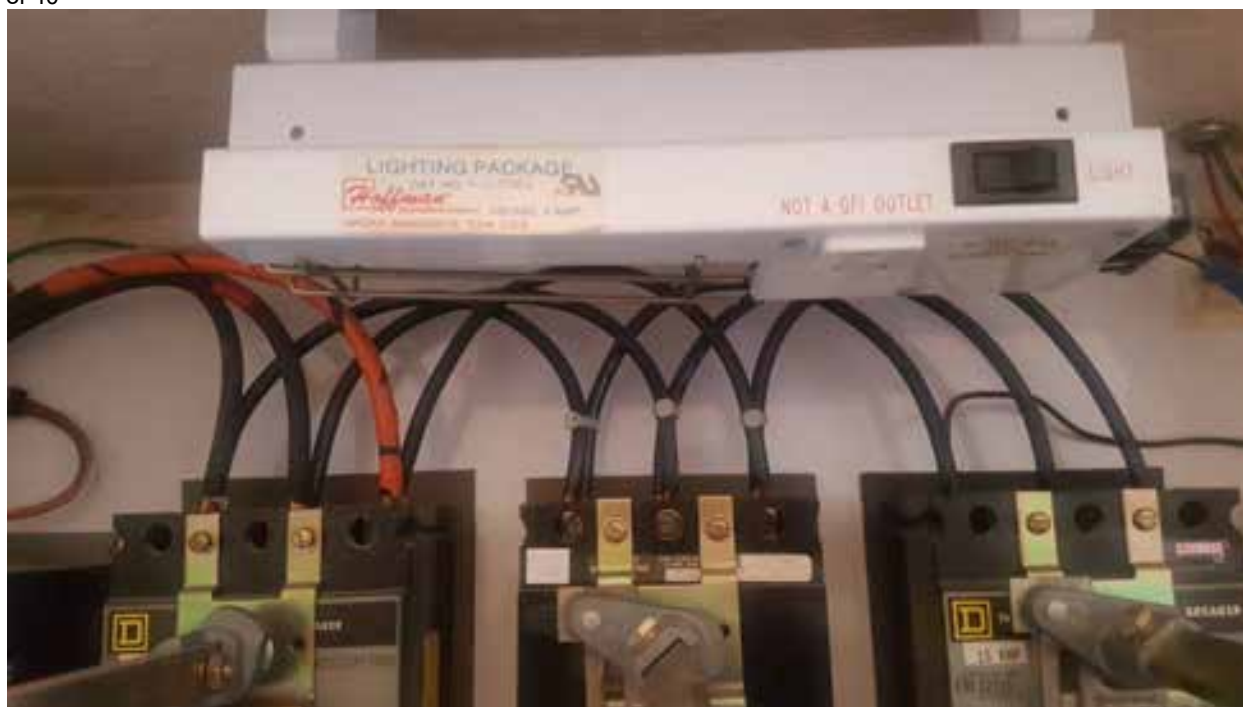
*Figure 31 - Terminal Lift Station wiring - Interior looks good, only one picture to show general condition*

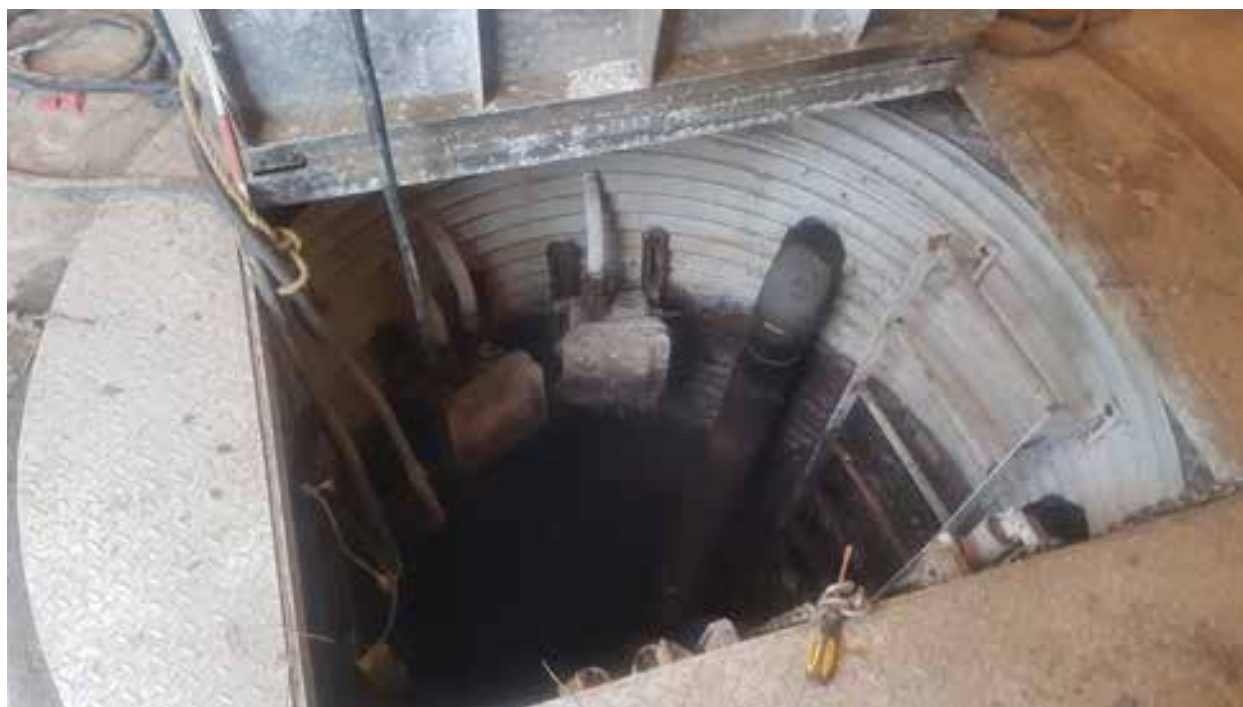
*Figure 32 - Terminal Lift Station - Show of wet well. Functioning pump is on entrance side. Power junction boxes should be taken out of the wet well, and new ones placed above with conduit running down into wetwell.*

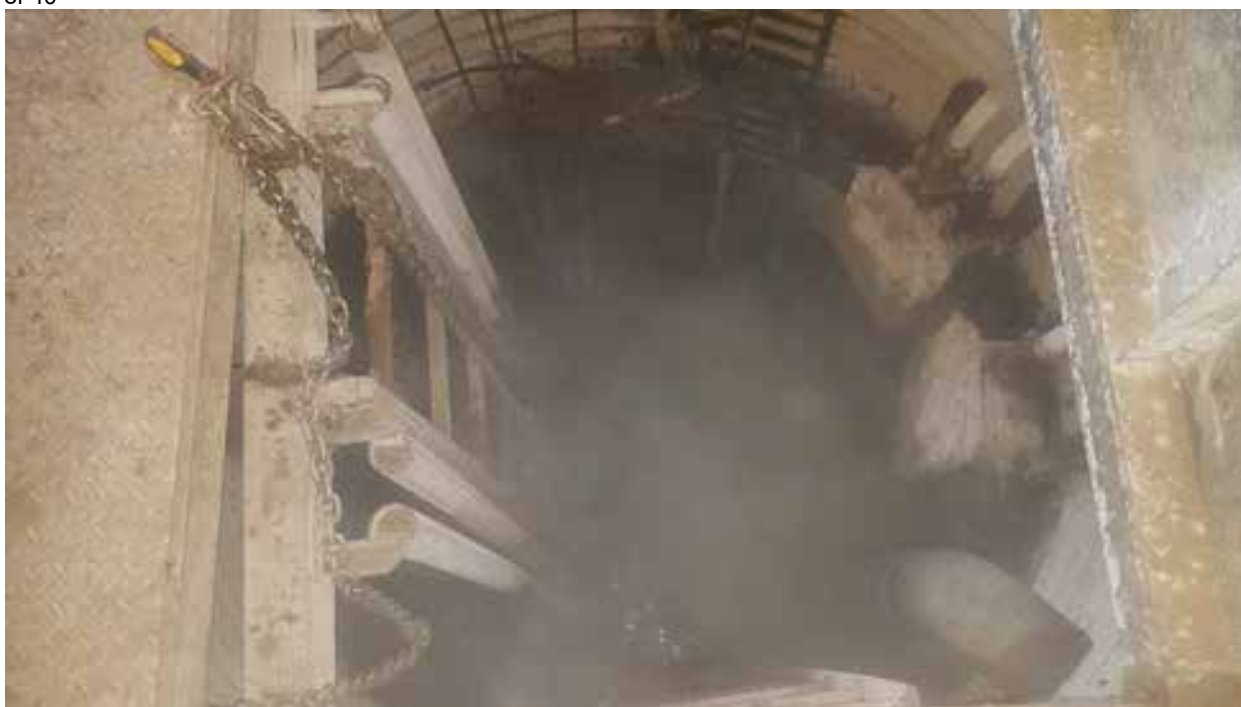
*Figure 33 - Terminal Lift Station - Rails intact - side closes to picture is where pump was reportedly dropped and broke the bottom supports.*

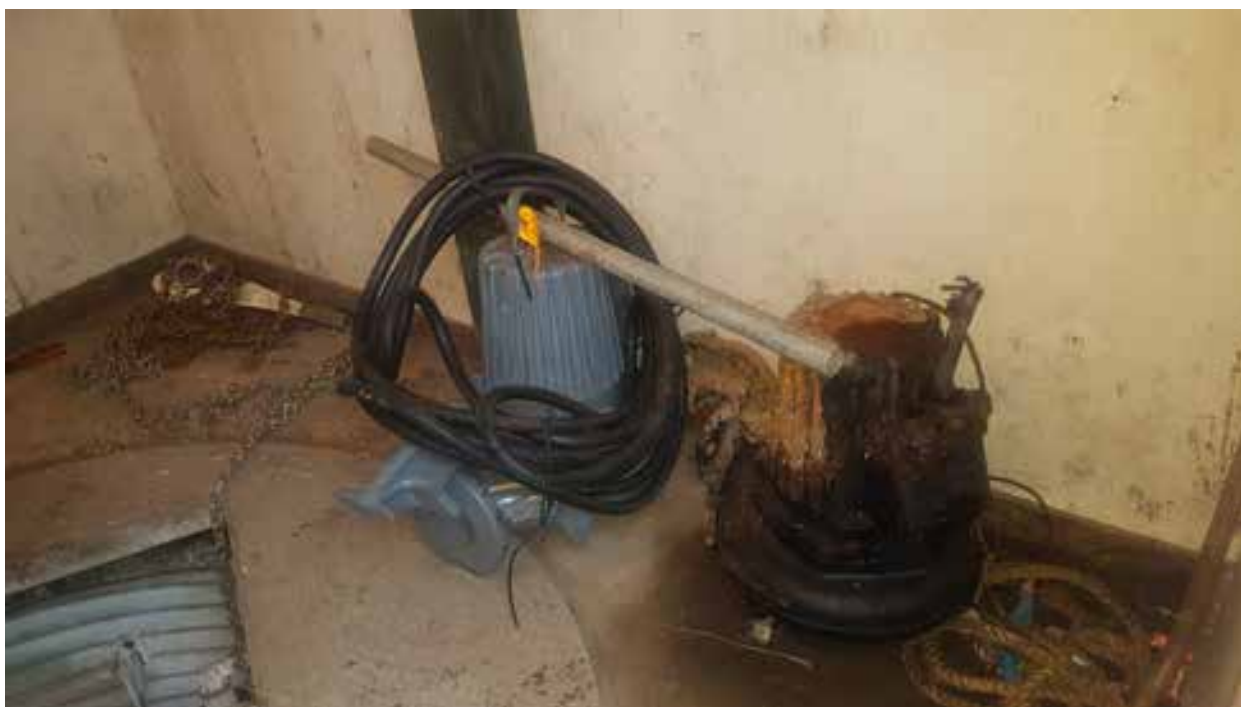
*Figure 294 - Terminal Lift Station - Spare Pump - Could be installed if supports were fixed properly.*

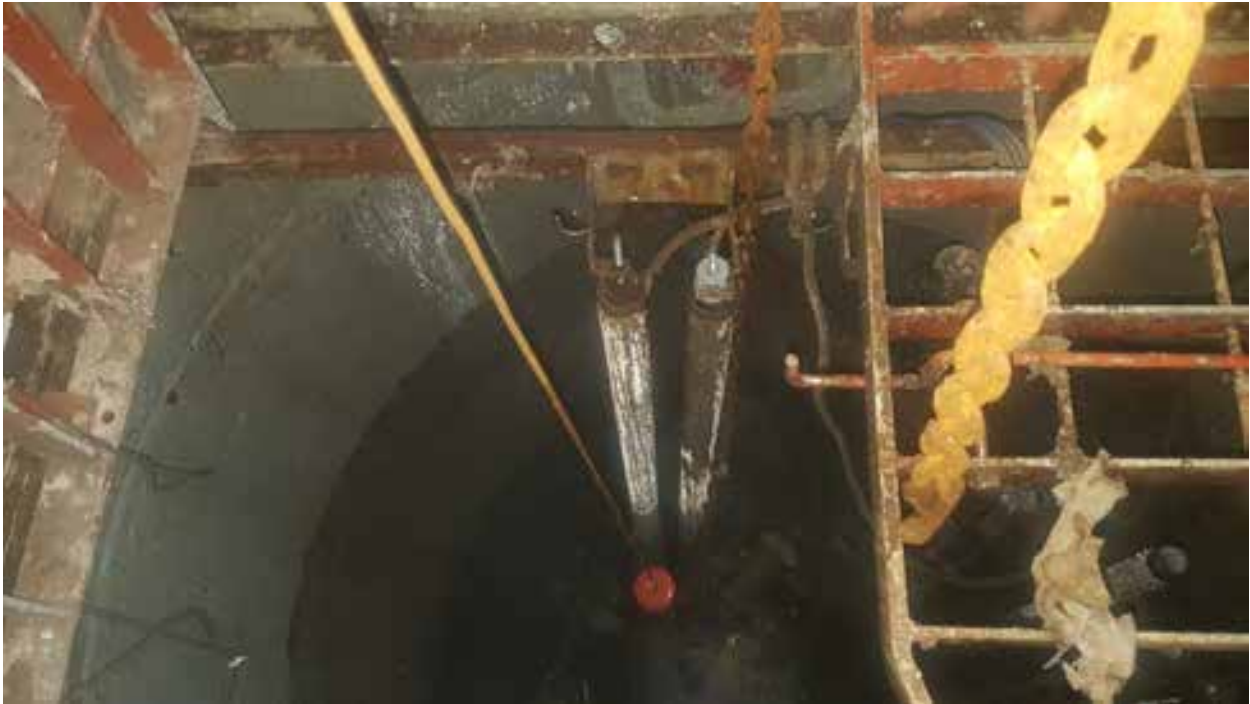
*Figure 37 - Covenant Lift Station - Rail mounting brackets have been jacking up. They buckle when operators try to pull pump. Operators would rather "jog" the pumps over and over instead of risking losing the support bracing.*

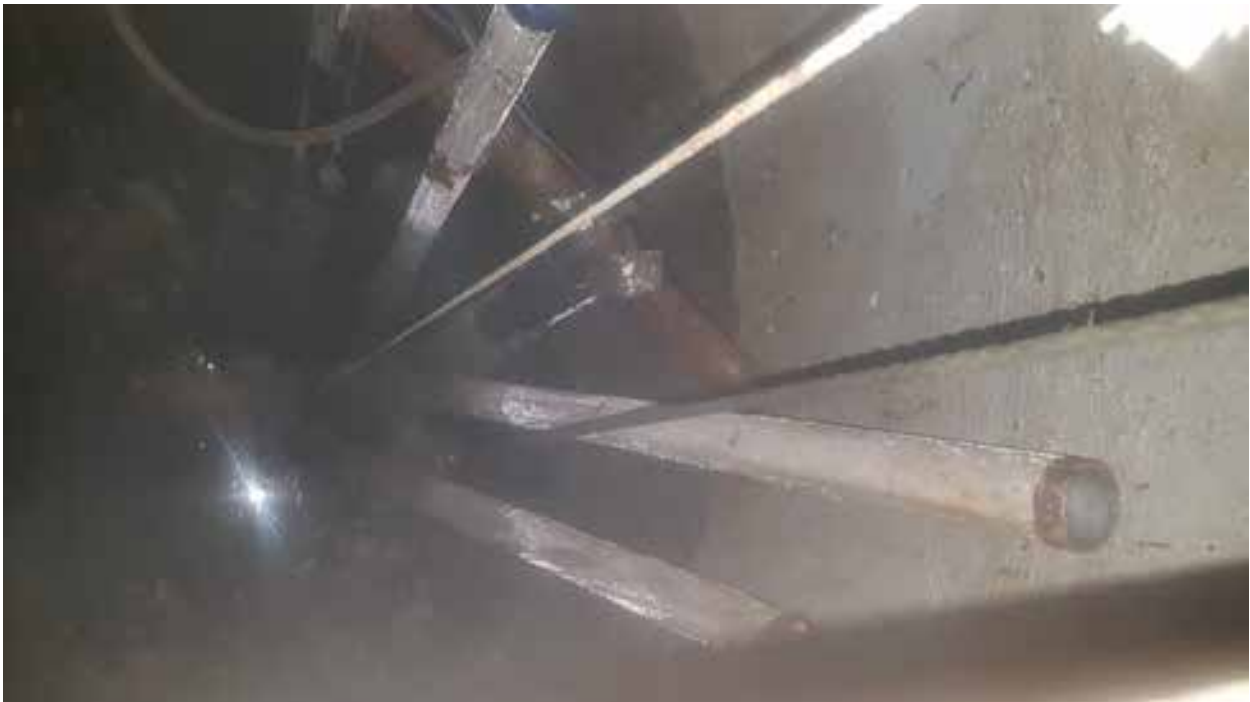
*Figure 3830 - "Support" bar that operators must stand on to re-align pump rails when they dislodge, as well as re-wire a new pump when one fails. Bar is angled behind the set of functioning pump rails (left) to the concrete wetwell behind the shadow of the chain.*

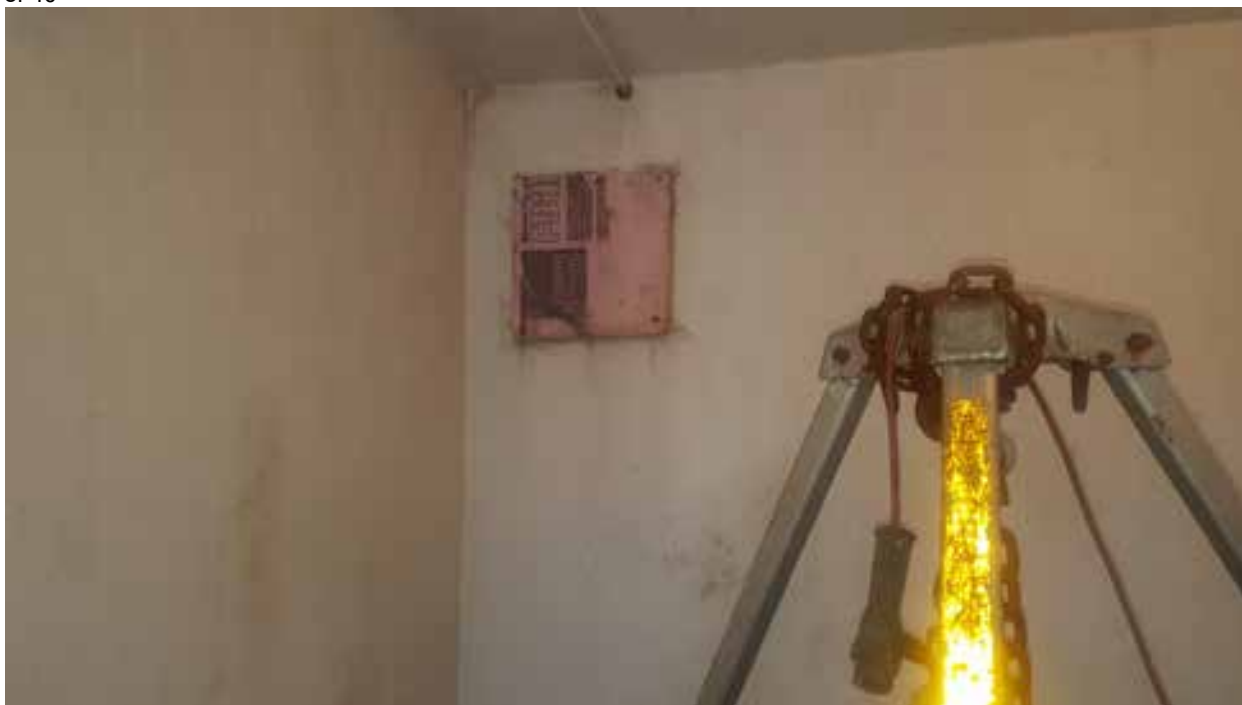
*Figure 39 - Covenant Lift Station - Vent Package Removed. Boarded Up*

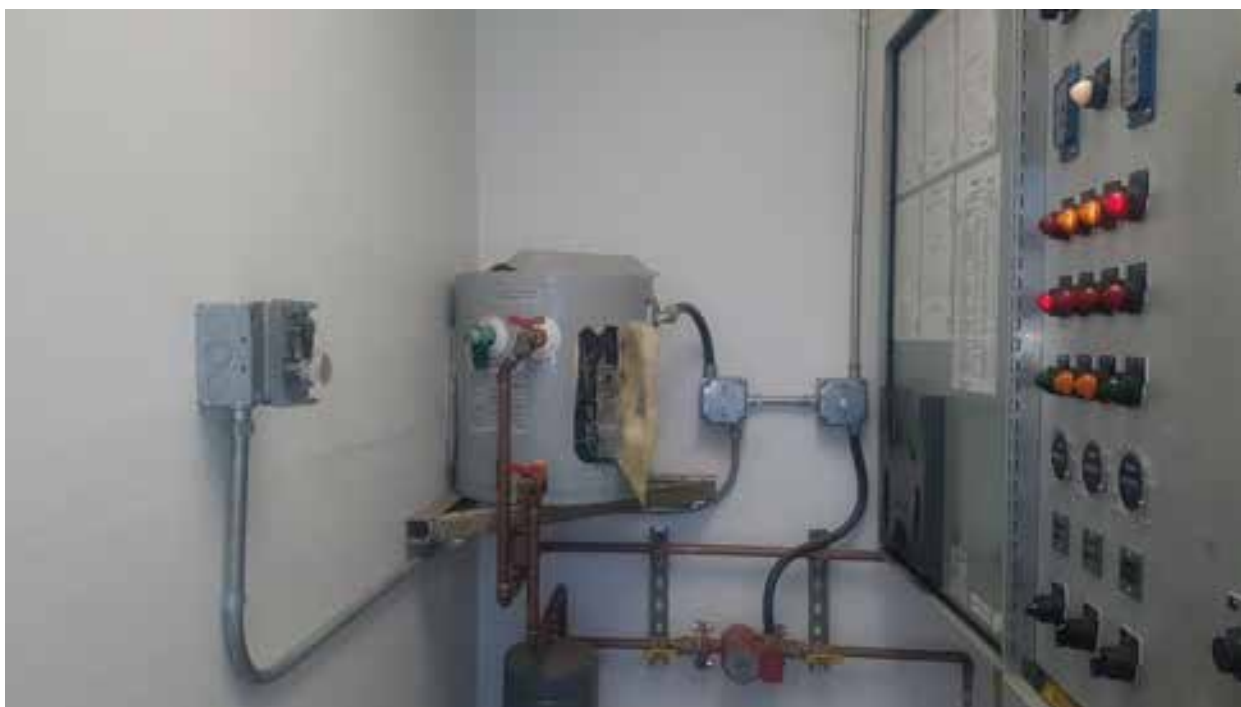
*Figure 42- Covenant lift station - Broken water/glycol heater for slab, control panel on right*

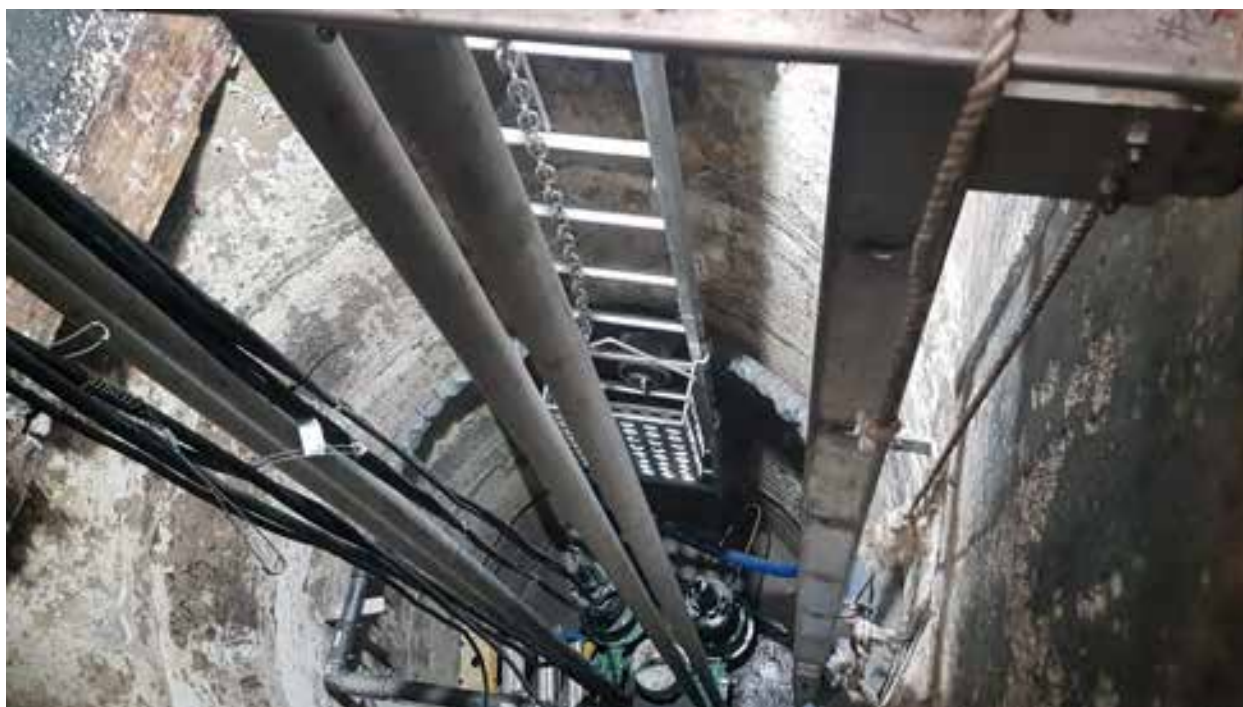
*Figure 334 - HVLS Looking down well after all pump cables and power have been set. Temporary connection hose is routed around the ladder (grey)*

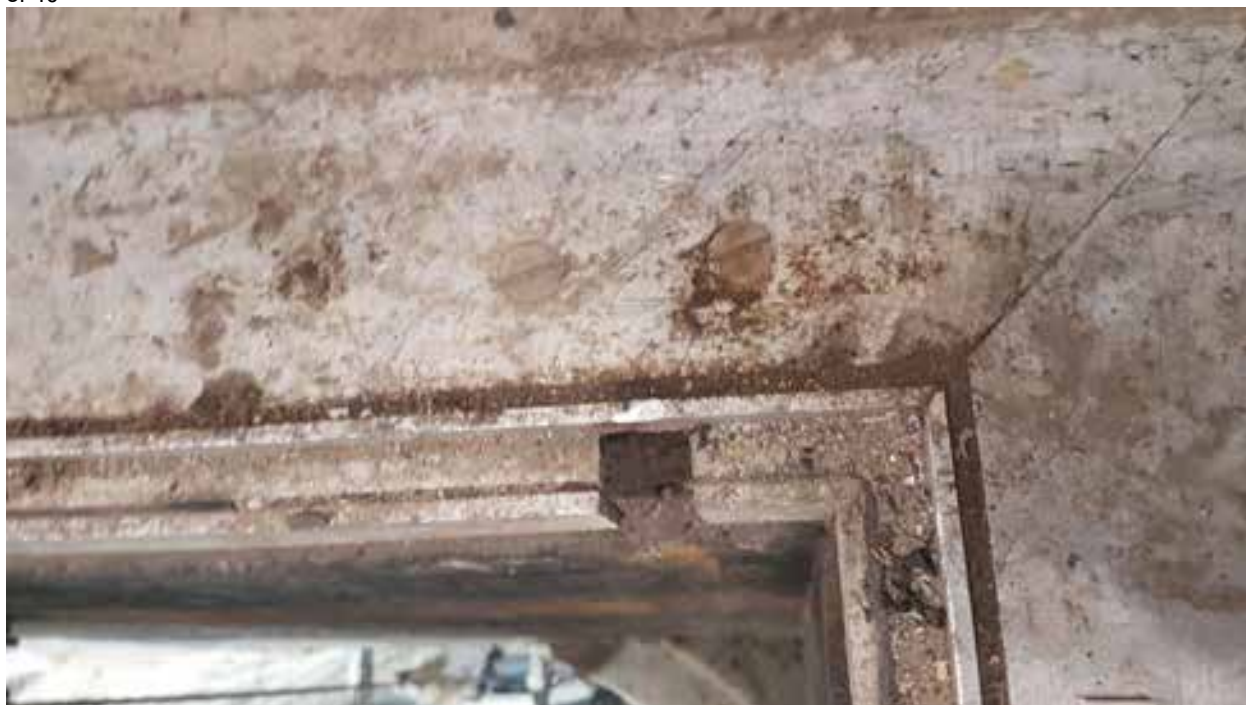
*Figure 45 - HVLS wet well hatch existing - requires demolition prior to installation of new hatch*

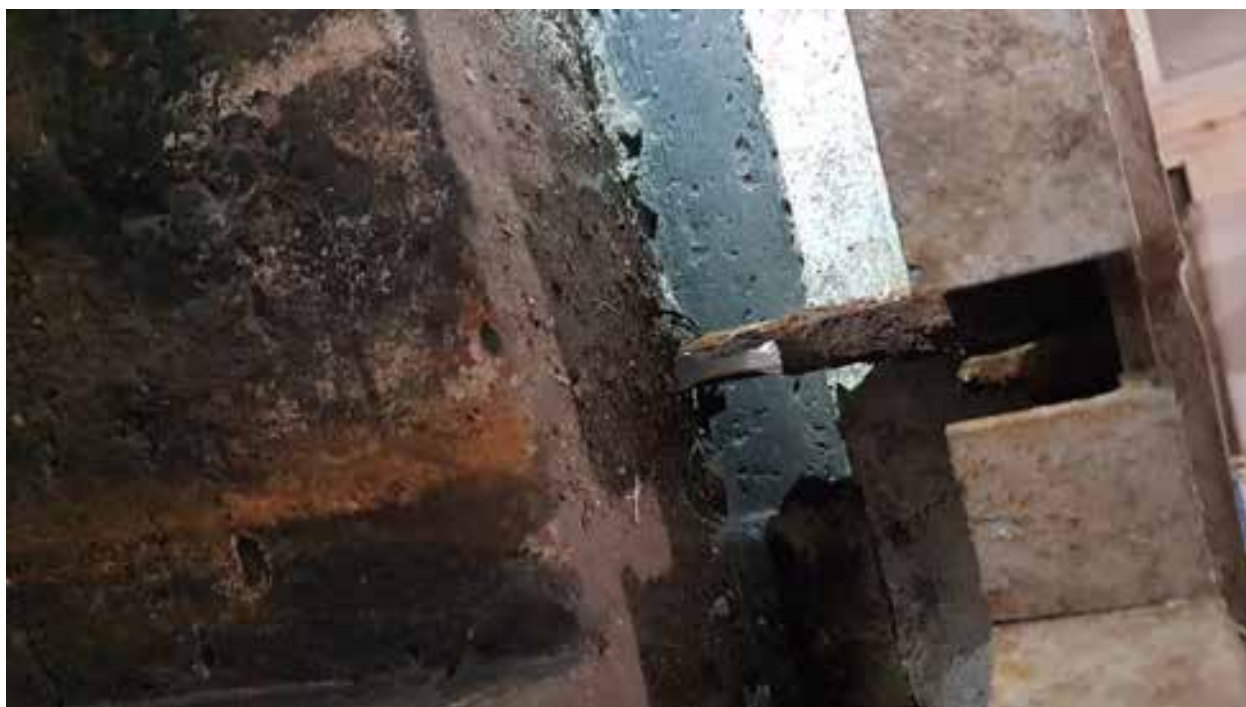
*Figure 46 - HVLS Existing Wet Well hatch - interior shot showing hinge and how angle iron is set in concrete*

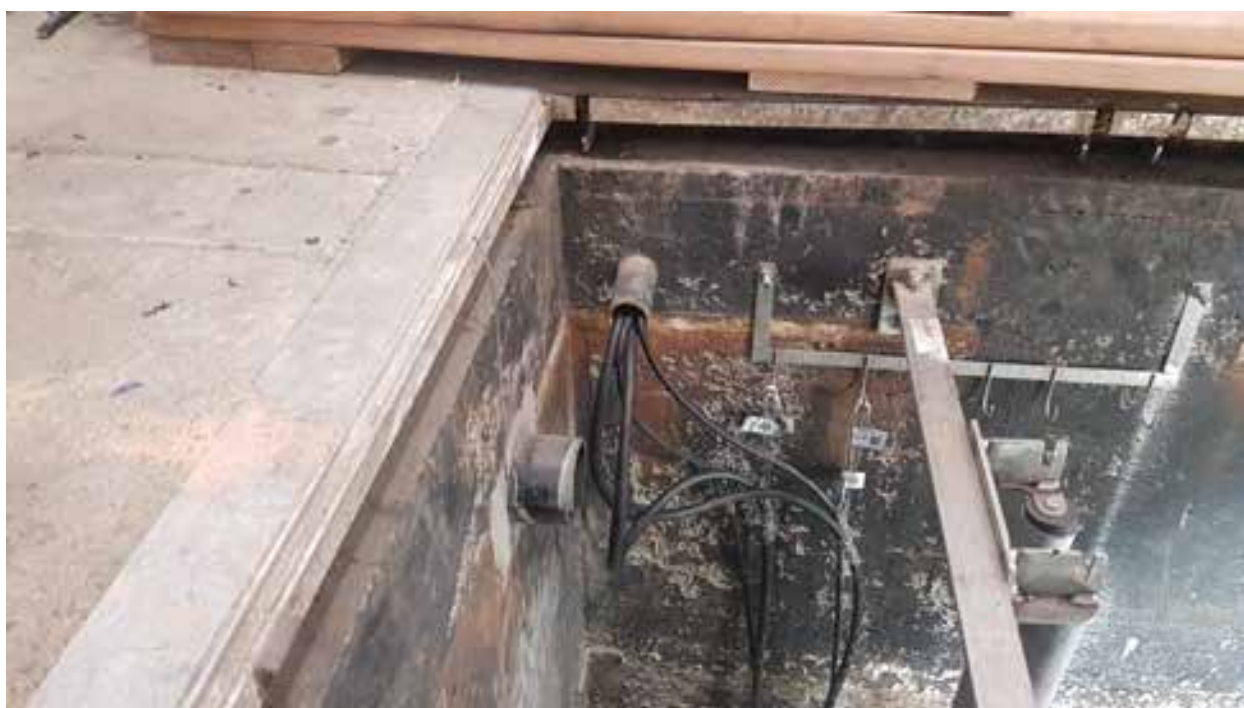
*Figure 52 - HVLS with pump power cables running through conduit - suggest future orders for pump power cables to longer than necessary.*
