# **Environmental Assessment**

*Unalakleet, Replacement of the Water  
Distribution System and Water Service Lines*

Village Safe Water  
The City of Unalakleet, Alaska  
May 2025

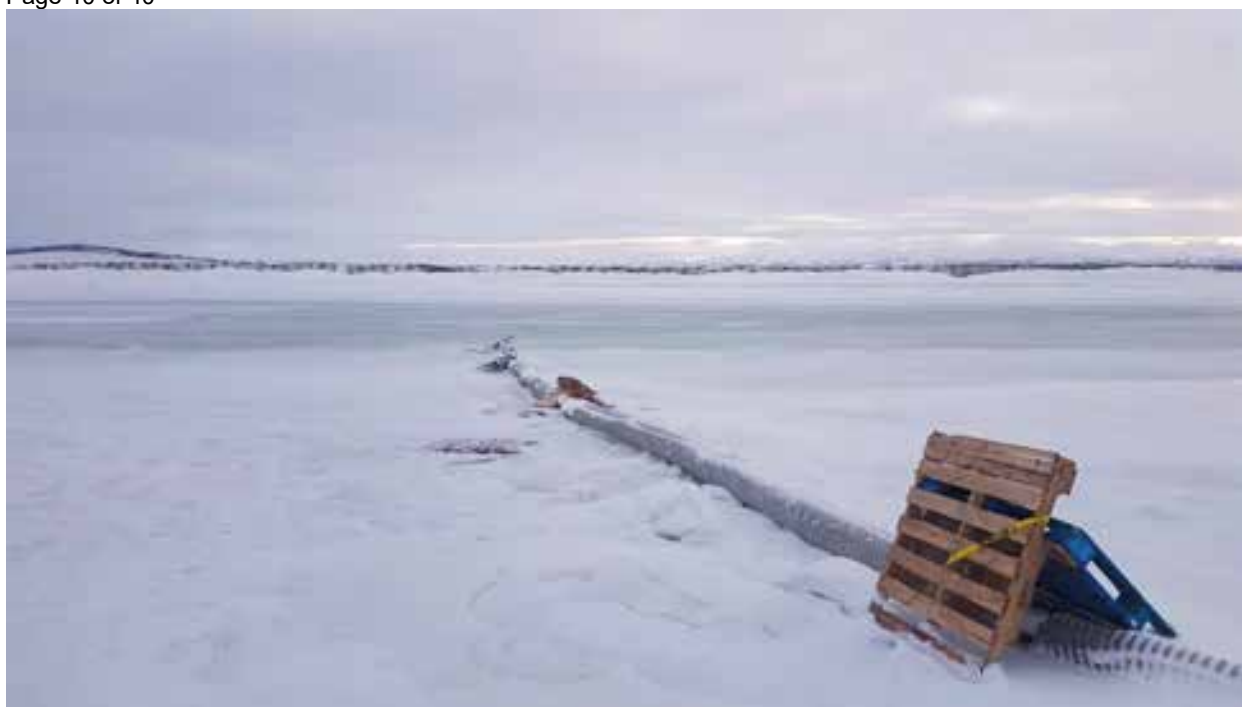
*Figure 55 - Slough Bypass for freeze prevention of system.*
