# PROJECT INFORMATION REPORT REHABILITATION OF DAMAGED FLOOD CONTROL WORKS SKAGWAY RIVER LEVEE, SKAGWAY, ALASKA ALASKA DISTRICT

March 15, 2024

PROJECT NAME: Skagway River Levee

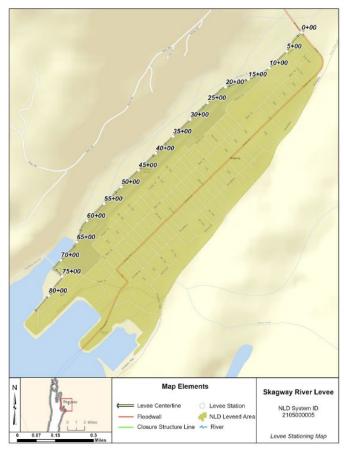
Figure 1. Skagway River Levee Stationing Map from MMC Report

The stationing for the scenarios discussed above can be seen in Figure 1. The total number of structures inundated, and the damages associated with each scenario can be seen in Table 3. The breach (LB) and no-breach (NLB) scenarios do not differ greatly. As such, in this analysis, we have averaged them into "Low", "Medium", and "High" damage levels, and kept the "Airport" scenario separate. We have also updated damage estimates to 2023 dollars using the owner's equivalent rent of residences in urban Alaska from the Bureau of Labor Statistics (Table 4).

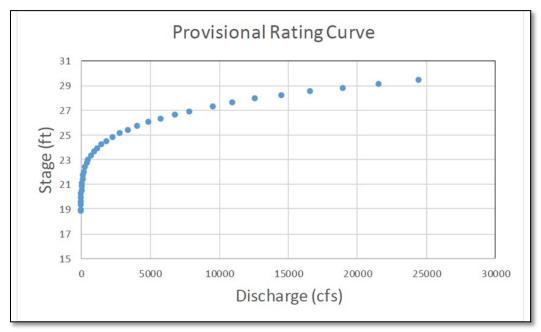
Figure 2 was taken from the 2021 report and shows the relationship between stage height and flow volume for the Skagway River based on the data from the United States Geological Survey (USGS) 15056100 Skagway River at Skagway, Alaska gage for years 1963-1986 and from the current NWS gage SKGA2 located on the pedestrian bridge beside the highway bridge. It should be noted, this data was considered suspect and was identified as such in the MMC report but was used here because it was the only data available.

Figure 2. Provisional Rating Curve for the Skagway River

For this analysis we have cross-referenced this graph with the Annual Exceedance Probability flow rates from the USGS. This provides an approximate relationship between stage, flow rate, and the likeliness of a given flood (Table 5). It should be noted that there is no historical flood record against which to validate these relationships. The report stage values are based off the non-operational USGS gage and do not correlate to the NWS gage stage value of the 2022 flood event.

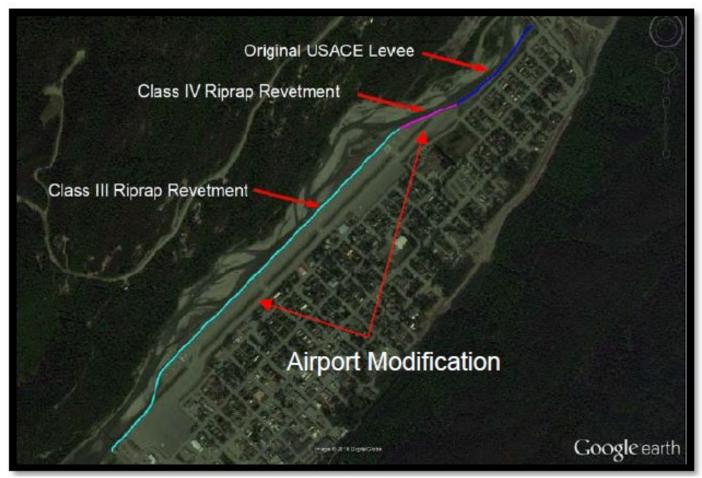
Figure 5 – Components of the Skagway River Levee.

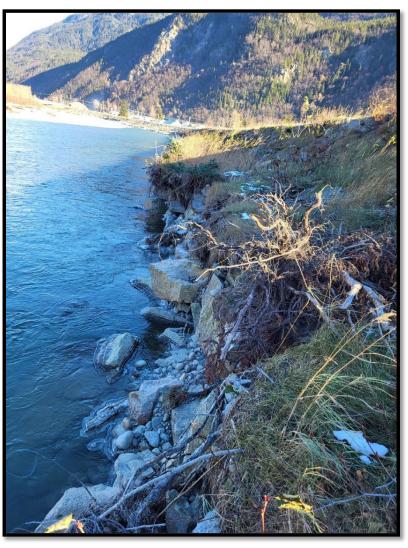
Figure 6 – Erosion along toe where airport modification was complete in 2001. Area should have a 13-foot-wide toe and the toe is only roughly 3 feet wide in this section.

The Repair in Place Alternative includes a construction length of approximately 5,000 LF which will reconstruct the riverward levee side slopes and toe with Class IV riprap for the entire length of the repairs. Based on the amount of Class III armor stone that was displaced during the flood of record, it was deemed critical to increase the armor stone size for stability and longevity of the structure. PL 84-99 authorizes using updated Engineering techniques for levee rehabilitation projects. Increases in armor stone size is authorized from updated scour analysis. This will entail reshaping the riverward slope to a 1.5H:1V side slope, restoring the riverward toe to its original design width, and adding a one stone thickness Class IV riprap armor layer over the existing levee. Due to scour and erosion of the existing slopes, Class II riprap will be used to reshape the existing structure with a 1.5H:1V side slope before the addition of Class IV riprap.

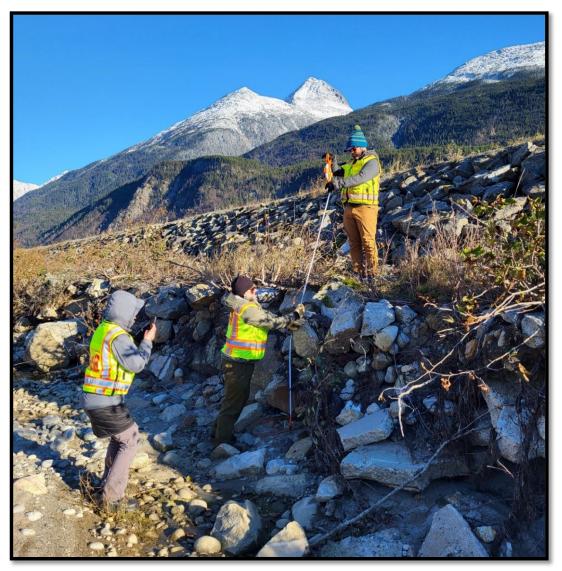
Figure 7 - Erosion along toe where airport modification was complete in 2001. Measured 5 feet of scour in this location.

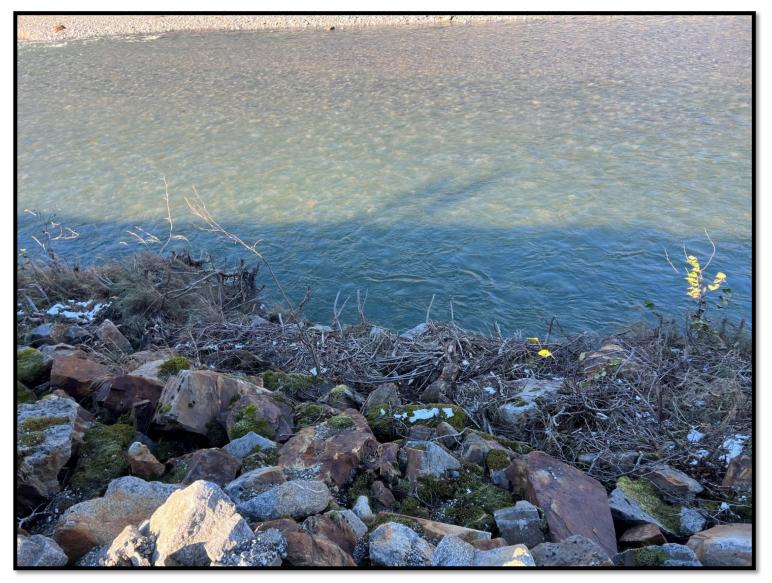
Figure 8 – One of the areas along the levee where the toe is completely gone from erosion. Scour and undermining of the structure is beginning to occur.

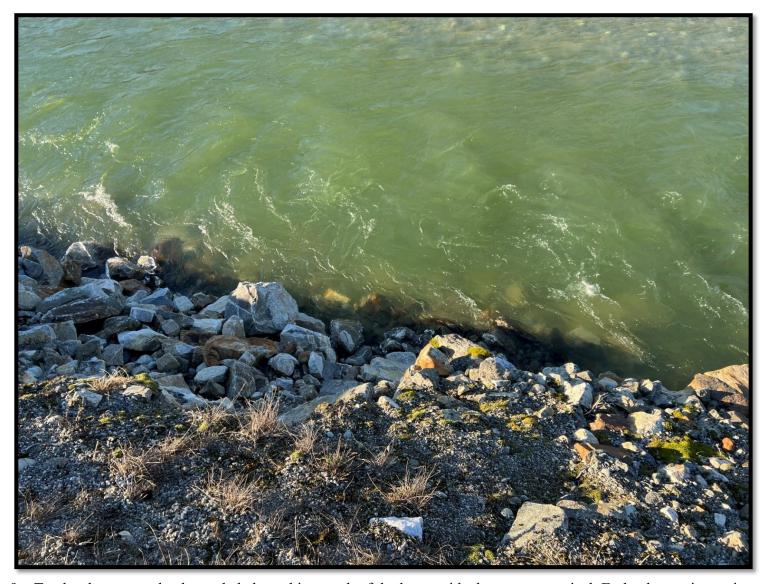
Figure 9 – Toe has been completely eroded along this stretch of the levee with slopes near vertical. Embankment is starting to slide.

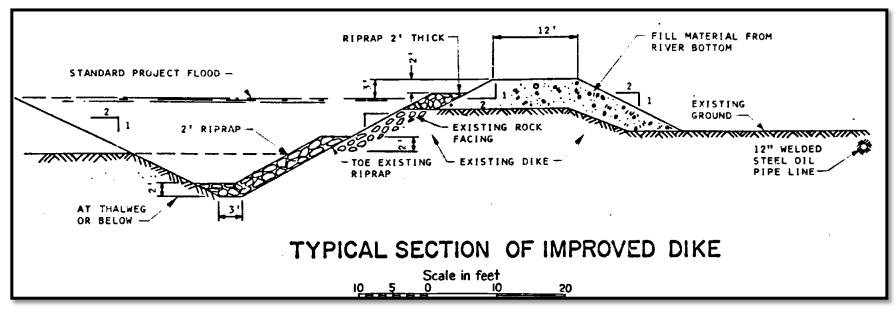
Figure 10 – Typical Cross Section from Original Levee Design completed by the USACE in 1940.

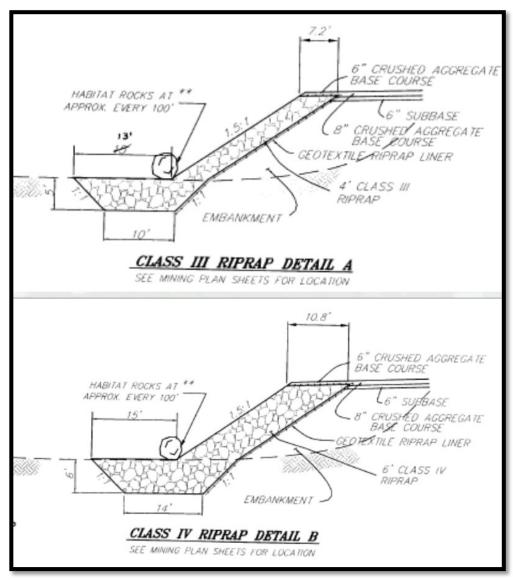
Figure 11 – Typical Cross Section for Class III and IV Rip Rap Design from 2001 Airport Modification.

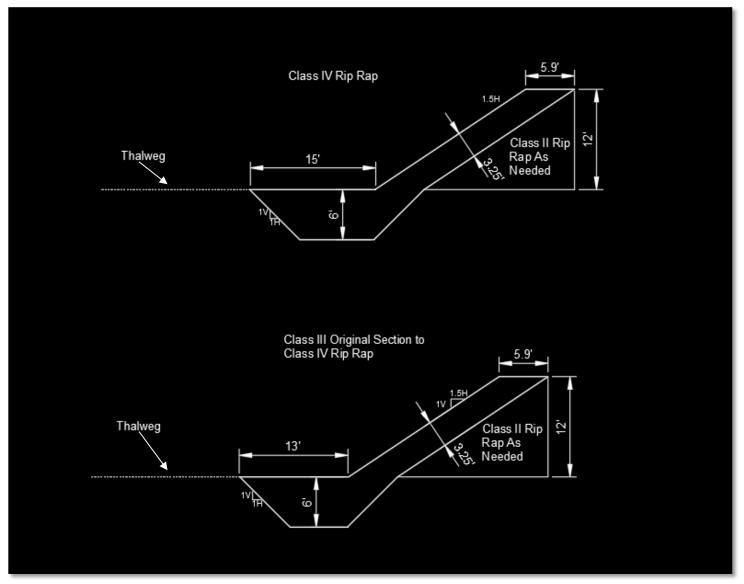
Figure 16 – Cross Sectional View for Levee Repairs along Skagway Runway.

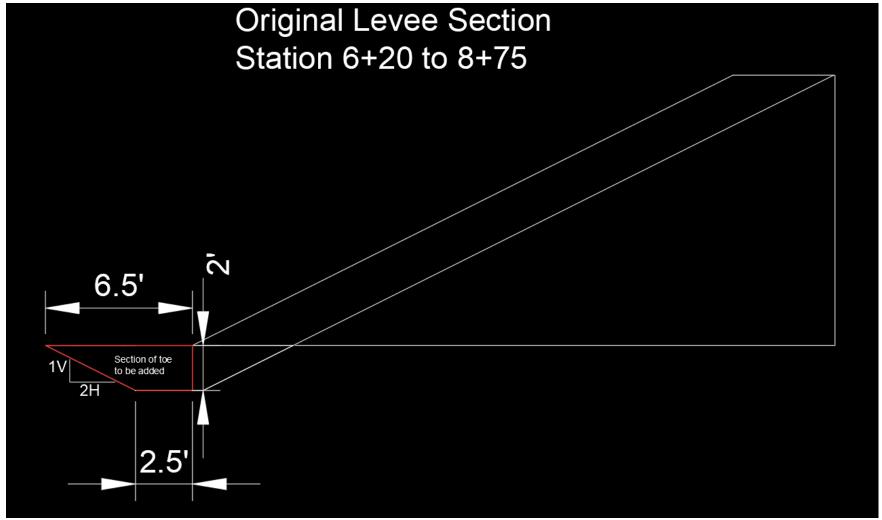
Figure 17 – Cross Sectional View of Original Levee Section Repairs.
