Beluga Slough Outlet Maintenance Project Site Natural Features

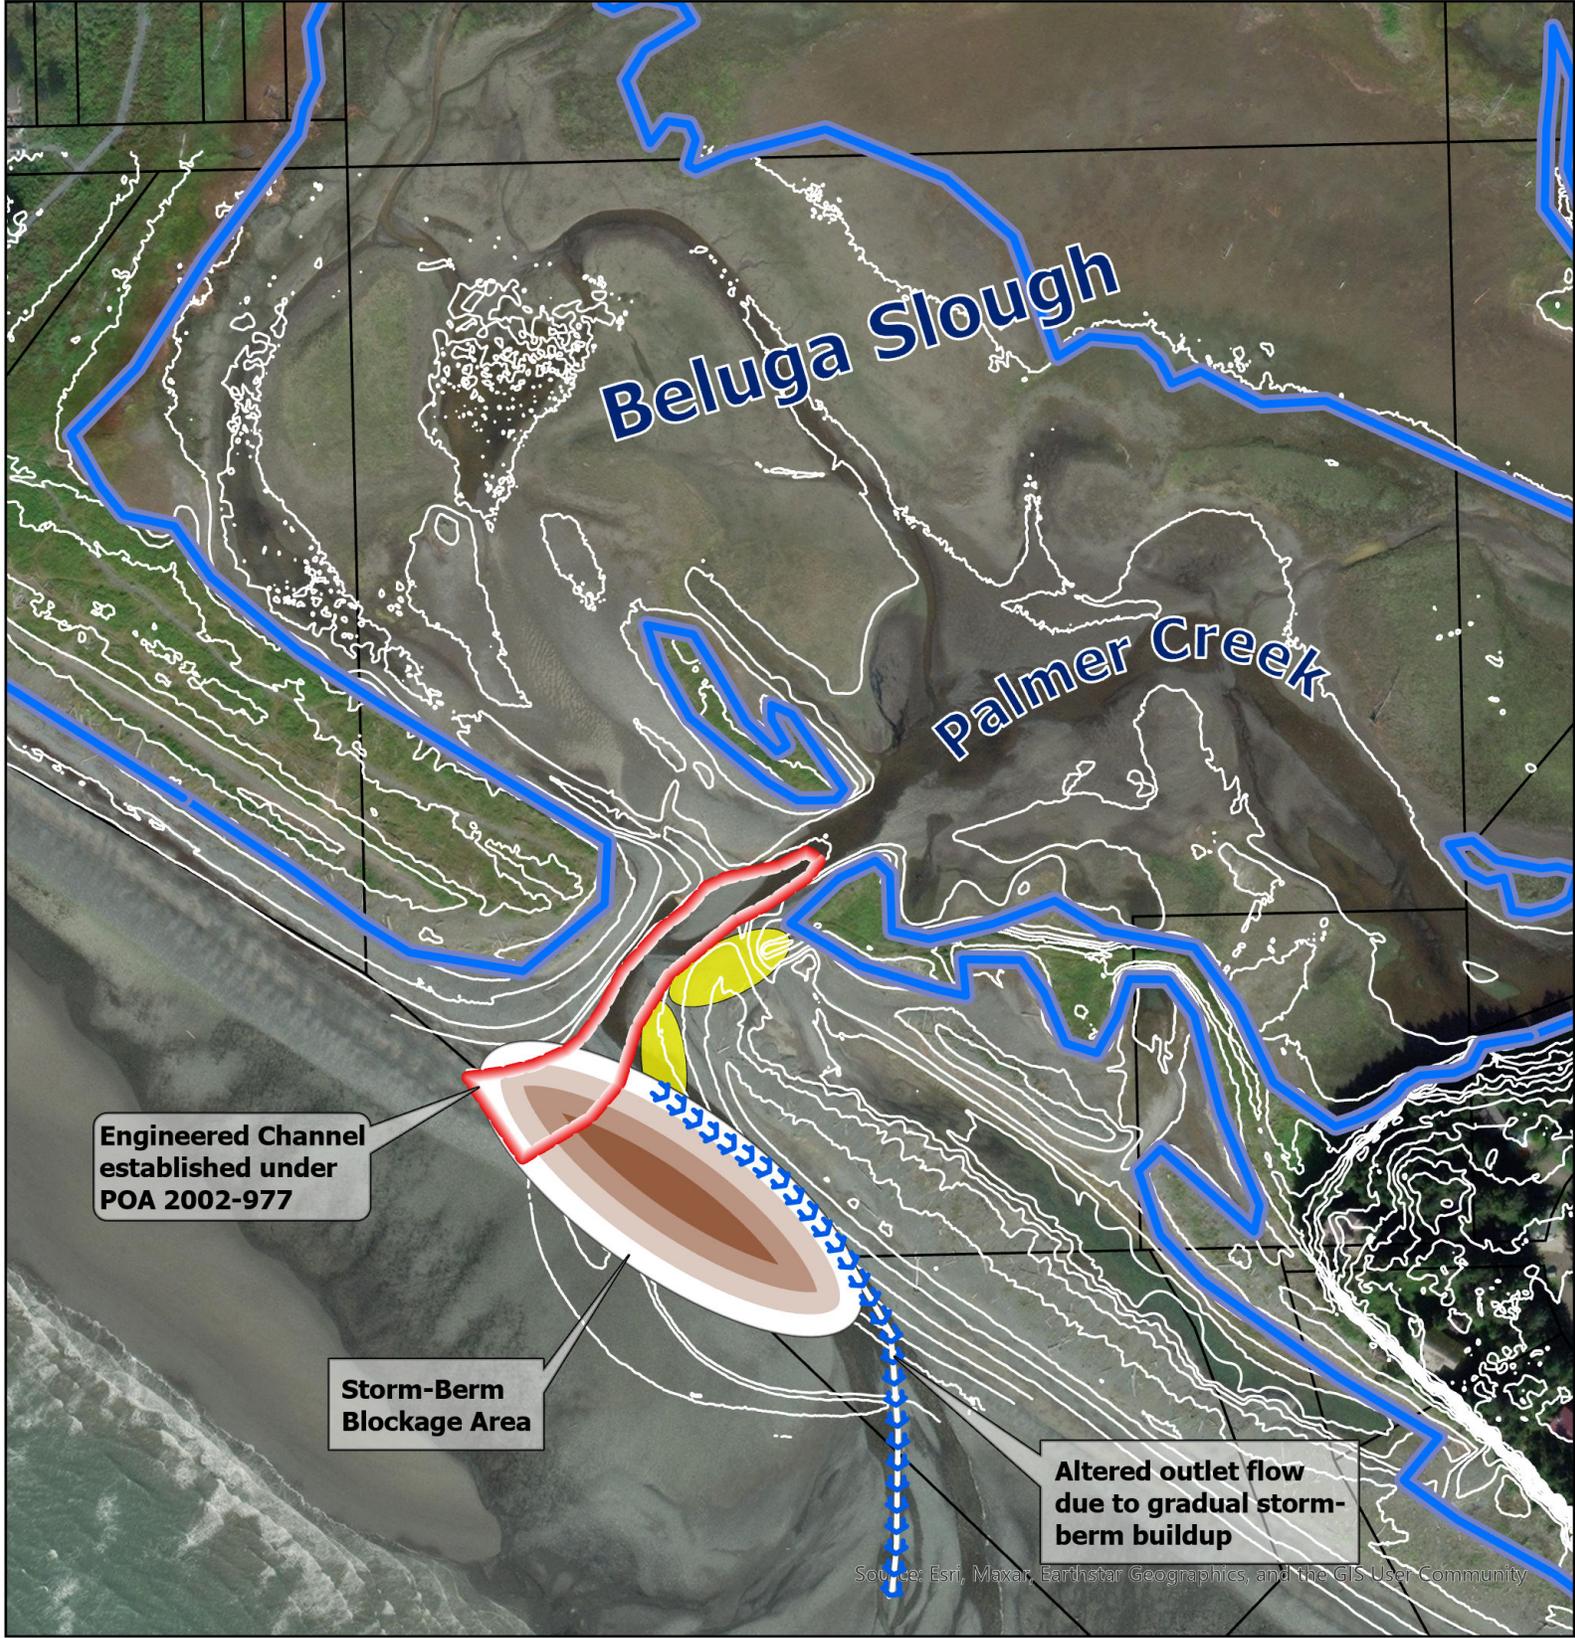
The 2019 contour lines indicate where the engineered outflow established to mitigate storm berm buildup. The channel diverts flow eastward and is eventually blocked off.

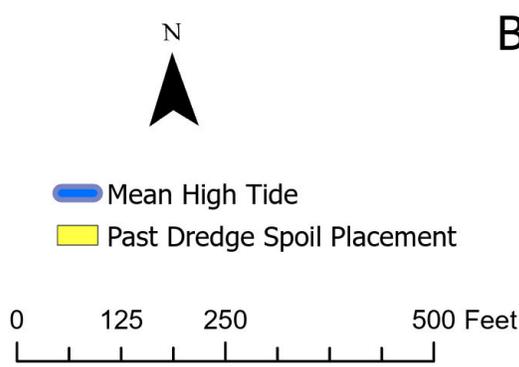
Data Source
 Contours: 2019 LiDAR, AKDGGs
 Mean High Tide: NOAA CUSP
 Aerial: MAXAR, Collection Date-
 9/4/2023
