**Exhibit 6 – Cell 4 Expansion Construction Quality  
Assurance Report and Engineer of Record  
Statement of Compliance**

# MATANUSKA-SUSITNA BOROUGH CELL 4 EXPANSION CONSTRUCTION DOCUMENTATION REPORT

MATSU CENTRAL LANDFILL  
PROJECT NO. 167550

REVISION 1  
JANUARY 2026

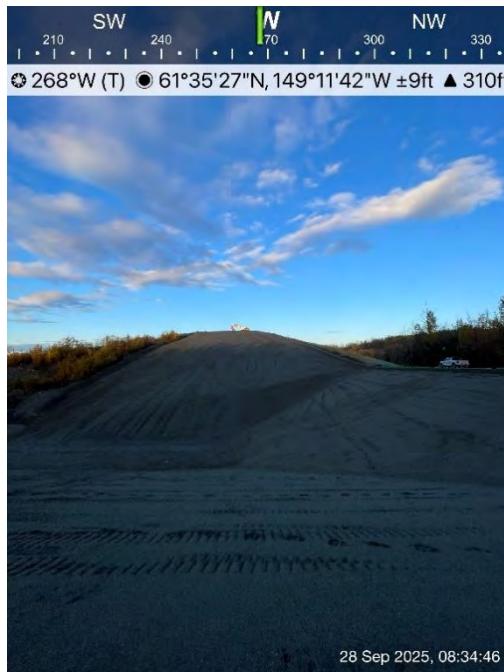
Figure 1: 09/28/25 - Cell 4 Expansion Prepared Sand Leveling Course Layer

Outside the Cell 2A final cover overlay area of the Cell 4 Expansion, the sand leveling material was placed in a singular lift of 6 inches and was compacted into a smooth surface with a steel drum roller.

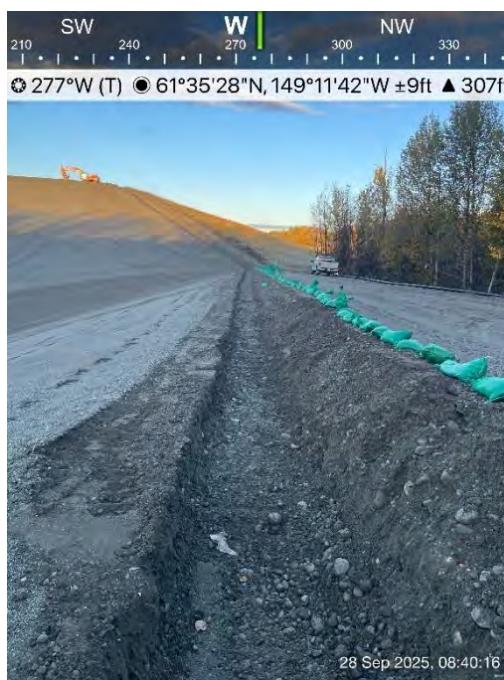
Figure 2: 09/28/25 - Cell 4 Expansion Termination Berm Trench

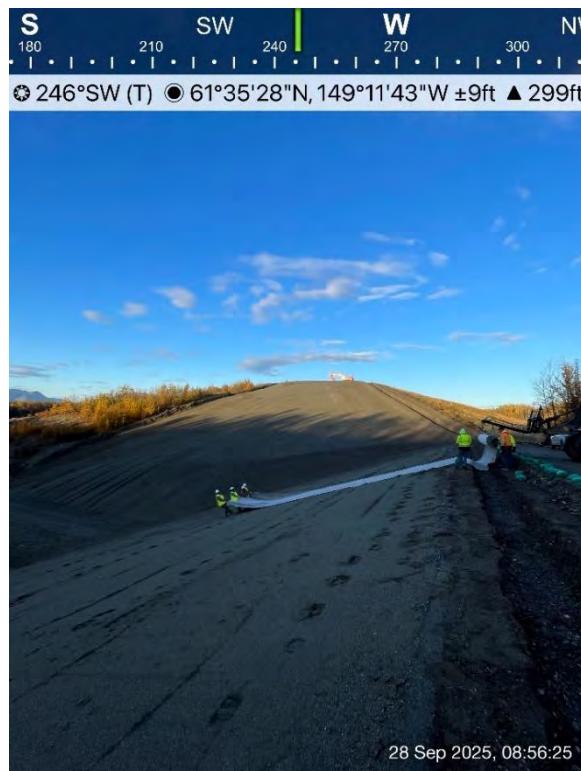
Figure 3: 09/28/25 – Placement of GCL on the Northern Slope of Cell 4 Expansion with a Spreader Bar

Burns & McDonnell observed and documented the GCL installation. Deployment of the geosynthetic clay liner began on the northern slope of Cell 4 Expansion on September 28, 2025. The last panel of geosynthetic clay liner was placed on the western side of Cell 4 Expansion on October 6, 2025. NWL used an excavator with a spreader bar to deploy each roll of GCL. In accordance with the Project specifications, GCL panels were overlapped six-inches lengthwise and 12-inches widthwise. NWL spread bentonite along the edge of each overlap, then heat tacked the panels together. NWL overlapped panels so that they were shingled in the direction of the grade. As each panel was deployed and heat-tacked, it was inspected for damage and manufacturing defects. Any such occurrences were noted and flagged for repair.

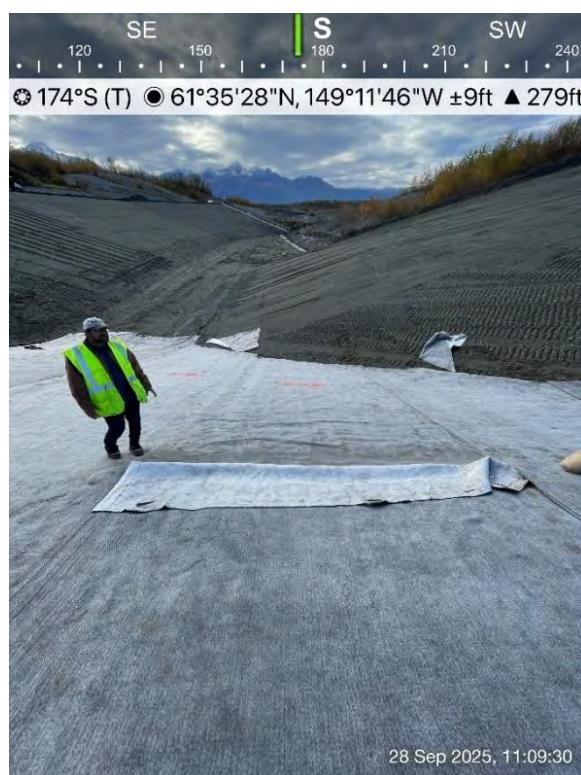
Figure 4: 09/28/25 – GCL Panel Overlapped a Min. of 12 Inches and Sprinkled with Granular Bentonite Prior to Heat Tack

All panels were heat-tacked and covered with geomembrane the same day they were deployed to avoid bentonite hydration. During placement and heat-tacking, each panel was labelled chronologically by NWL's Construction Quality Control (CQC) Representative. Panel numbers and lengths were documented by Burns & McDonnell (CQA). A panel placement log prepared by Burns & McDonnell and a Certification of Compliance from NWL are included in **Appendix E**.

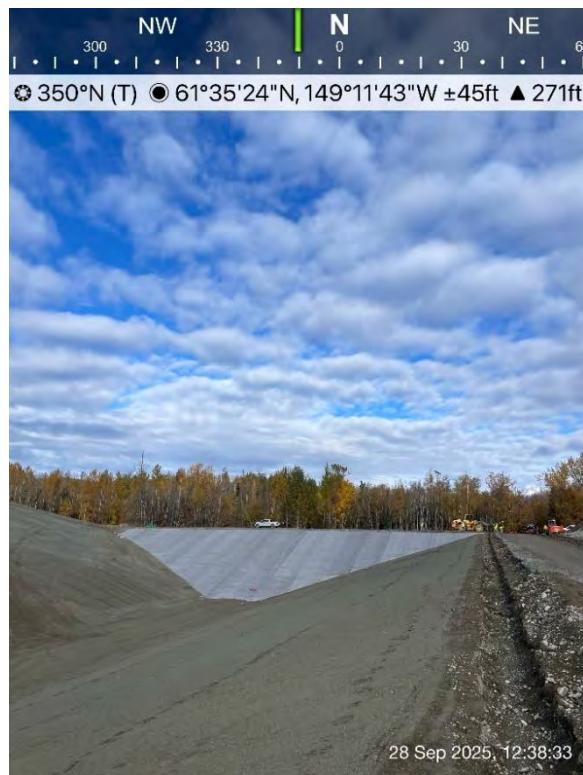
Figure 5: 09/28/25 - Cell 4 Expansion GCL Placement Day 1

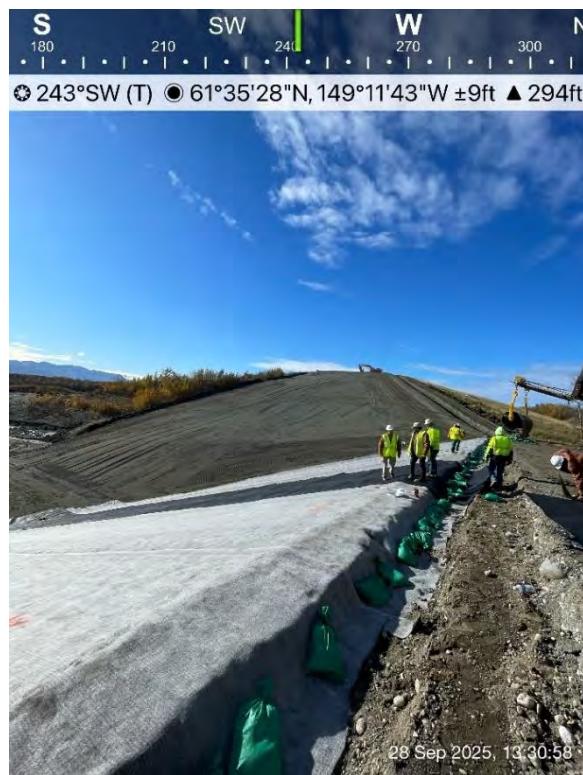
Figure 6: 09/28/25 - Placement of HDPE on the Northern Slope of Cell 4 Expansion with a Spreader Bar

Geomembrane panels were deployed using the excavator with a spreader bar, with NWL staff pulling the panels into place for seaming. All panels were seamed the same day they were deployed. An as-built layout of the panels and seams is included in **Appendix F**.

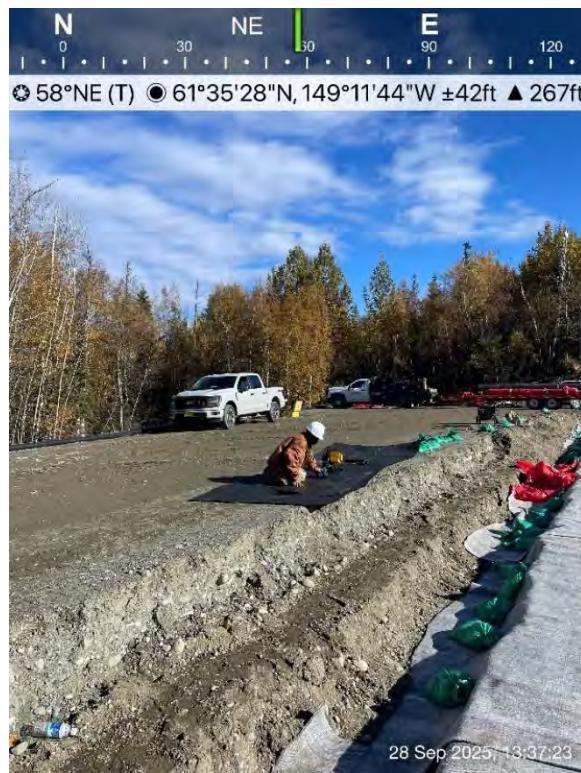
Figure 7: 09/28/25 – Trail Weld of HDPE Geomembrane Liner with Fusion Welder

Trial seaming was performed for each work shift, welding machine, and welder to verify optimum seaming methods based on current ambient conditions. Trial seams were inspected and destructively tested in the field to confirm compliance with specification requirements. Refer to **Appendix F** for trial seam test results.

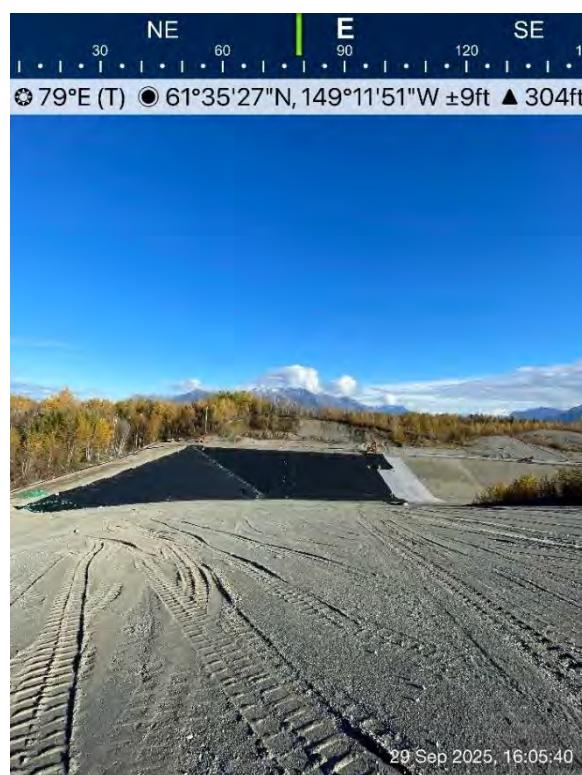
Figure 12: 09/29/25 - Cell 4 Expansion HDPE Geomembrane Liner Placement Day 2

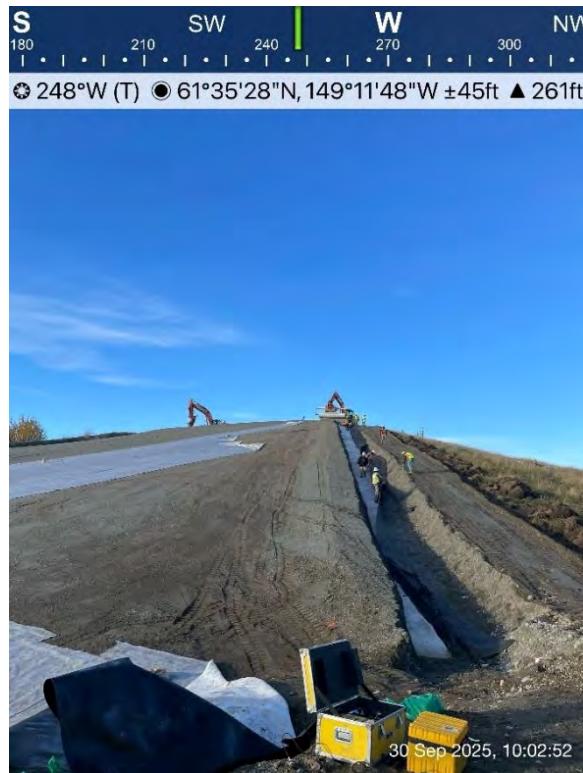
Figure 13: 09/30/25 - Cell 2A Final Cover GCL Exposed for Overlap with Cell 4 Expansion GCL

Within the Cell 2A final cover overlay area of the Cell 4 Expansion, unsuitable materials were removed from the existing sand leveling course after removing the existing GCL. Additional sand material was added as needed to create a consistent surface free of ruts or gaps in the sand and compacted into a smooth surface with a steel drum roller.

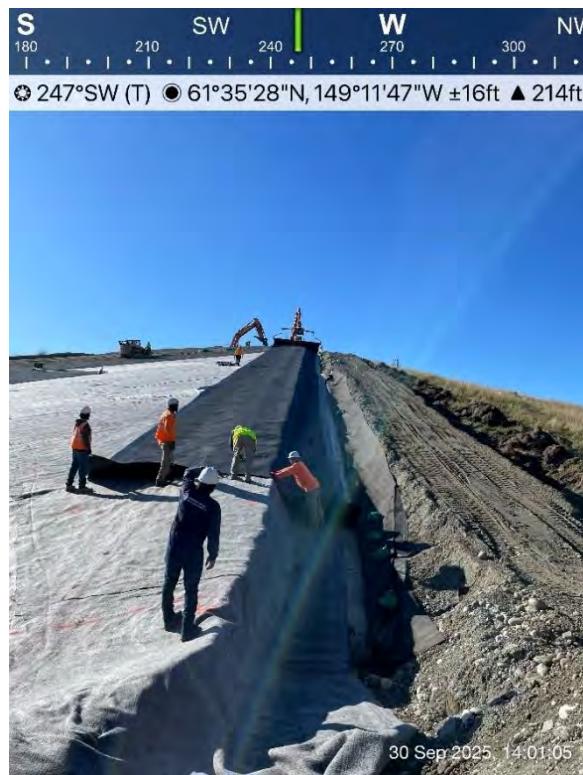
Figure 15: 09/30/25 - Cell 4 Expansion LLDPE Geomembrane Liner Placement of Cell 2A Overlay Area

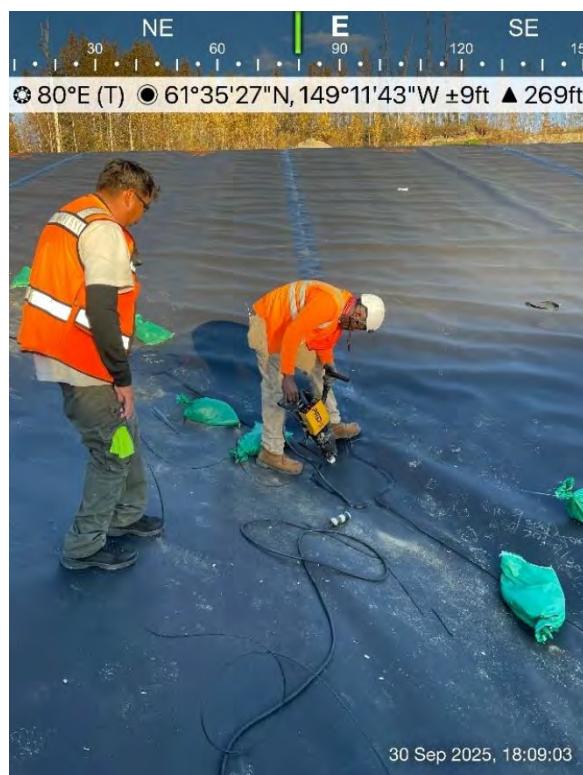
Figure 16: 09/30/25 - Cell 4 Expansion Extrusion Welding a Patch Over Air Test Holes

During air pressure testing, a hollow needle was inserted into the air channel formed by the double-wedge weld. The ends of the seam were sealed, and the channel was pressurized to approximately 30 pounds per square inch (psi) and held for five minutes. If the pressure dropped less than two psi within five minutes, the seam was considered competent. Any seams that experienced a pressure drop greater

than two psi were visually inspected, and vacuum tested to determine the location of the leak. Repairs were then placed as needed along the seam. All the air pressure tested seams passed on this Project.

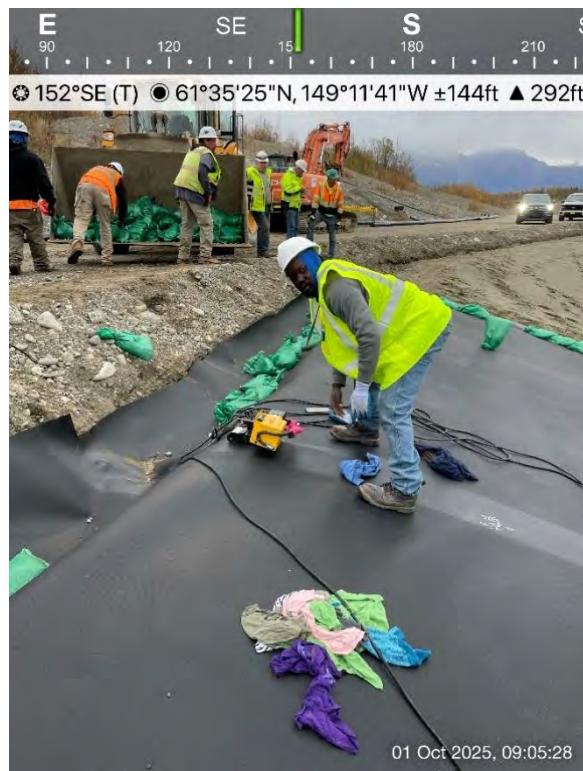
Figure 19: 10/01/25 - Cell 4 Expansion Geomembrane Liner Seam Fusion Weld

The methods used for the seaming of the geomembrane liner included double-wedge welding and extrusion welding. All panels were seamed using the double wedge weld. Extrusion welding was limited to hard-to-reach areas, patching, repairs, and the Cell 2A liner tie-in.

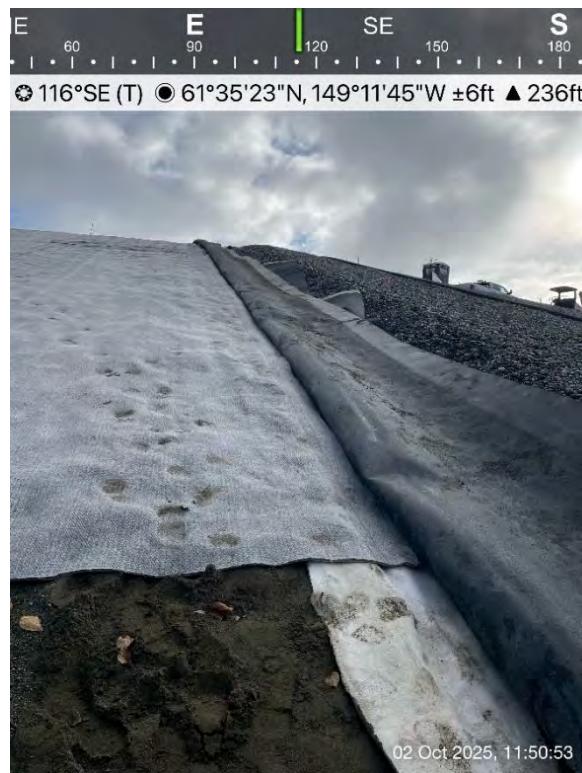
Figure 21: 10/02/25 – Cell 4 Expansion GCL Overlapped with Existing Cell 4 GCL

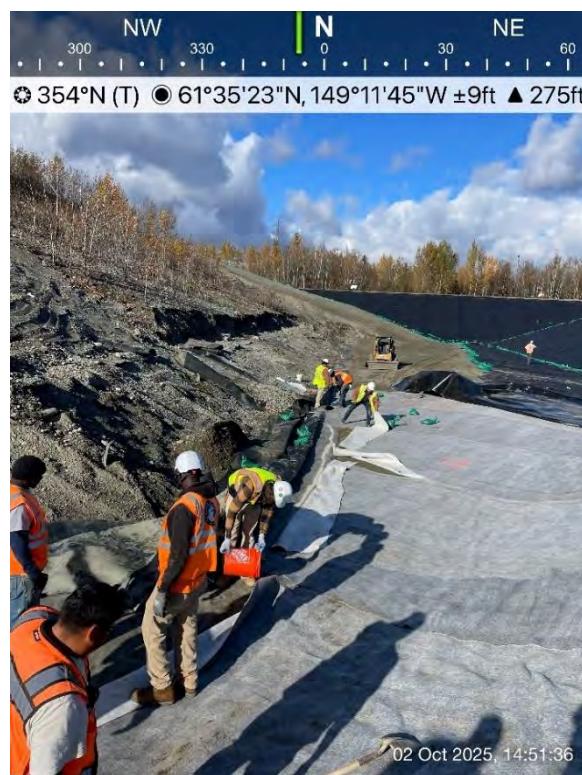
Figure 22: 10/02/25 - Cell 4 Expansion GCL Overlapped with Existing Cell 2B GCL

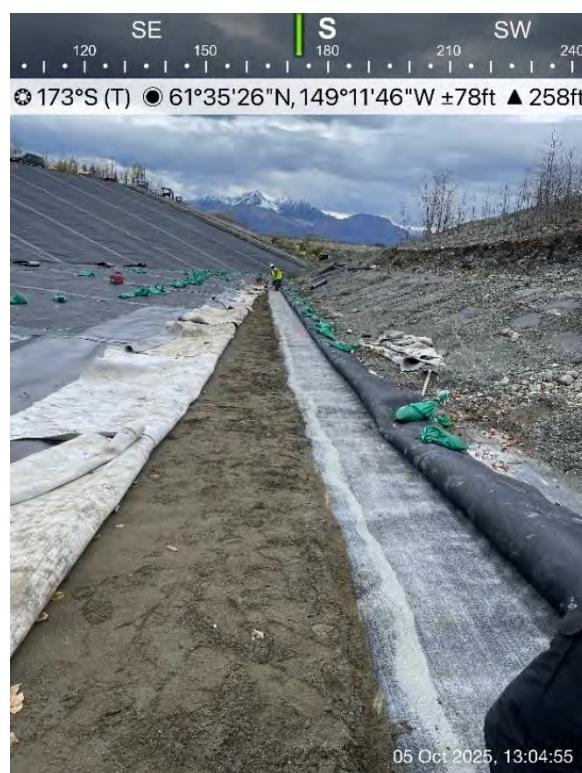
Figure 28: 10/05/25 - West Side of Existing Cell 2B GCL Exposed and Sprinkled with Granular Bentonite

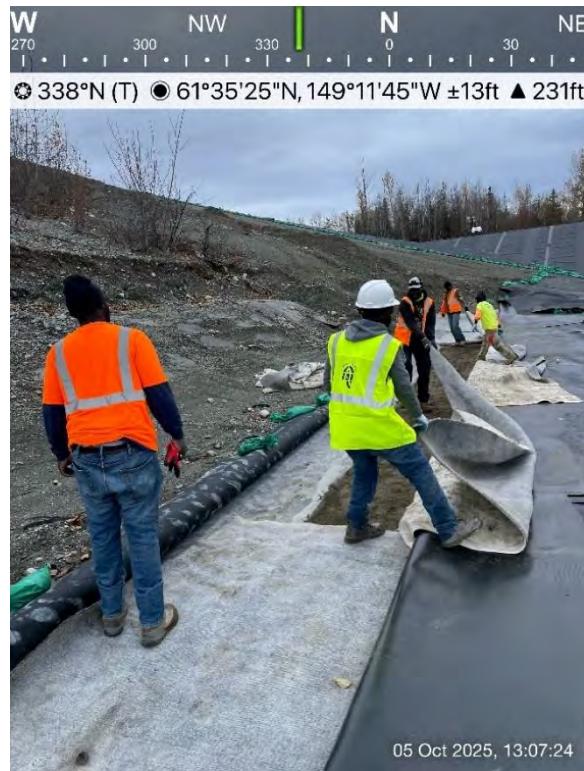
Figure 29: 10/05/25 – West Side of Existing Cell 2B GCL Overlapped with Cell 4 Expansion GCL

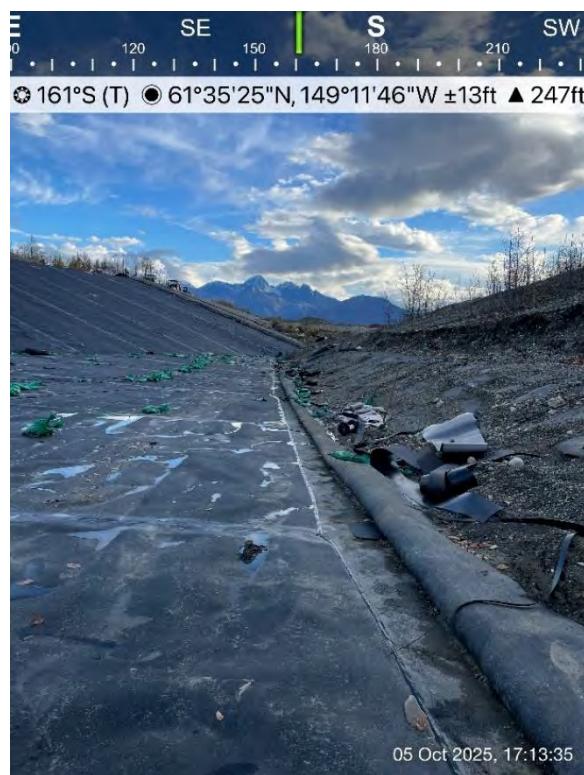
Figure 30: 10/05/25 – Cell 4 Expansion HDPE Liner Extrusion Welded to Existing Cell 2B HDPE Liner

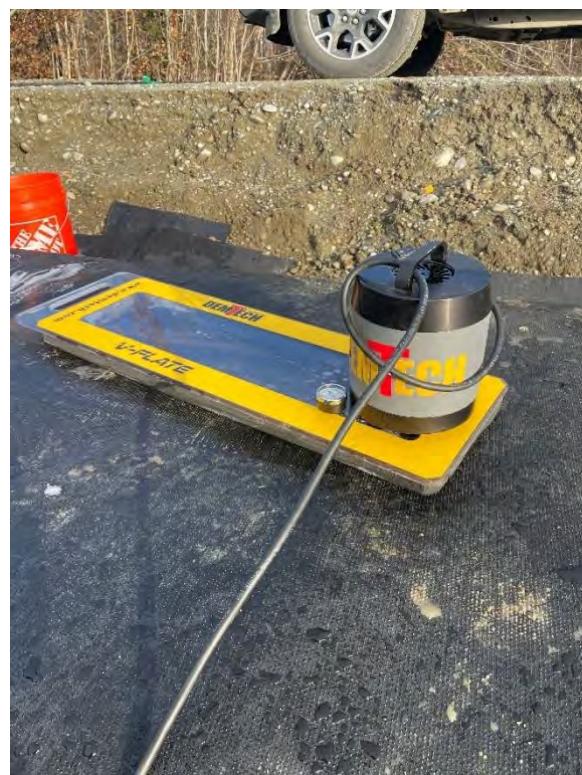
Figure 32: 10/06/25 – Vacuum Test Apparatus

During vacuum testing, the seam or area of concern was covered with a water and soap solution. A vacuum apparatus was then placed over the area and sealed. A leak was indicated by bubbles forming from the soap solution. If any leaks were found, the seams were repaired and retested. All the extrusion welds passed the vacuum testing on this Project, either initially or after being re-patched.

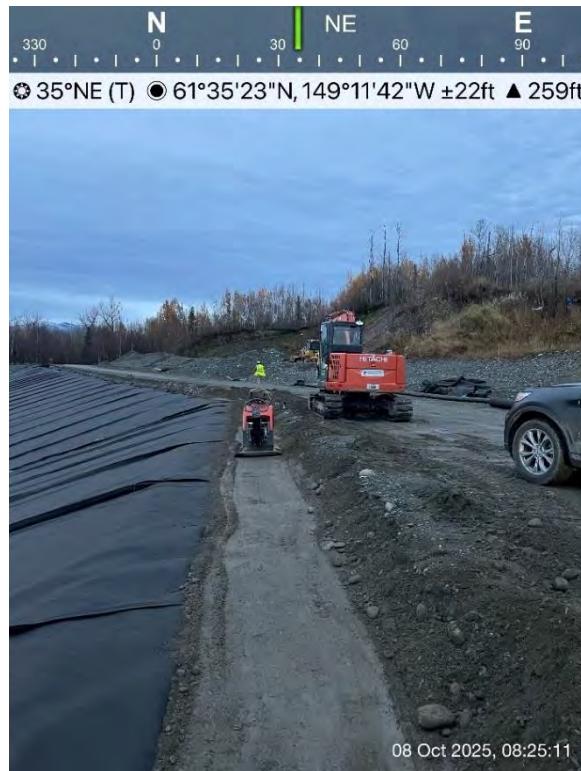
Figure 33: 10/08/25 - Cell 4 Expansion Termination Berm Backfill and Compaction

Mid October, SCC completed the north and east liner termination berm of Cell 4 Expansion, placing material over the Cell 4 Expansion liner. Plywood was placed on top of the liner and the berm was constructed over the plywood. These sheets of plywood serve to protect the liner during the construction and closure of future landfill cells.

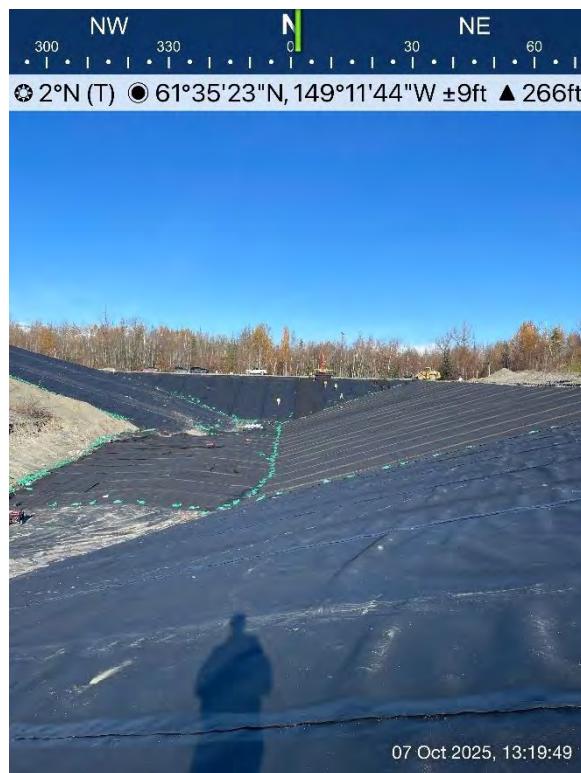
Figure 34: 10/07/25 - Cell 4 Expansion Geotextile Cushion Deployment with Spreader Bar

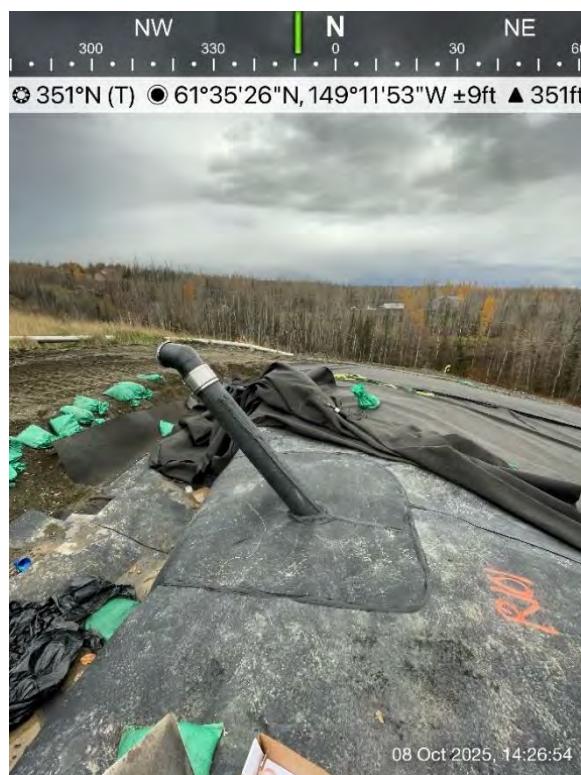
Figure 36: 10/08/25 – Remote GW-13 LLDPE Boot

Each seam was visually inspected and non-destructively tested for continuity and air or watertightness. The competency of the seaming process was checked by one of three methods: air pressure, vacuum, or spark testing. Air pressure testing was performed on double-wedge welds. Vacuum testing was performed on extrusion welds, including repairs, panel seams, and all caps. Spark testing was performed on the RGW-13 pipe penetration LLDPE boot in locations where the vacuum testing could not be conducted.

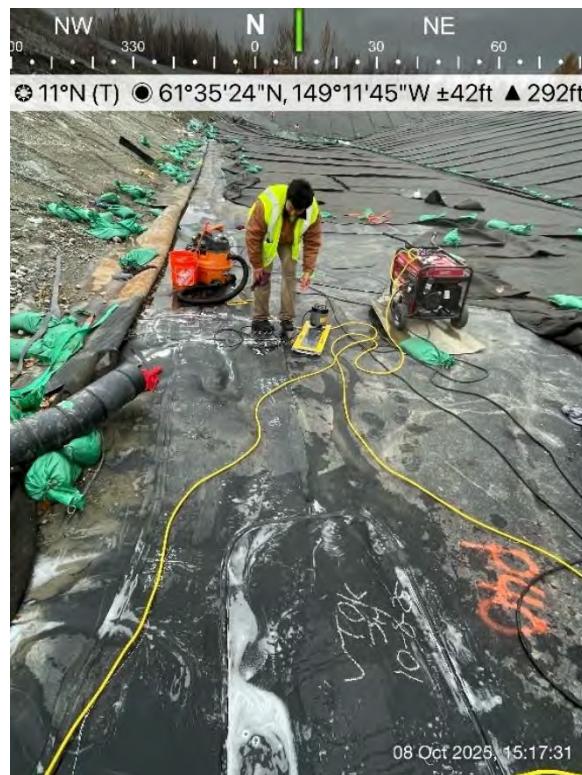
Figure 37: 10/08/25 – Non-Destructive Vacuum Testing of Extrusion Welds

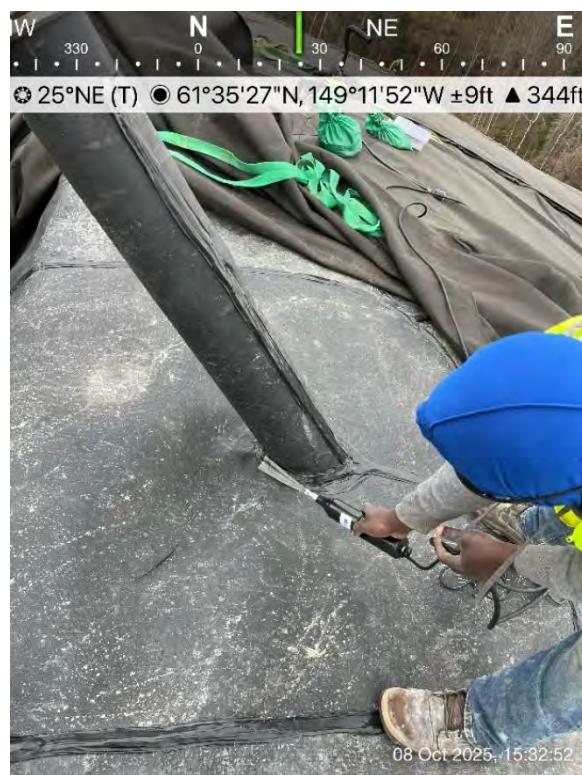
Figure 38: 10/08/25 – Non-Destructive Spark Testing of Pipe Boot

During spark testing, 24-gage copper wire was placed within 1/4-inch of edge of extrusion seam. An electrode was passed over the seam and observed for spark. A leak would be indicated by a spark. No sparks were observed, and the extrusion weld passed the spark testing on this Project.

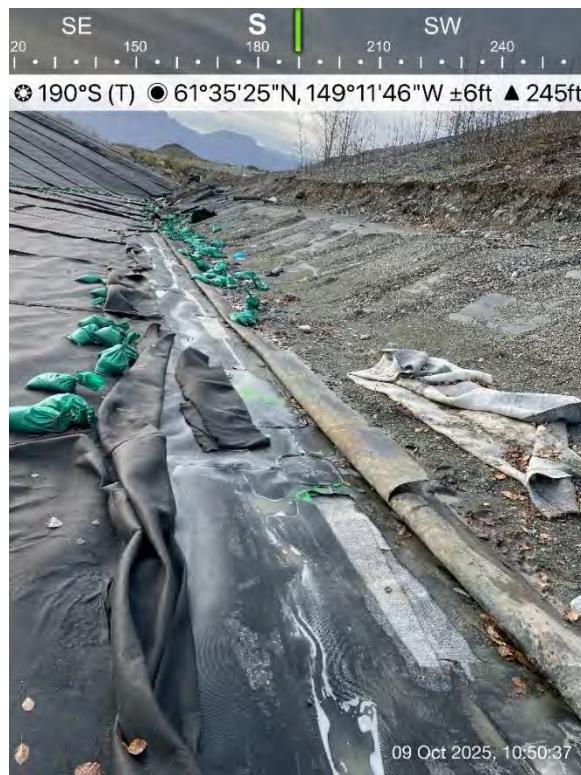
Figure 39:10/08/25 – Bounding Samples of DS-20 Collected for Destructive Testing in the Field and Laboratory

Destructive testing consisted of material conformance testing and destructive seam testing, conducted both in the field and in the laboratory. Refer to **Appendix F** for all destructive test results. The material conformance testing, and laboratory destructive seam tests were performed by TRI.

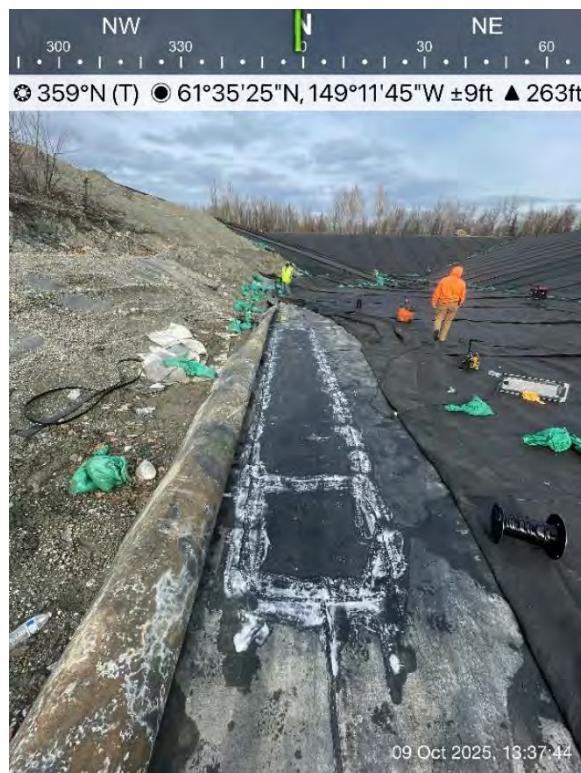
Figure 40:10/08/25 – Extrusion Patch of DS-20 and Bounding Samples
