# **PROJECT DESCRIPTION**

## **Kalotsa Site Pad Expansion**

# **2025 Wetland Delineation Summary Report: Kalotsa Pad Site Expansion Kenai Peninsula, Alaska**

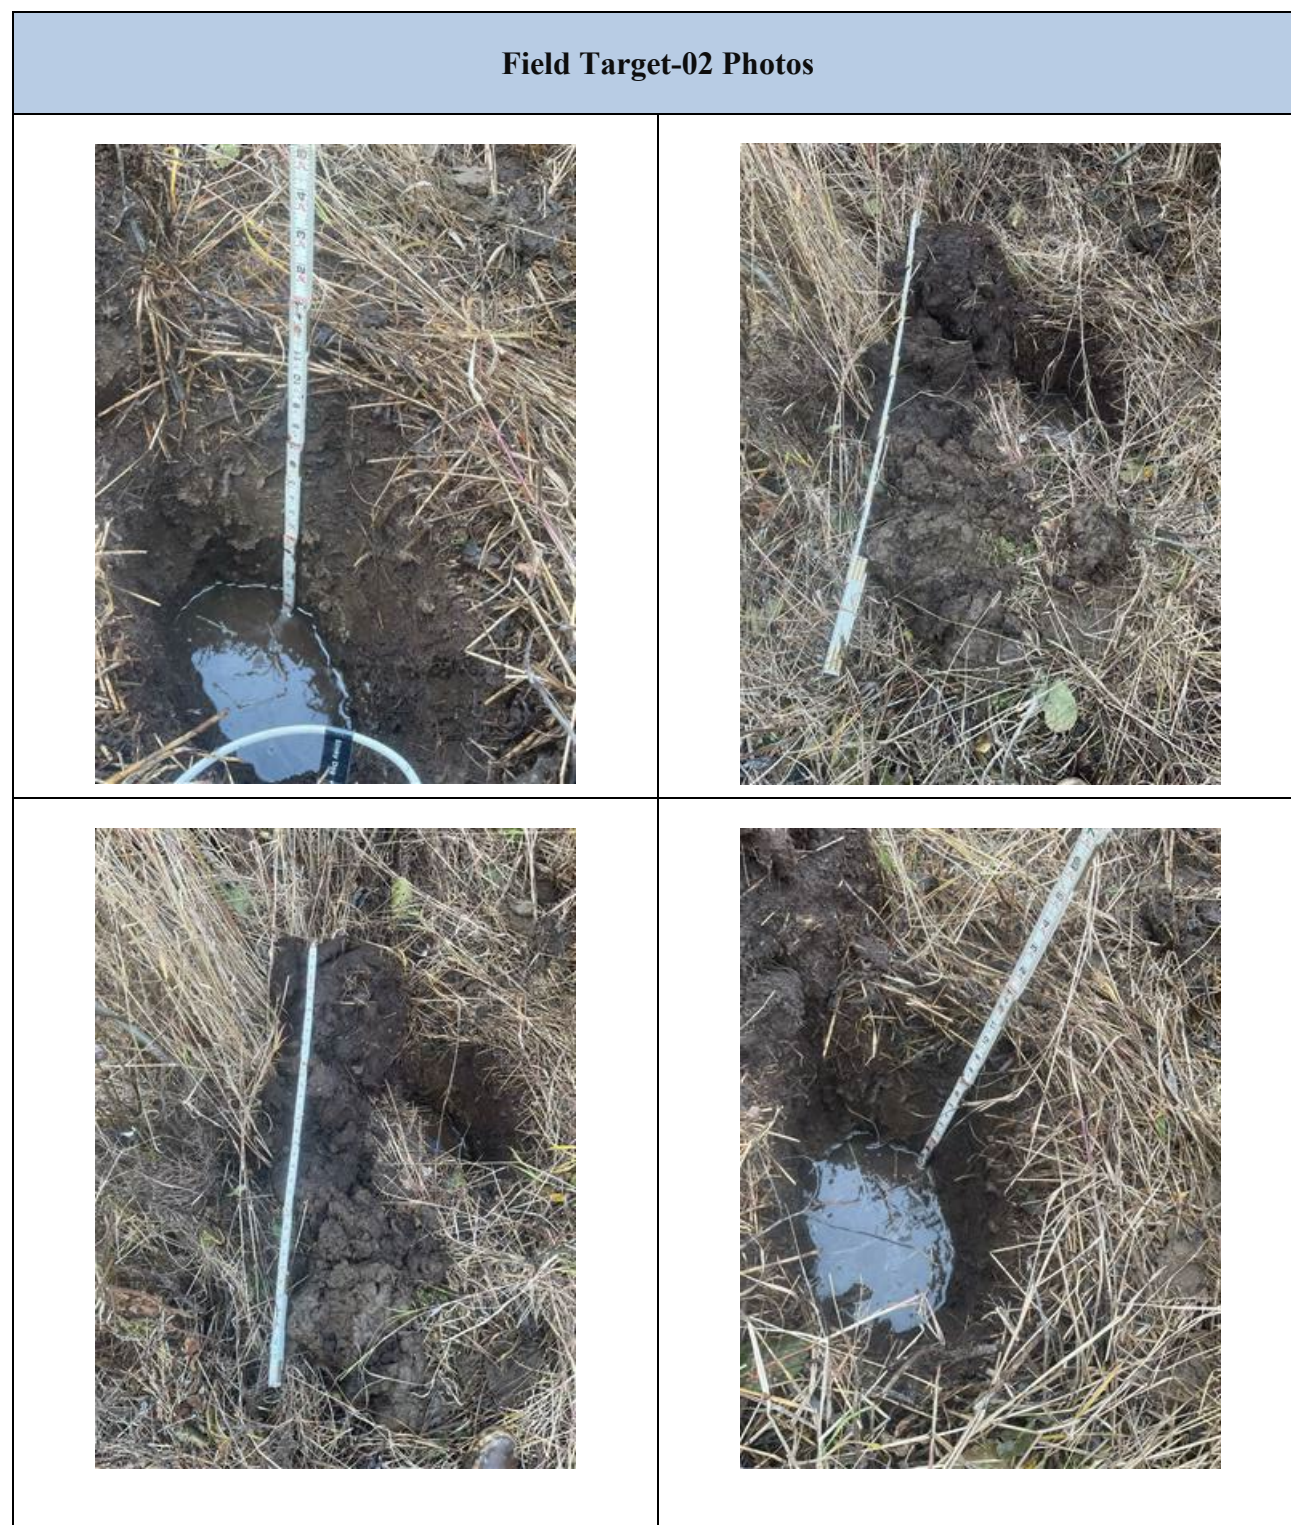
**Field Target-02 Photographs**

From top to bottom, left to right: Initial water level in test pit, soil plug showing saturation and texture, Water levels in test pit at the end of site analysis. Note how the water level rose from 13 inches below ground surface to 10 inches below ground surface.

Remarks:  
Standing water 12 feet from test pit. Soils fully inundated with water in test pit 12 inches below ground surface. Water table was initially encountered at 13 inches below ground surface, but had risen to 10 inches below ground surface by the end of the site analysis

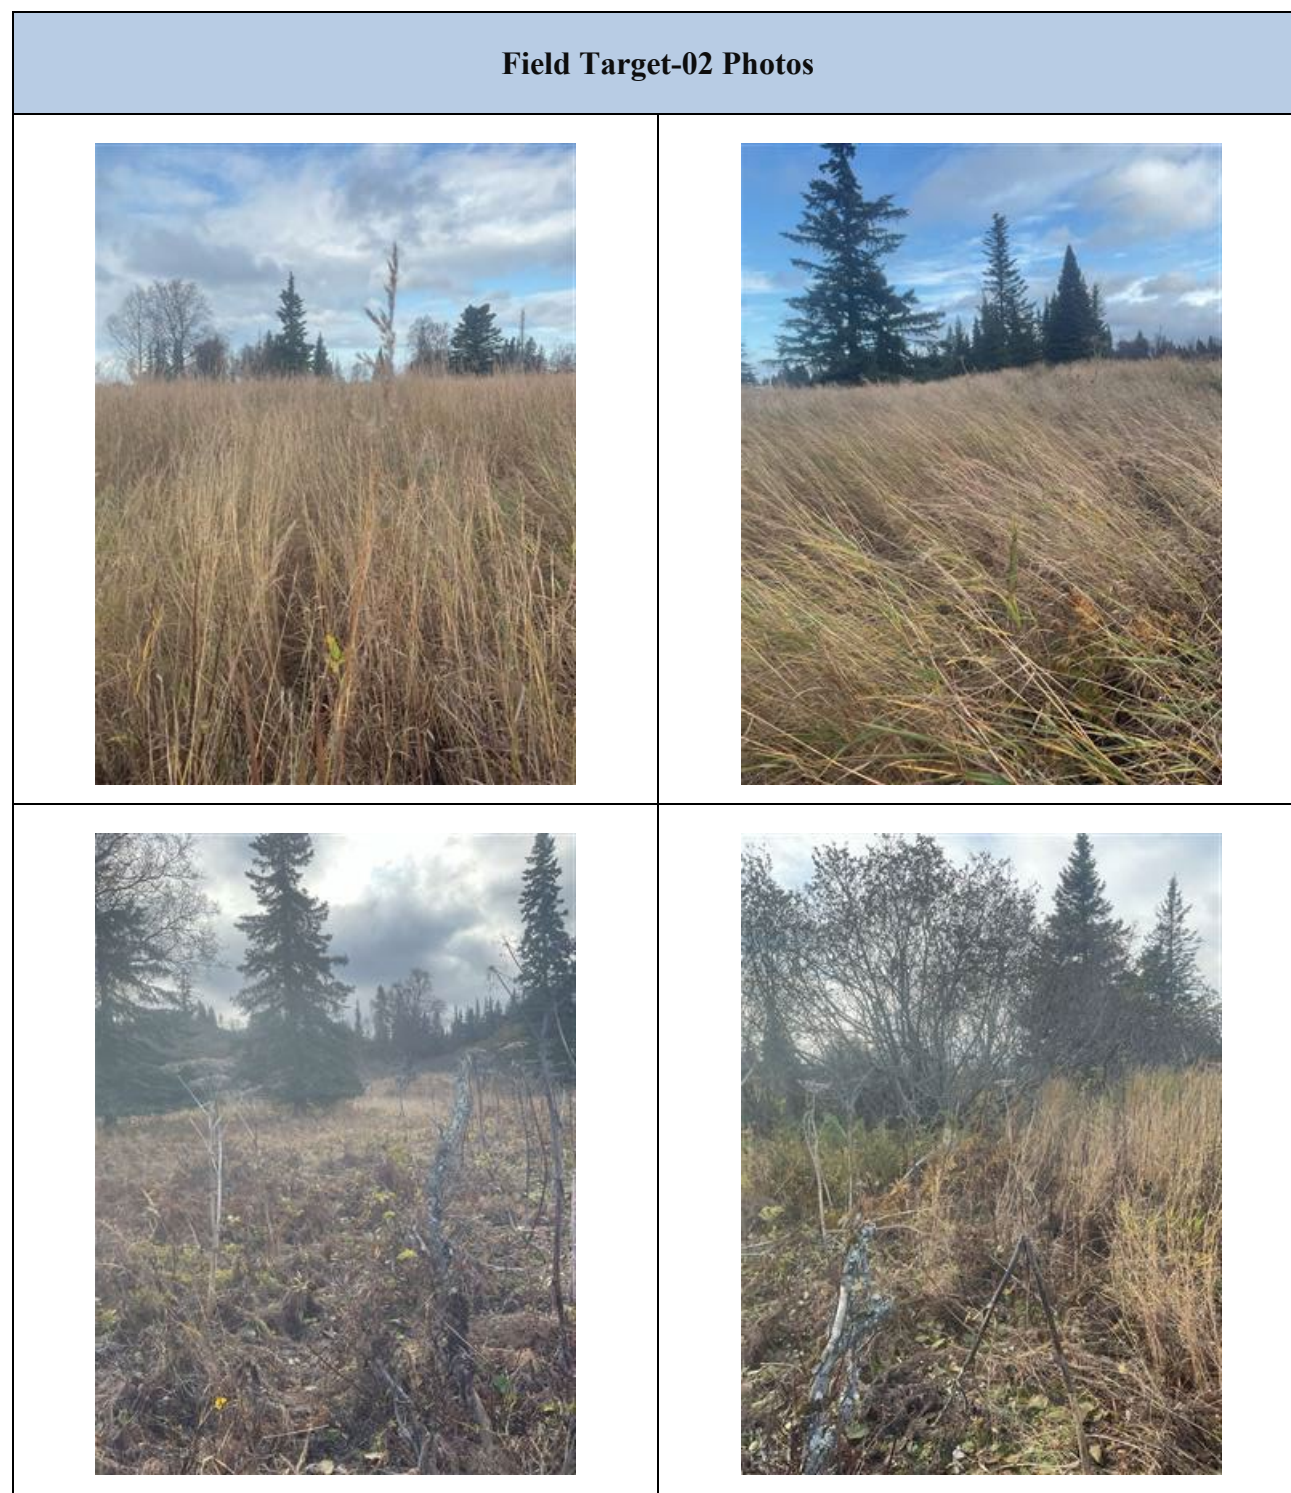
**Field Target-02 Photographs**

At Edge of PEM1E wetland and Uplands. Cardinal Directions from top to bottom, left to right:  
Facing northwest toward Pad, facing northeast toward Pad, facing south, and facing west.

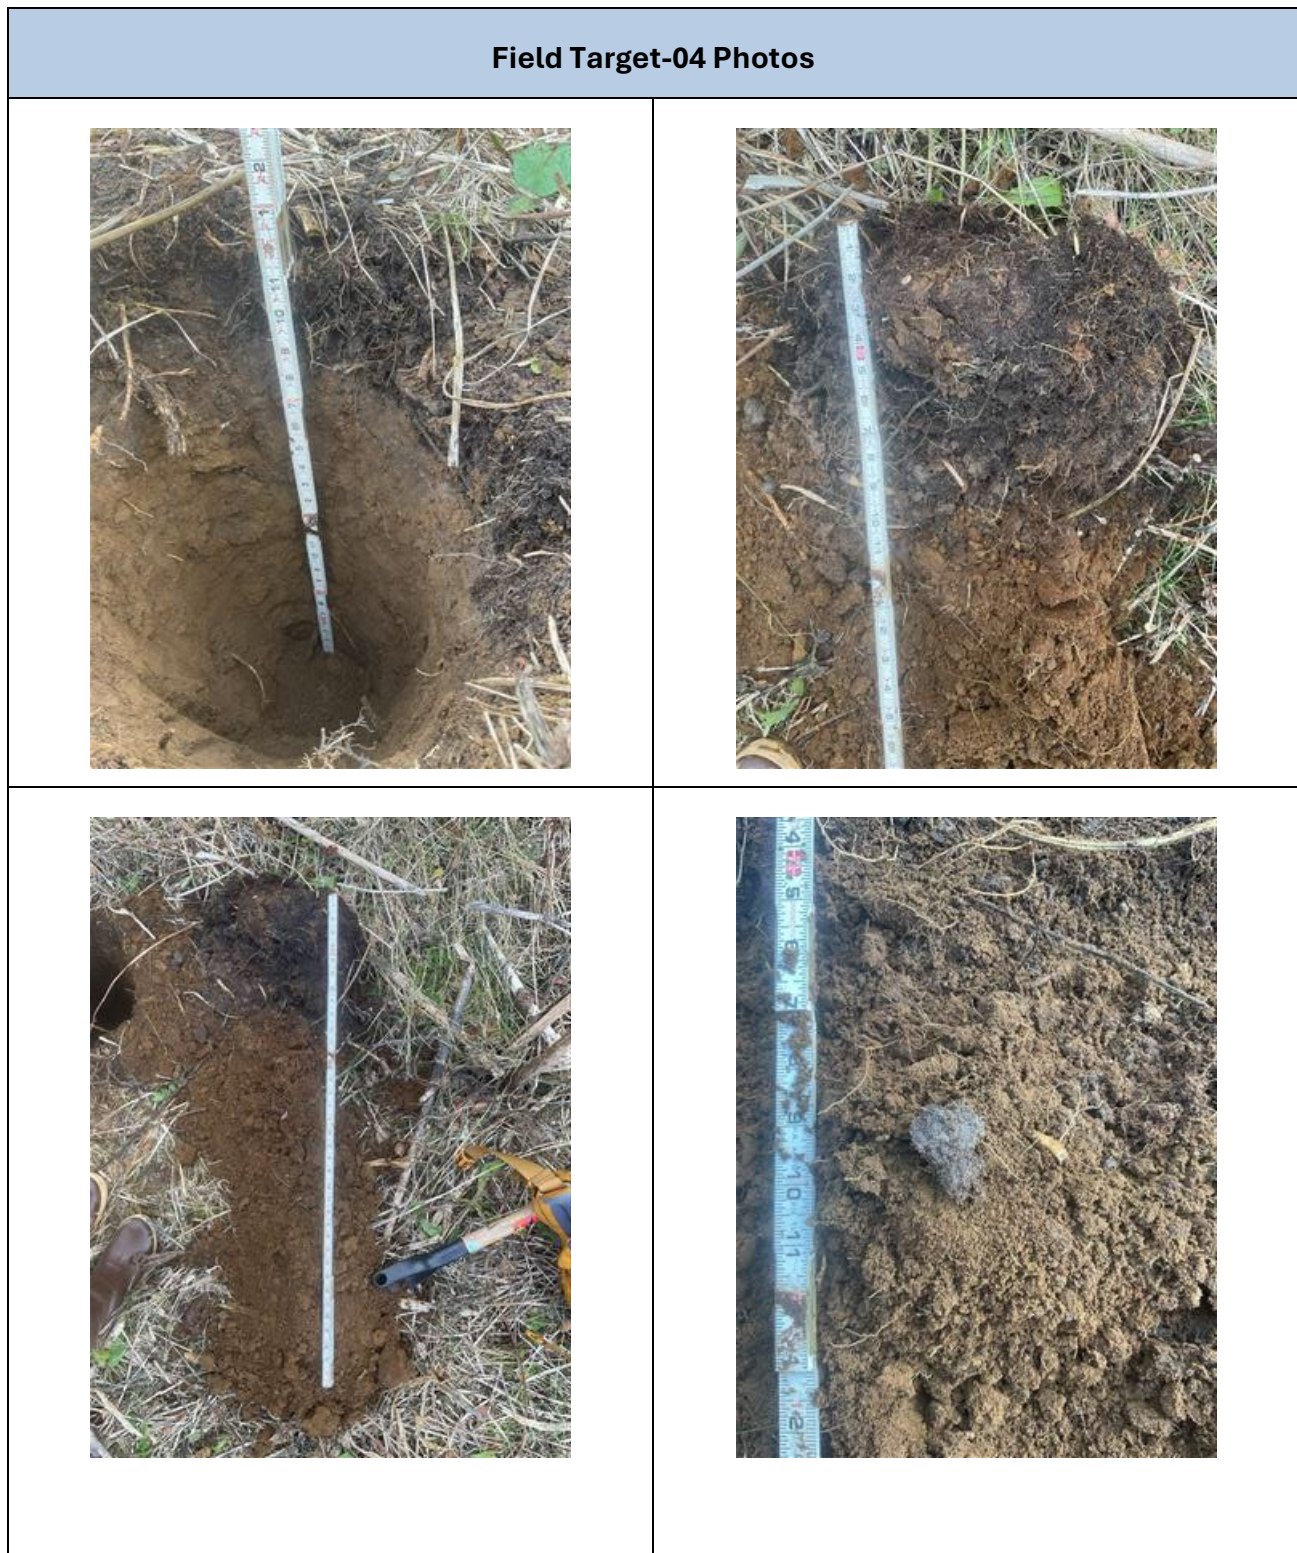
**Field Target-04 Photographs**

From top to bottom, left to right: Test Pit Downhole, Close up Shot of Soil Plug, Soil Plug Overview, Showing Soil Texture and Clumps of Ash. Note the thinner vegetative mat and bright colors of the soil compared to the other test sites.

Remarks:  
Area drier overall compared to other sites in the project area. No water observed or other indicators of long term inundation.

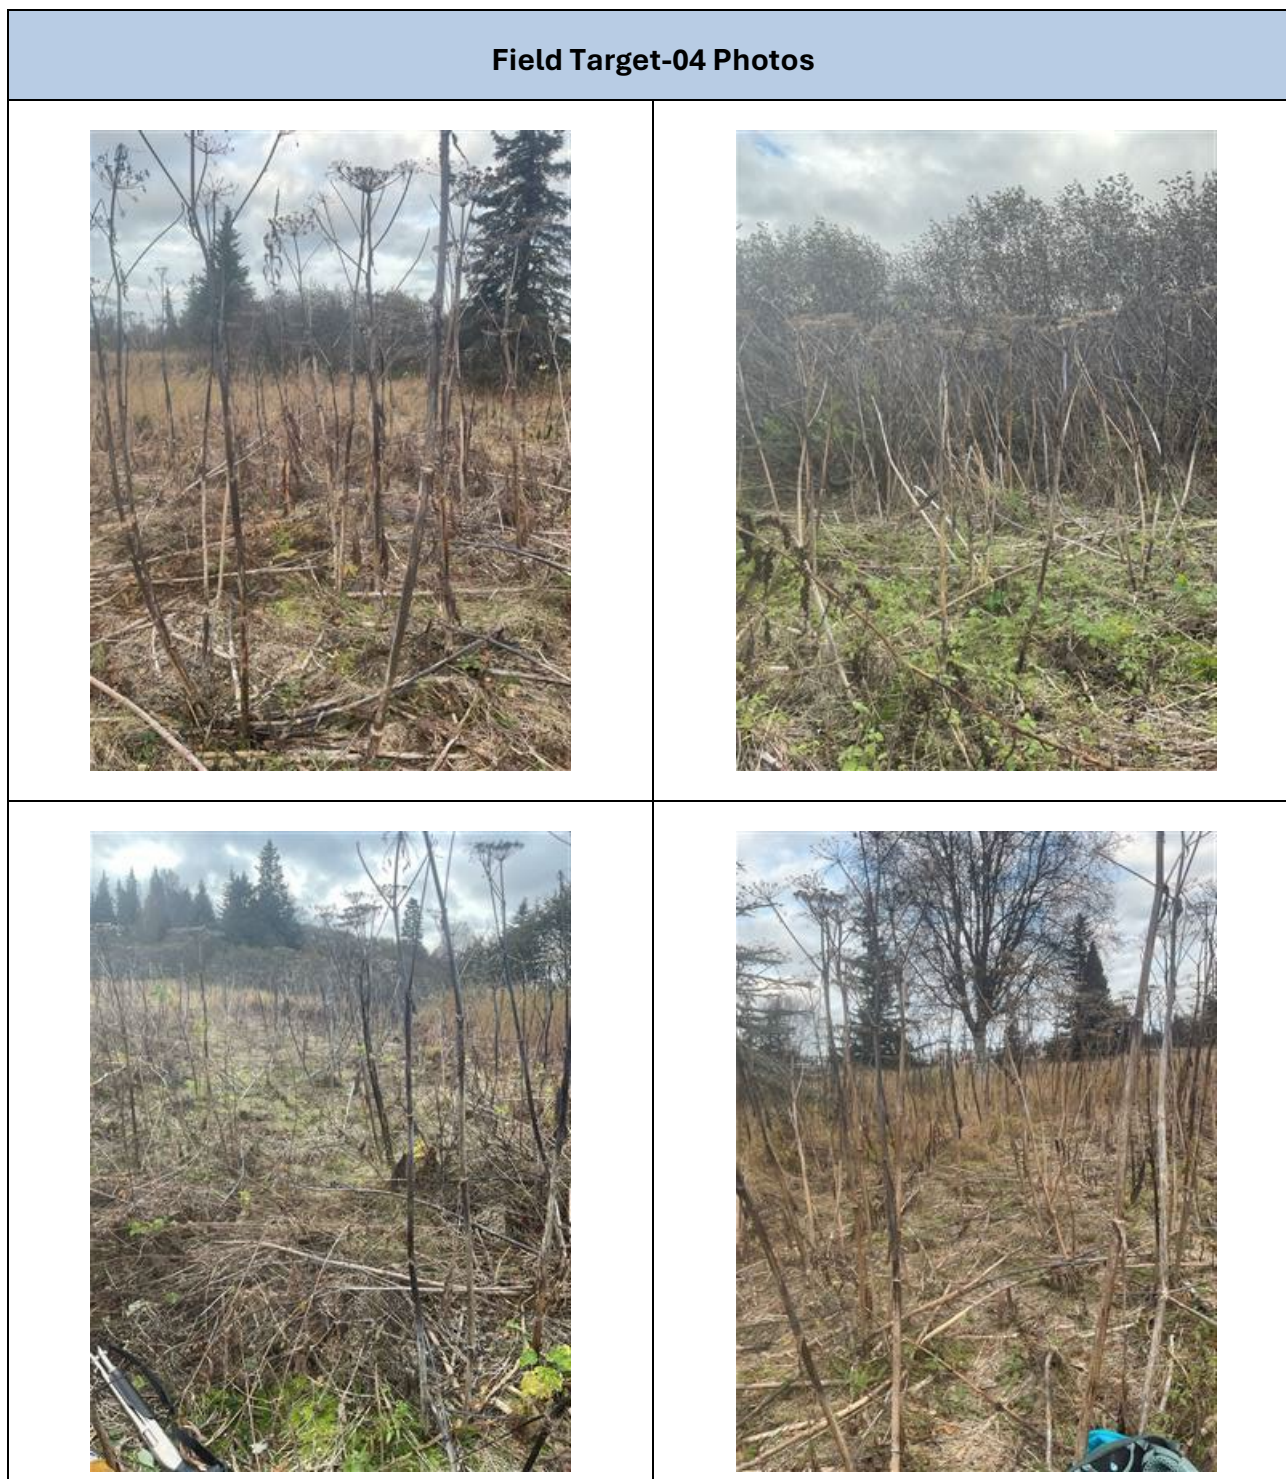
**Field Target-04 Photographs**

Cardinal Directions from top to bottom, left to right: facing north, facing east, facing south, and facing west.

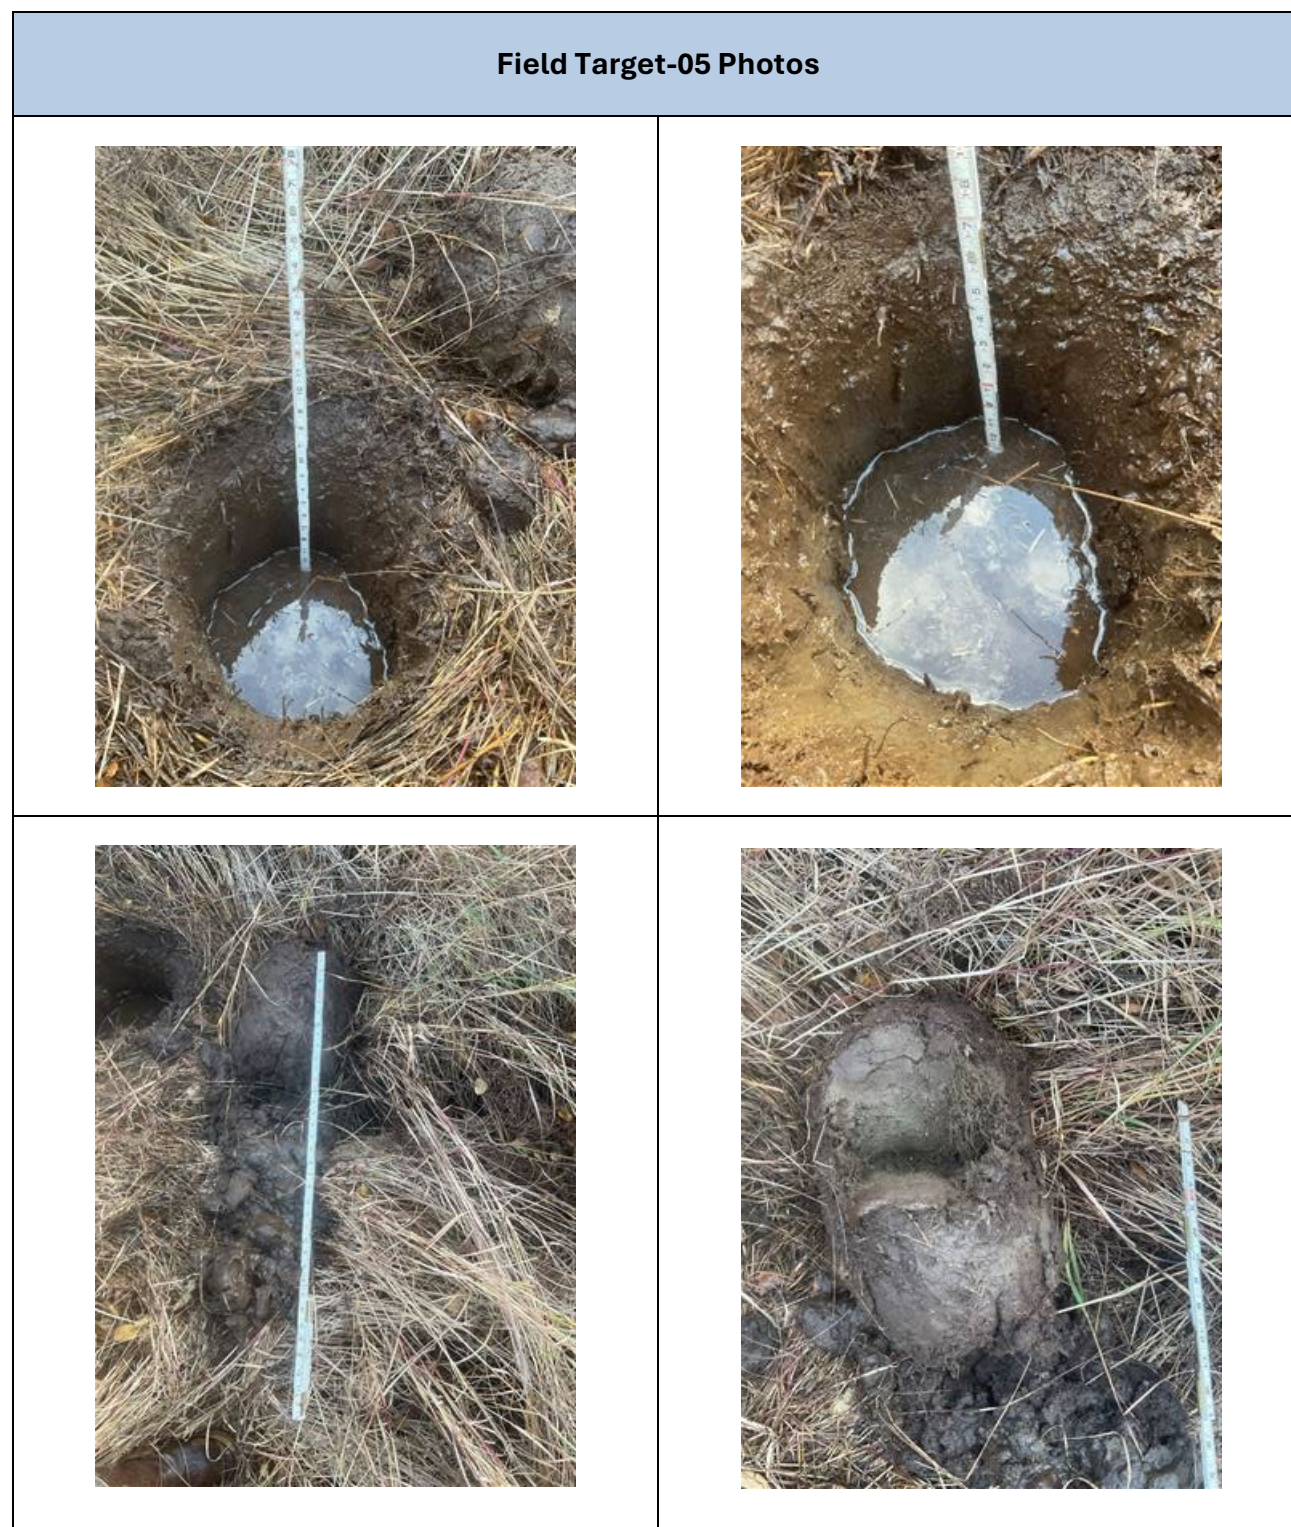
**Field Target-05 Photographs**

From top to bottom, left to right: test pit overview and initial water level, close up shot of test pit , soil plug overview, and close up shot of soil plug.

Remarks:  
3 inches of standing water found 4 feet from where the test pit was dug. Where surface water is not found, ground is very squishy. Fully inundated soils at 10 inches below ground surface. Saturation believed to be to the surface as seen by glistening sidewalls.

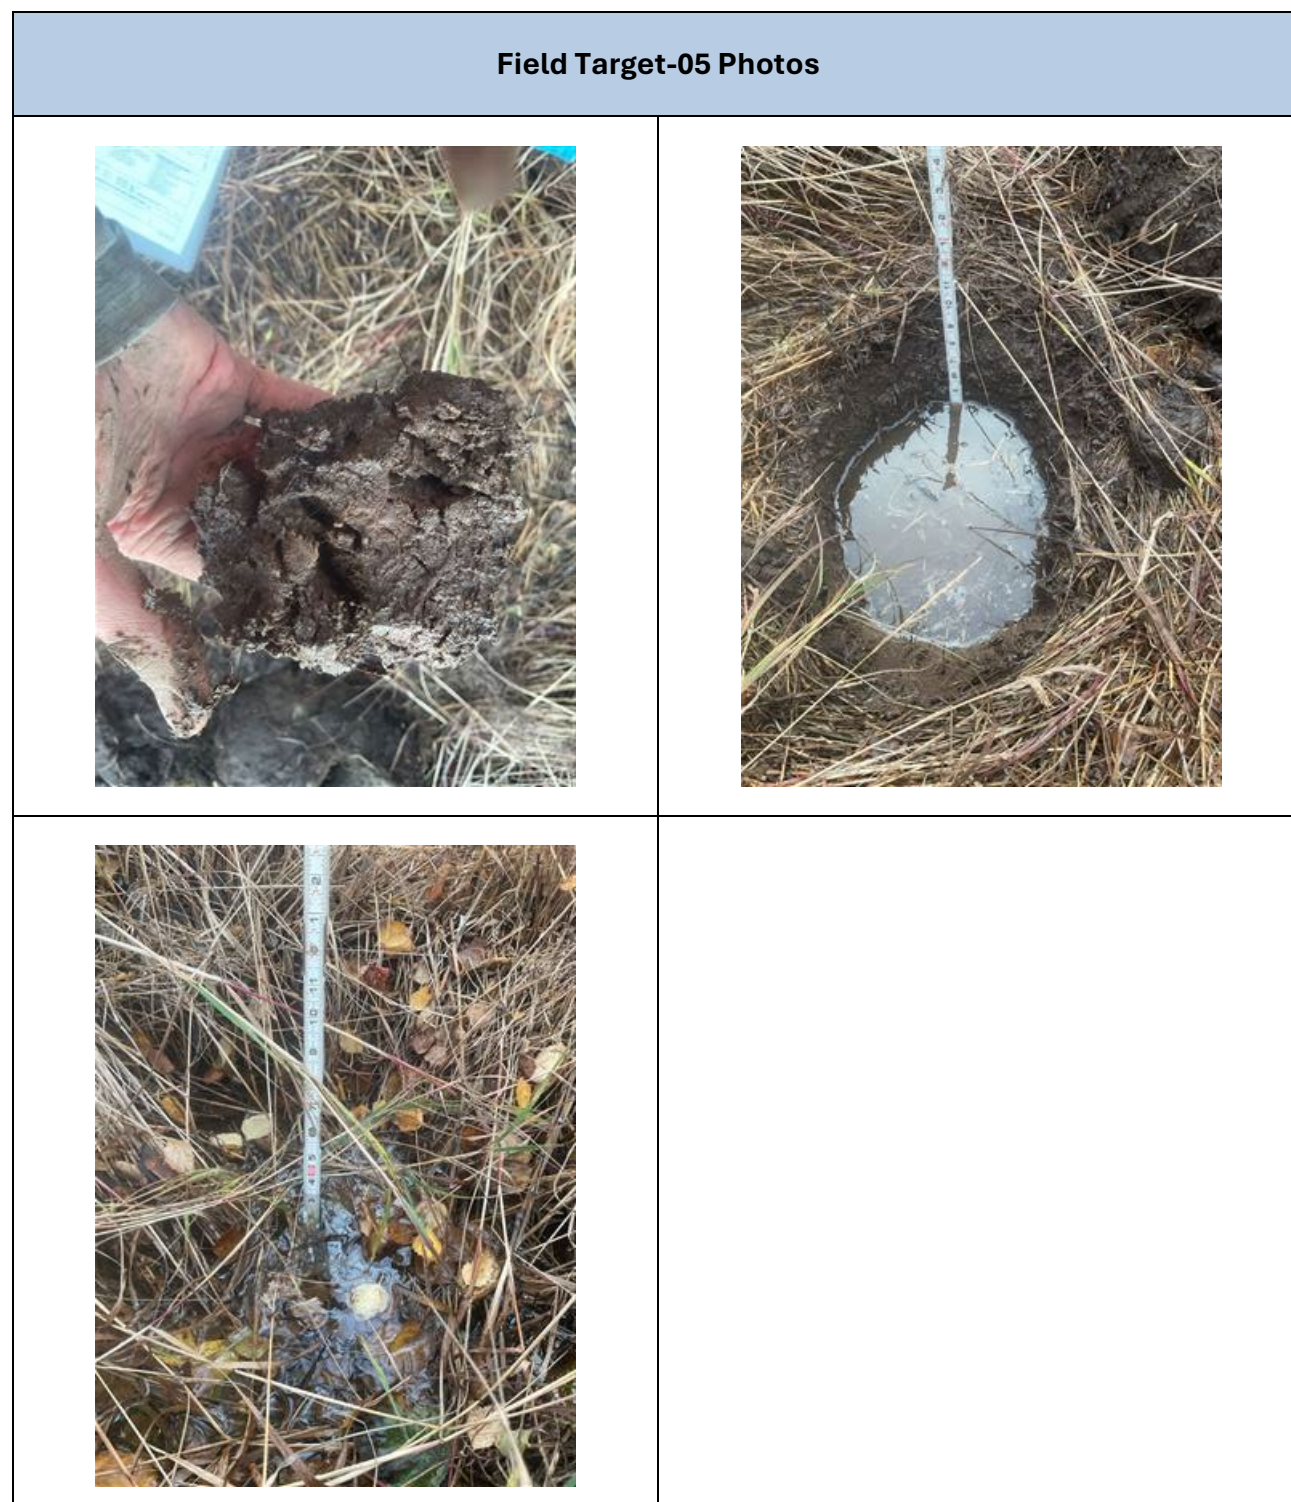
**Field Target-05 Photographs**

From top to bottom, left to right: showing the soil texture, water level in test pit at end of site analysis, and standing water measurement approximately 5 feet from the excavation site.

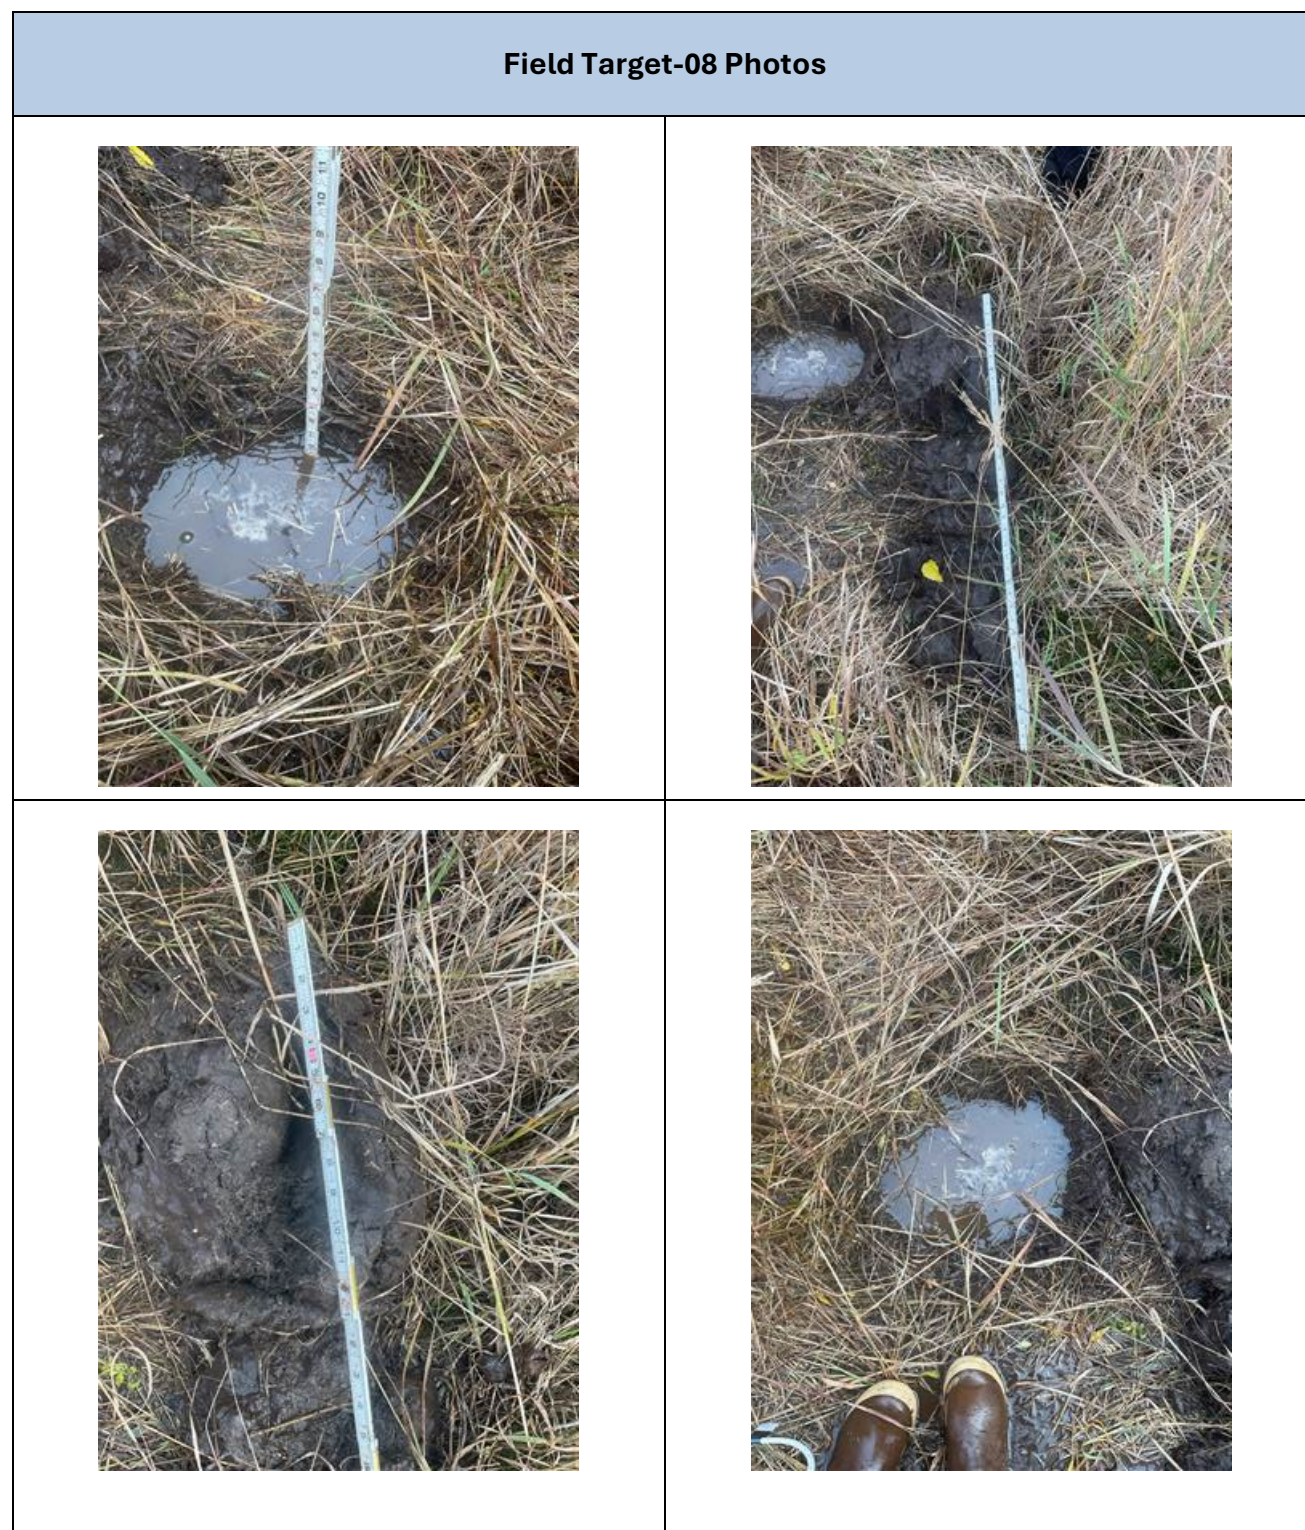
**Field Target-08 Photographs**

From top to bottom, left to right: water level in pit at initial excavation, soil plug overview, close up of soil plug showing fibric matter, and water level in test pit at the end of site analysis.

Remarks:  
Top 3 inches of plug was full plant matter, and fibric organic materials found in top 12 inches of plug. Color was uniform throughout. Soils were wet throughout plug, including to the surface. Soils described in the field as "silty loam". Soils without plant matter described as sloppy and muddy in the field.

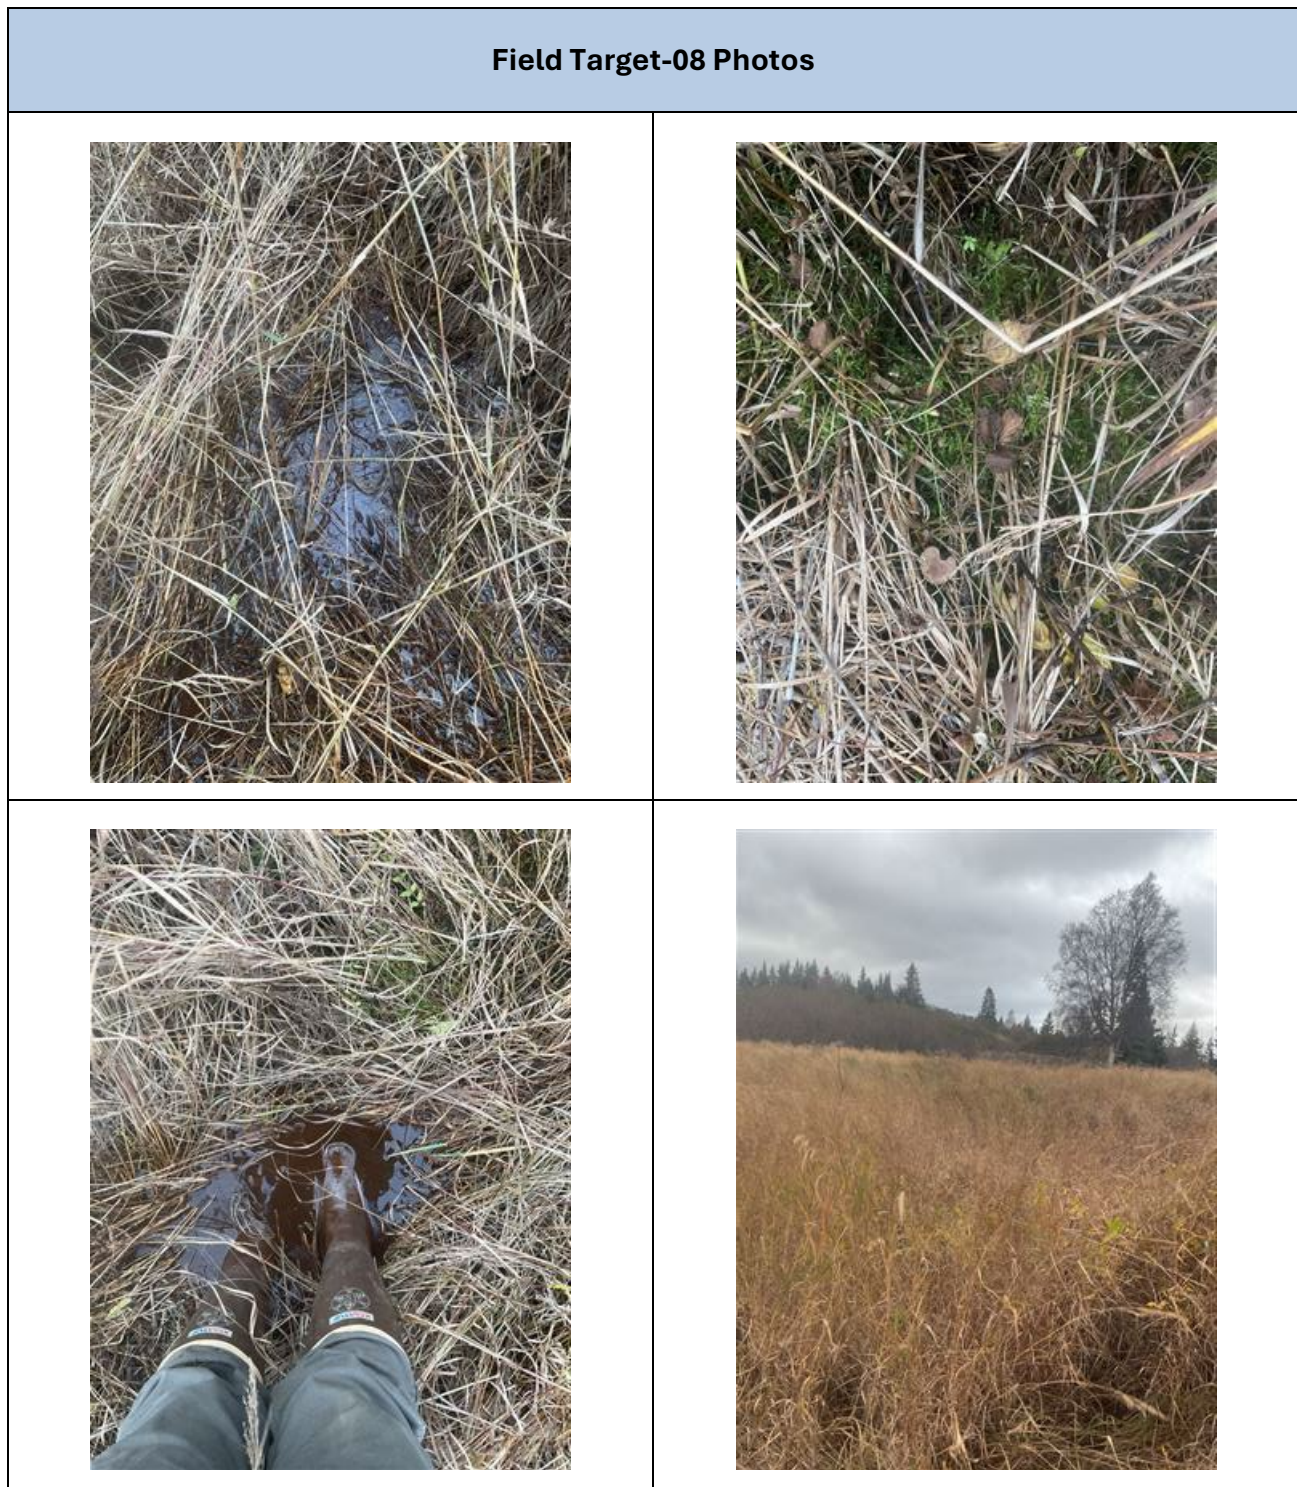
**Field Target-08 Photographs**

From top to bottom, left to right: Iron sheen observed on surface water, water staining on leaves, standing water observed at the test pit site, view from test pit site – looking south-southwest into the project area. Note the vegetation change from *C. canadensis* to *H. maximum* at the back of the photograph.

Remarks:  
Standing water at test pit and surrounding area, iron sheen observed on water surface that shattered when disturbed. Test pit full of water during entire site analysis. Water stained leaves observed at the site.

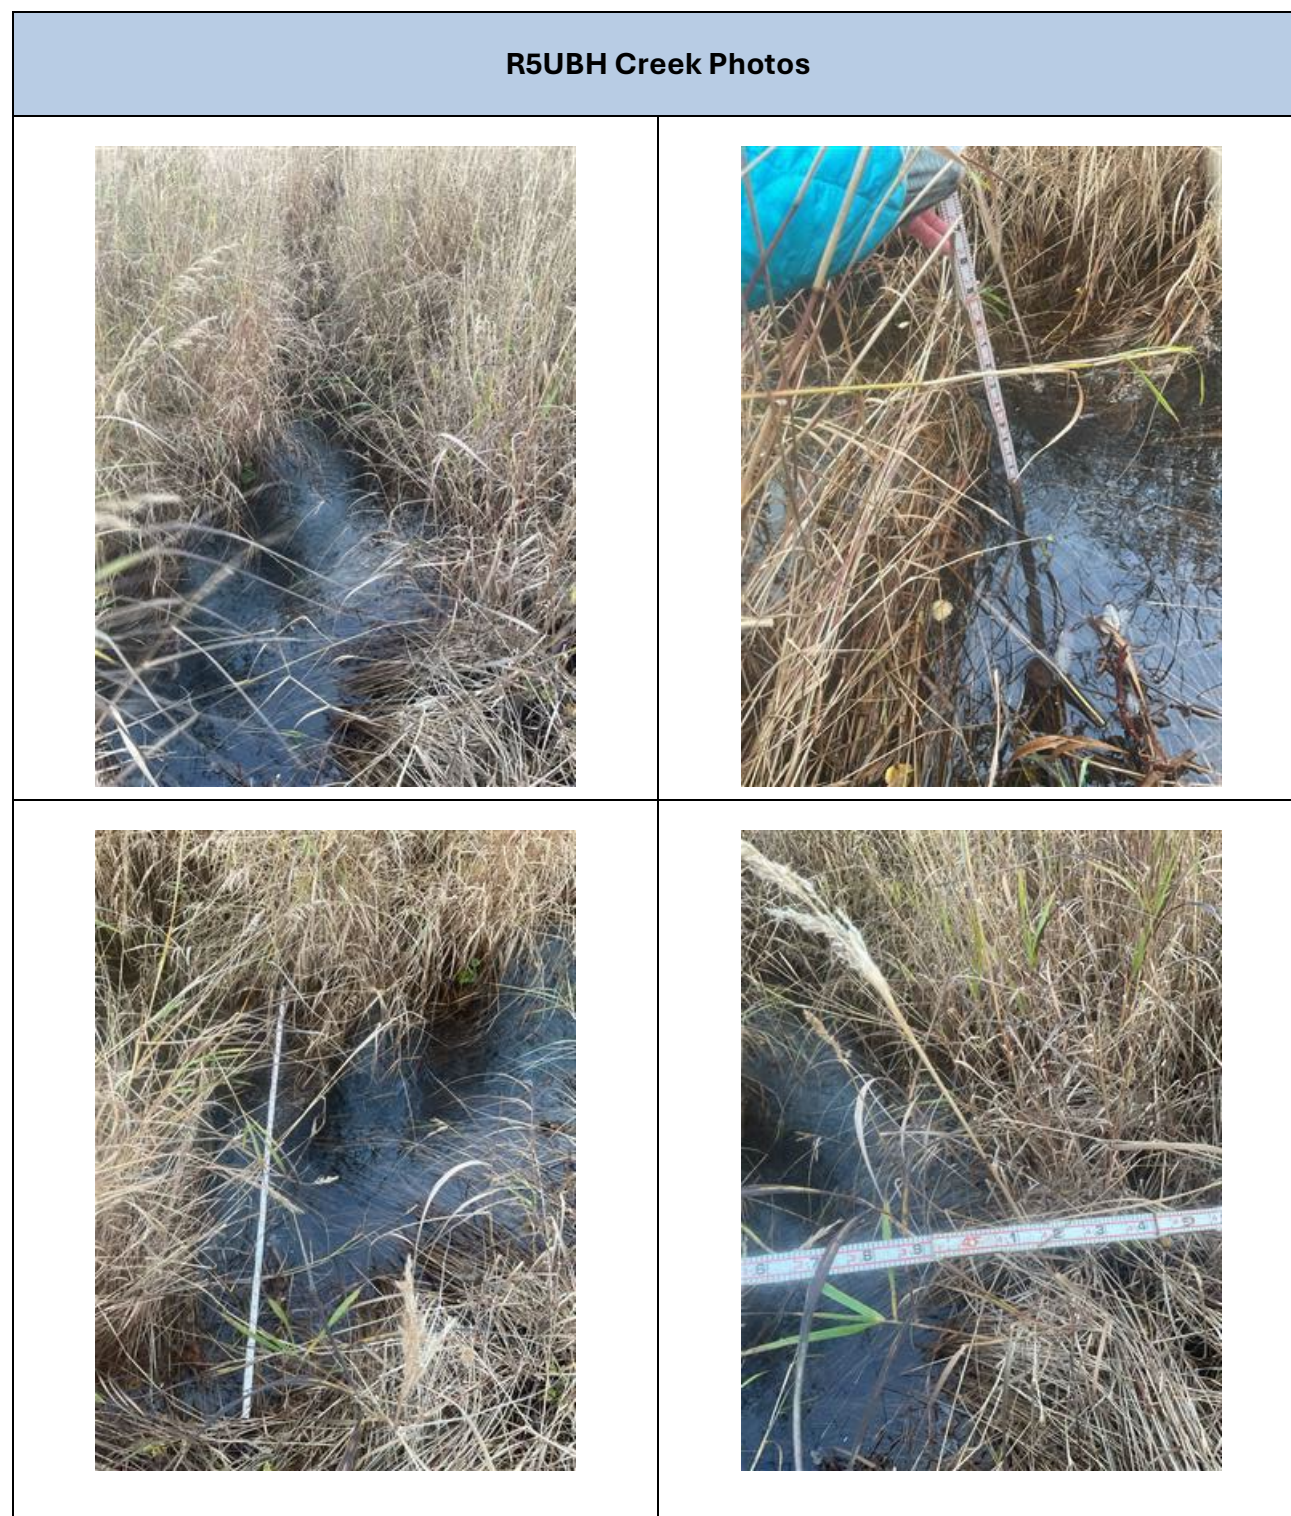
**R5UBH Creek Photographs**

From top to bottom, left to right: Overview picture of the R5UBH creek to the east of the Study Area, the creek depth, the creek width overview picture, and a close up shot of the creek width.

No other WOTUS were found in the Study Area, but there is a R5UBH riverine system just to the east of the Study Area that was previously mapped in the NWI. Although not part of the Study Area, site characterization data was collected. See Appendix B for more details.

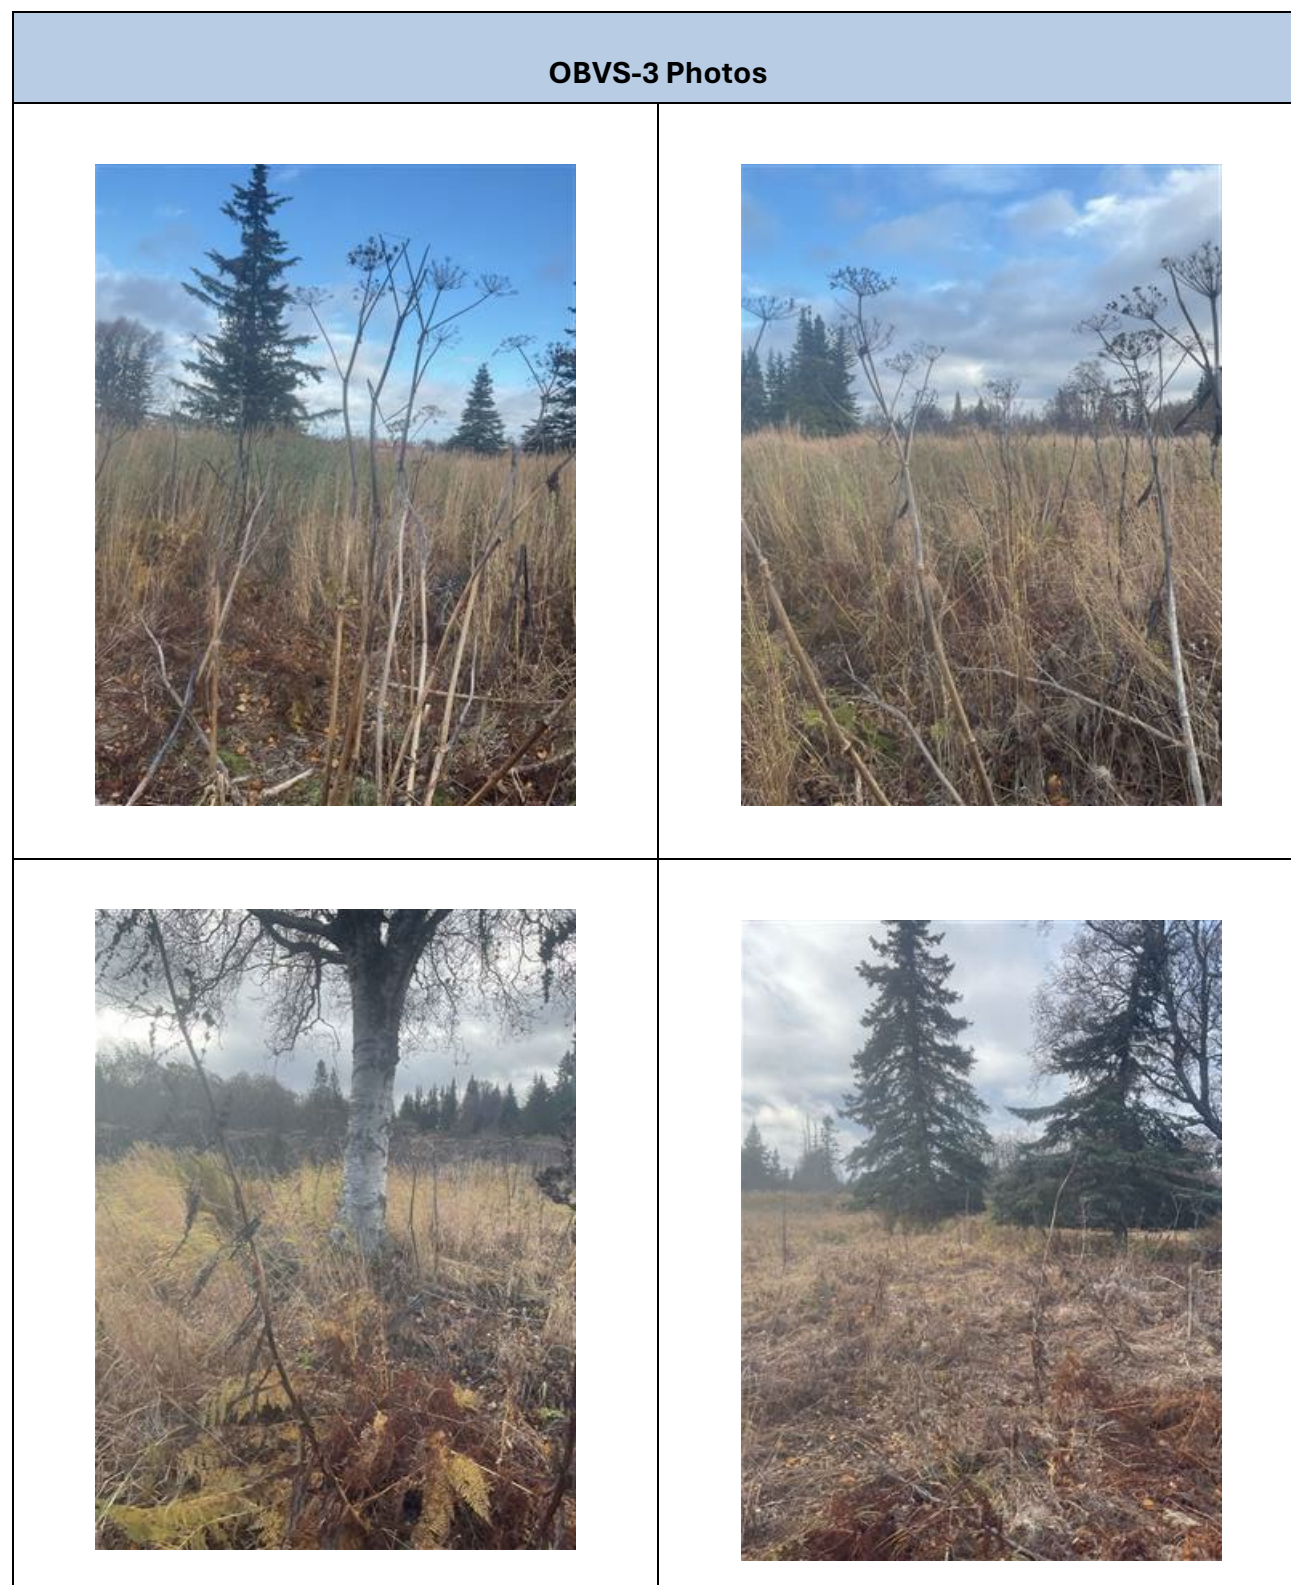
**Observation Point-3 Photographs**

Cardinal Directions from top to bottom, left to right: Facing North, Facing East, Facing South, Facing West

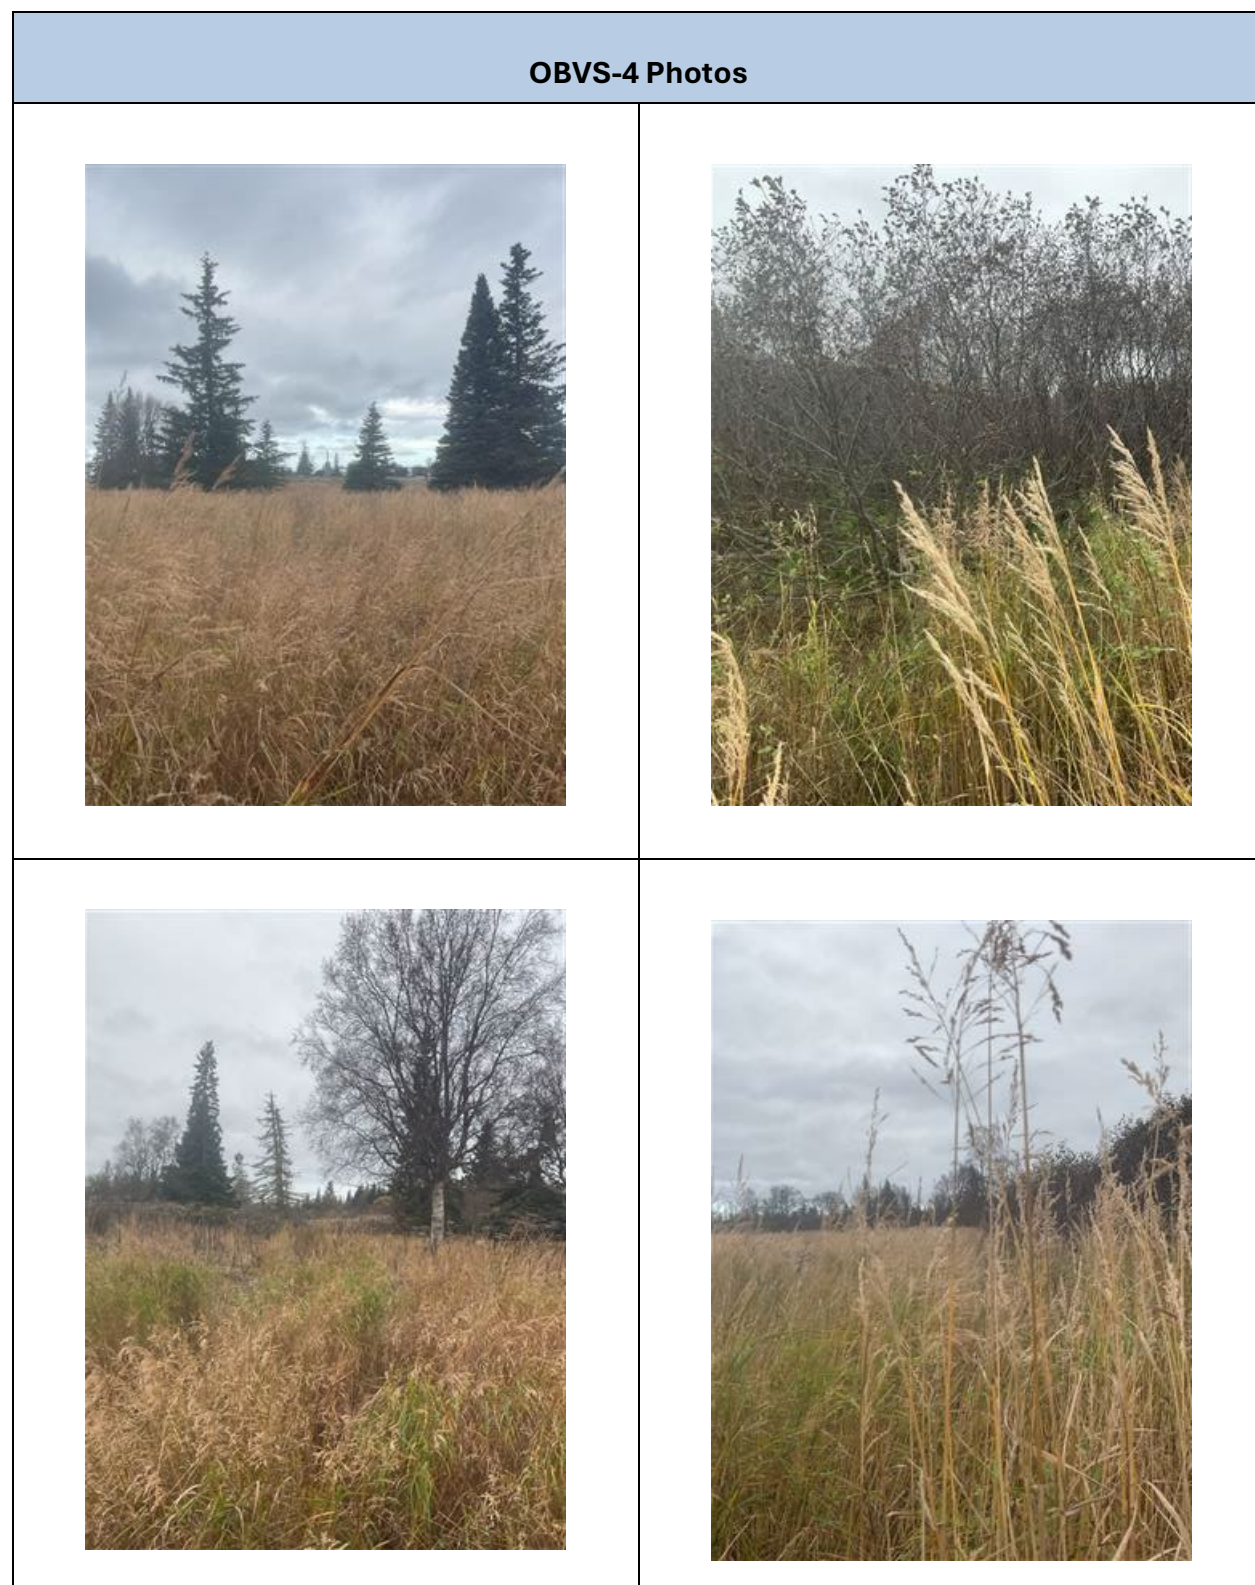
**Observation Point-4 Photographs**

Cardinal Directions from top to bottom, left to right: Facing North towards the pad, Facing East, Facing South, Facing West
