# **PROJECT DESCRIPTION**

## **Kalotsa Site Pad Expansion**

# **2025 Wetland Delineation Summary Report: Kalotsa Pad Site Expansion Kenai Peninsula, Alaska**

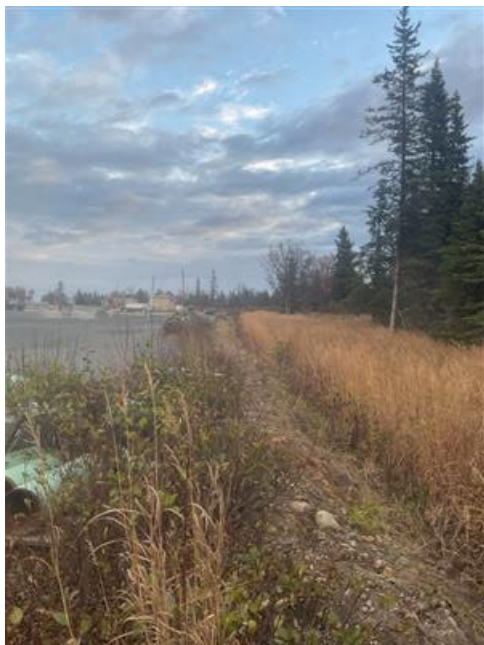
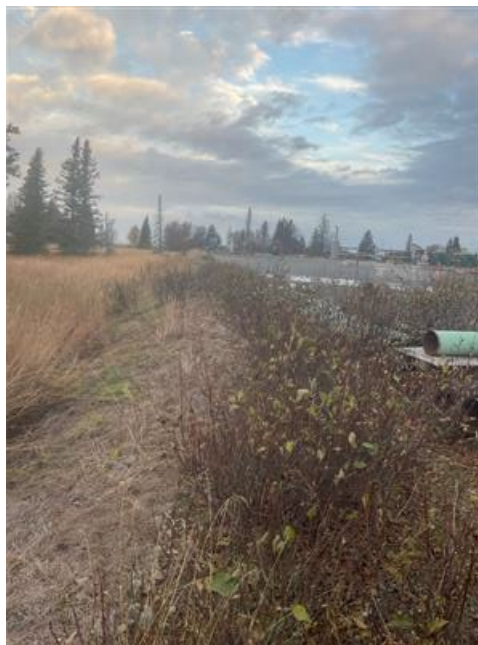
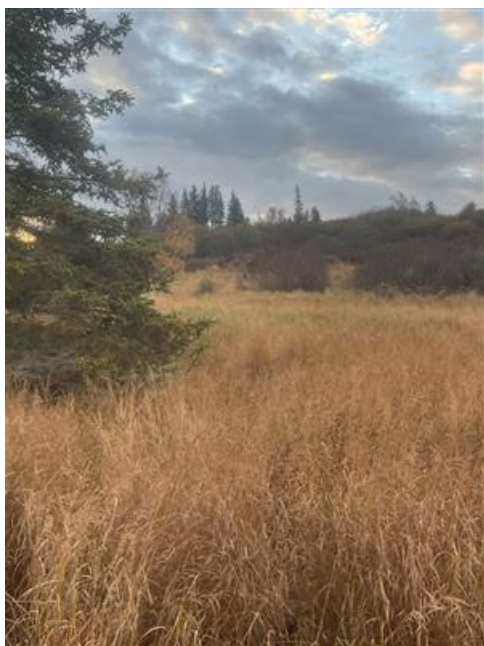
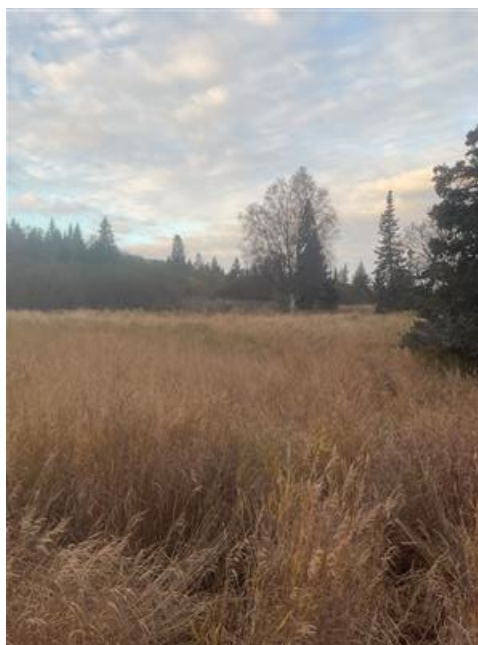
**Additional Study Area Photographs****Additional Study Area Photos – Northeast Edge of Pad – On Berm**

From top to bottom, left to right: Facing northeast into pad, Facing northwest along pad edge, Facing southeast into Study Area, Facing southwest into Study Area.

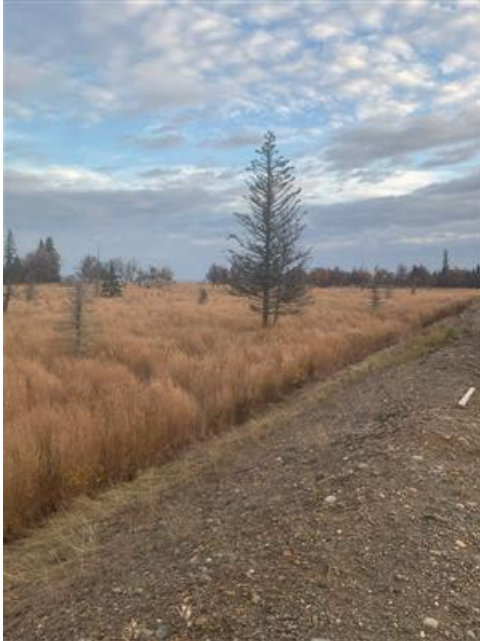
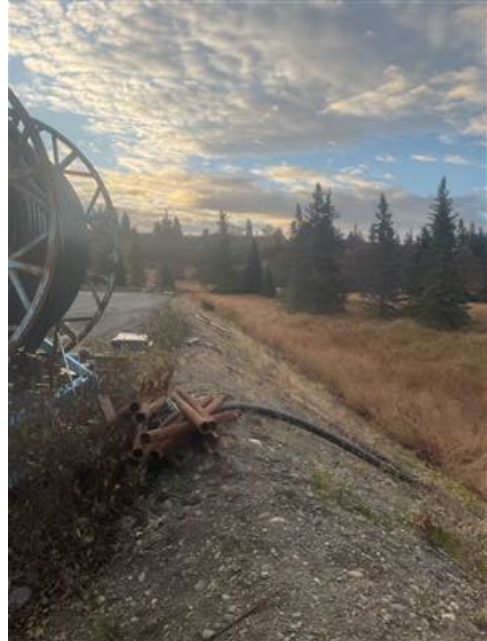
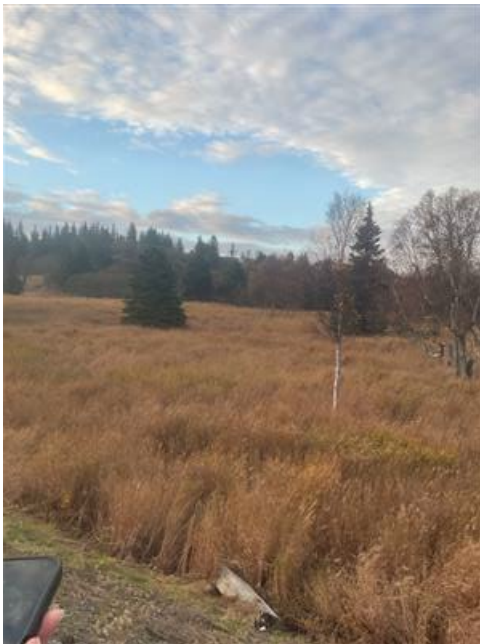
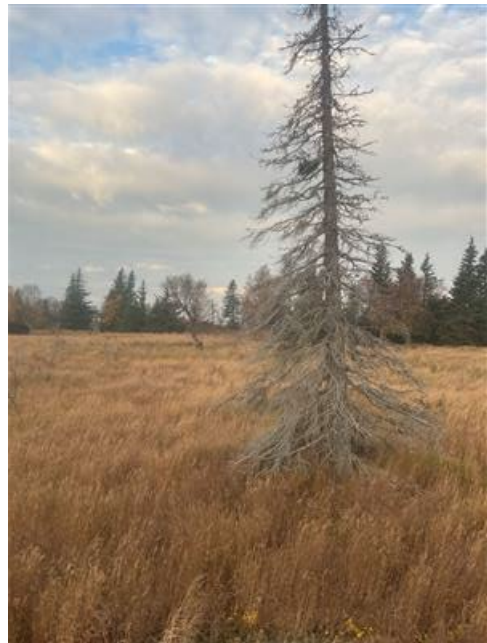
**Additional Study Area Photographs****Additional Study Area Photos – Northern Corner of Pad Edge and Study Area**

From top to bottom, left to right: Facing north away from the Study Area, facing south along existing pad edge, facing east into the Study Area, facing west along Study Area border
