Completed Projects on other Sloughs:

The following is a summary (with before and after photos) of sites that have been upgraded or “restored” on Twentythree Mile Slough and Piledriver Slough. Again, the funding is acknowledged.

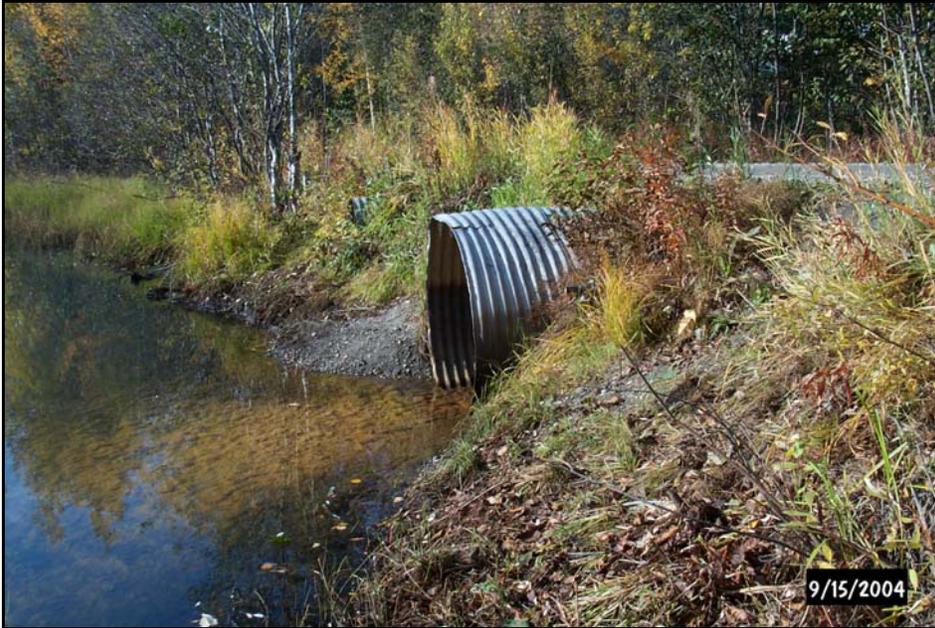
Before

In September 2004, one-36" culvert was removed from the Spruce Branch Road crossing of Chena Slough and replaced with a free-span 30' long steel bridge (originally used as a temporary bridge on the Pogo Mine Road). Funding was generated from the USFWS grant program and State grant monies.

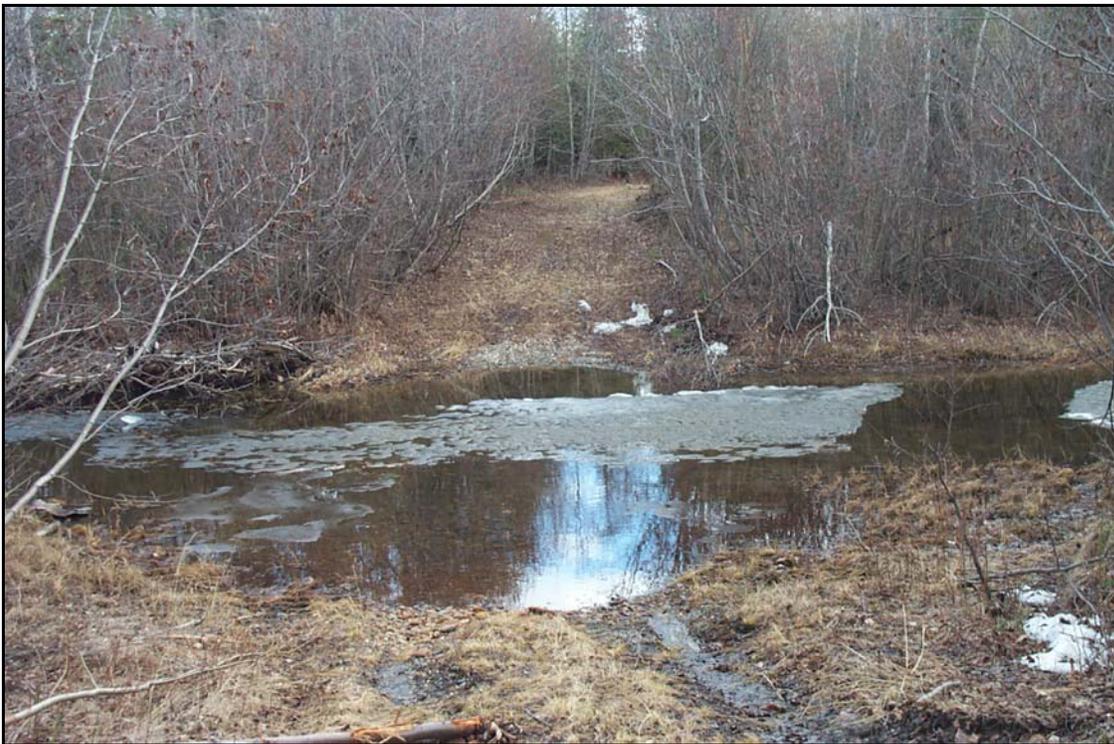
Before

In August 2003, a low water crossing of Twentythree Mile Slough was closed and a 40’ long steel bridge (originally used to access a timber sale on Montague Island) was constructed downstream from the low water crossing on the Old Valdez Trail. Funding came from the NFWF Grant, USFWS, and a State grant. Area residents provided material and in-kind work to install this bridge, re-connecting the original route of the Old Valdez Trail.

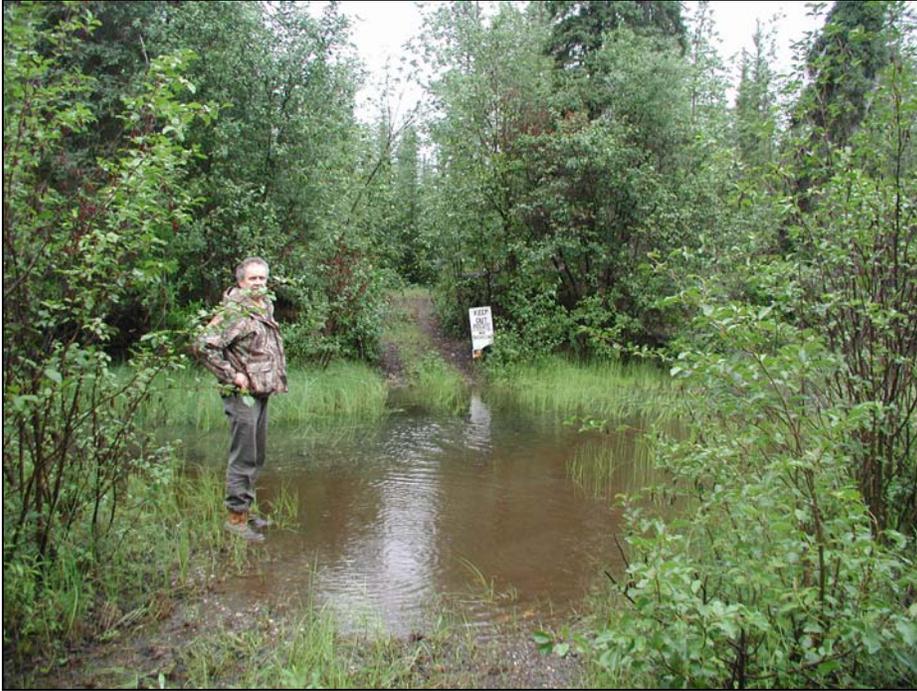
Before

In August 2003, a low water crossing of Twentythree Mile Slough was closed and a 40' long, free-span steel bridge (flatbed railcar) was constructed upstream from the low water crossing to access agricultural property and private homes. Money for this project was obtained from the USFWS and the private property owner.

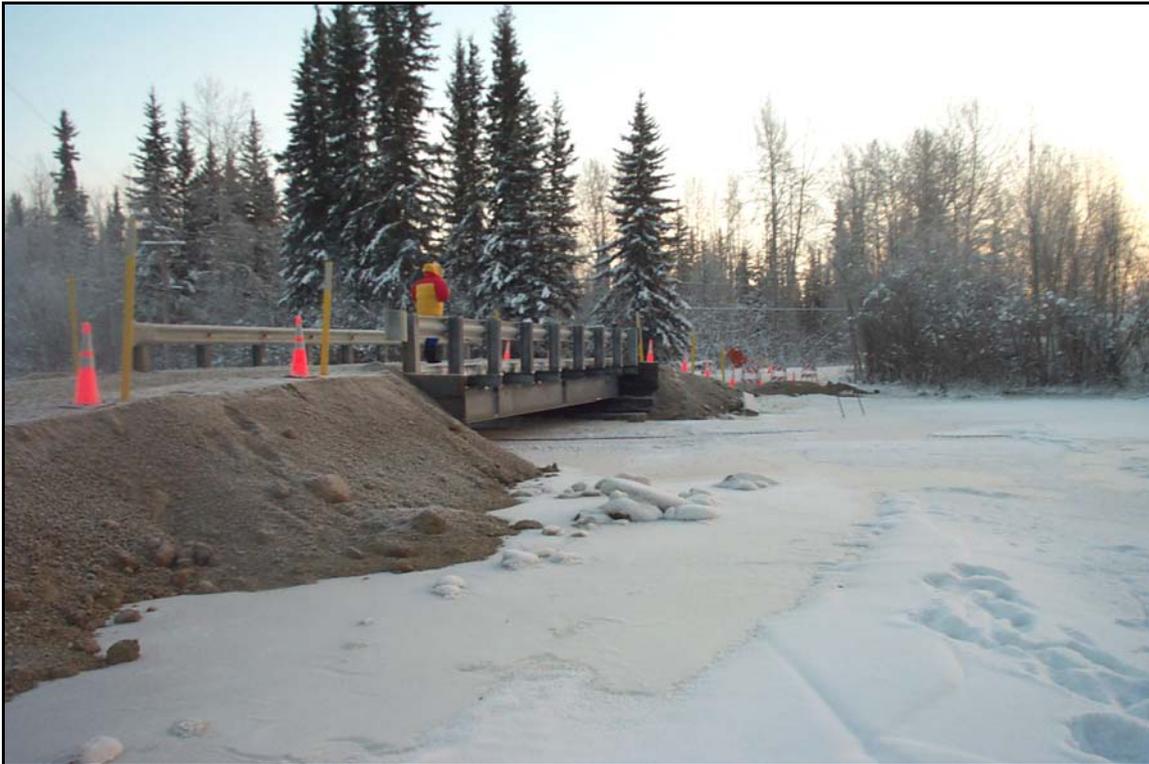
In January 2003 extensive overflow on Piledriver Slough at the Old Richardson Highway crossing (one 5’, one 4’ and one 3’ diameter culvert existed at the crossing) made the road unusable. The ADOT/PF Maintenance and Operation (M&O) crew installed a temporary bridge at the crossing site to keep the road open and safe.

Temporary bridge over the culverts

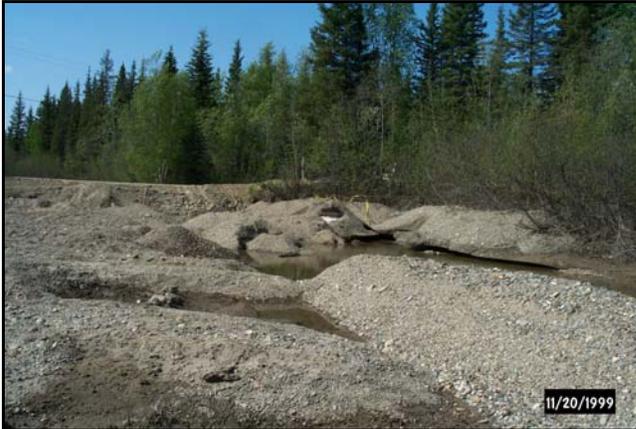
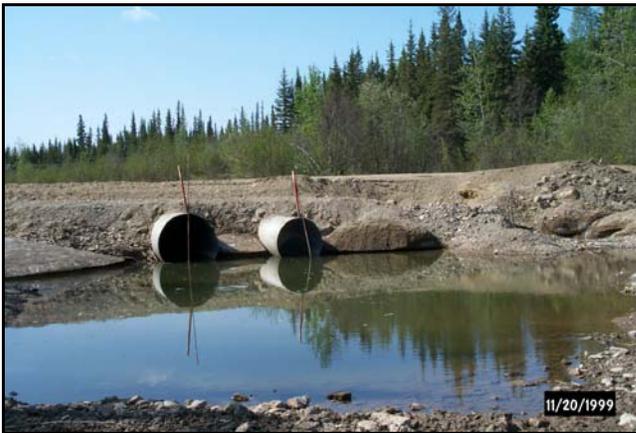
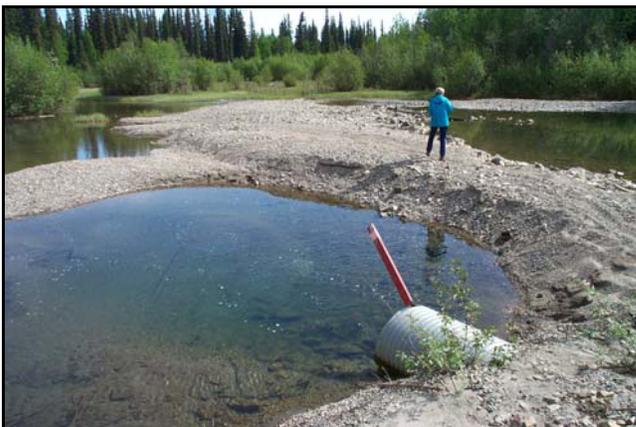
The Old Richardson Highway Piledriver Slough crossing caused problems on a yearly basis. Most often the road fill material would wash out during break-up (probably due to frozen, undersized culverts) and settle immediately downstream. Year after year new fill material would be brought in, and year after year it would wash downstream. This resulted in an extremely wide, braided channel immediately downstream of the crossing with large piles of gravel dividing the channels.

In October 2003, ADOT/PF M&O (with funding assistance from the USFWS) removed the existing culverts, created a “permanent” 30’ wide by 3’ deep channel with a bankfull bench at the downstream left-limit of the crossing, and installed two 12’ diameter arched culverts. The ADNR-OHMP and the USFWS worked closely with ADOT/PF to design and construct the new crossing and channel.

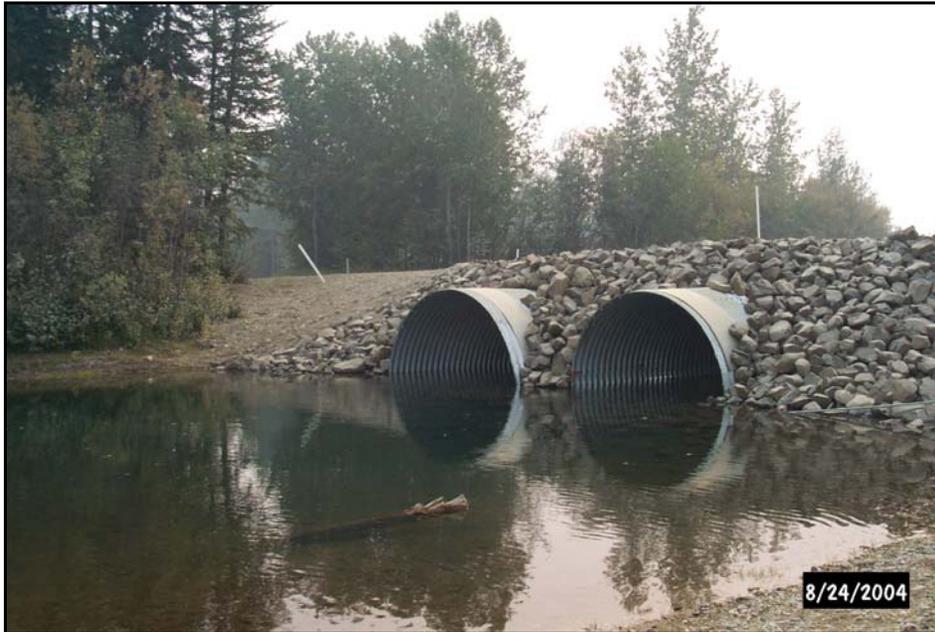
After (outlet – taken from bankfull bench)

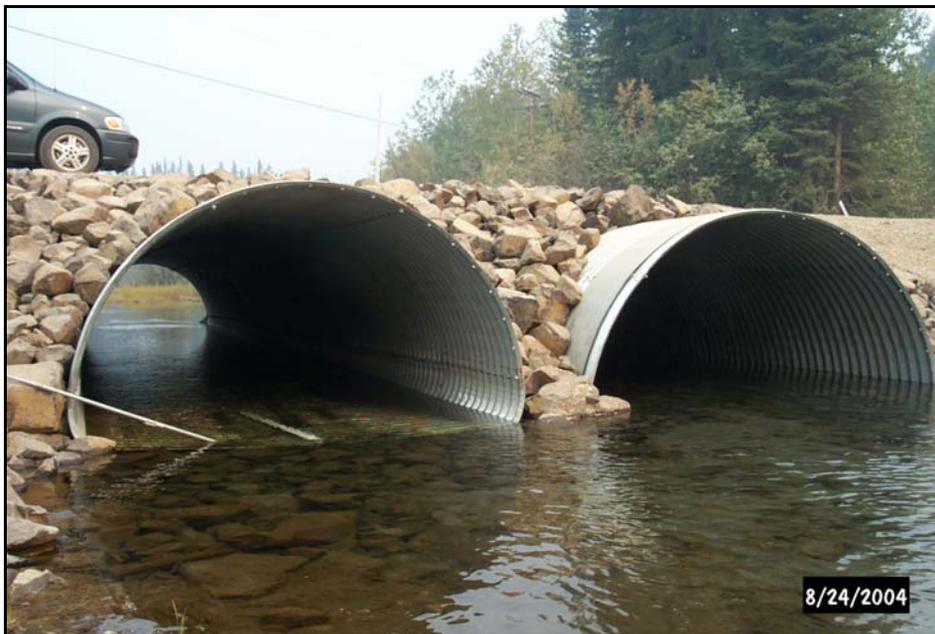
After (inlet)
