## ***Bluff Cabin Trail: Assessment & Prescription***

## Assessment

### ***Prescription***

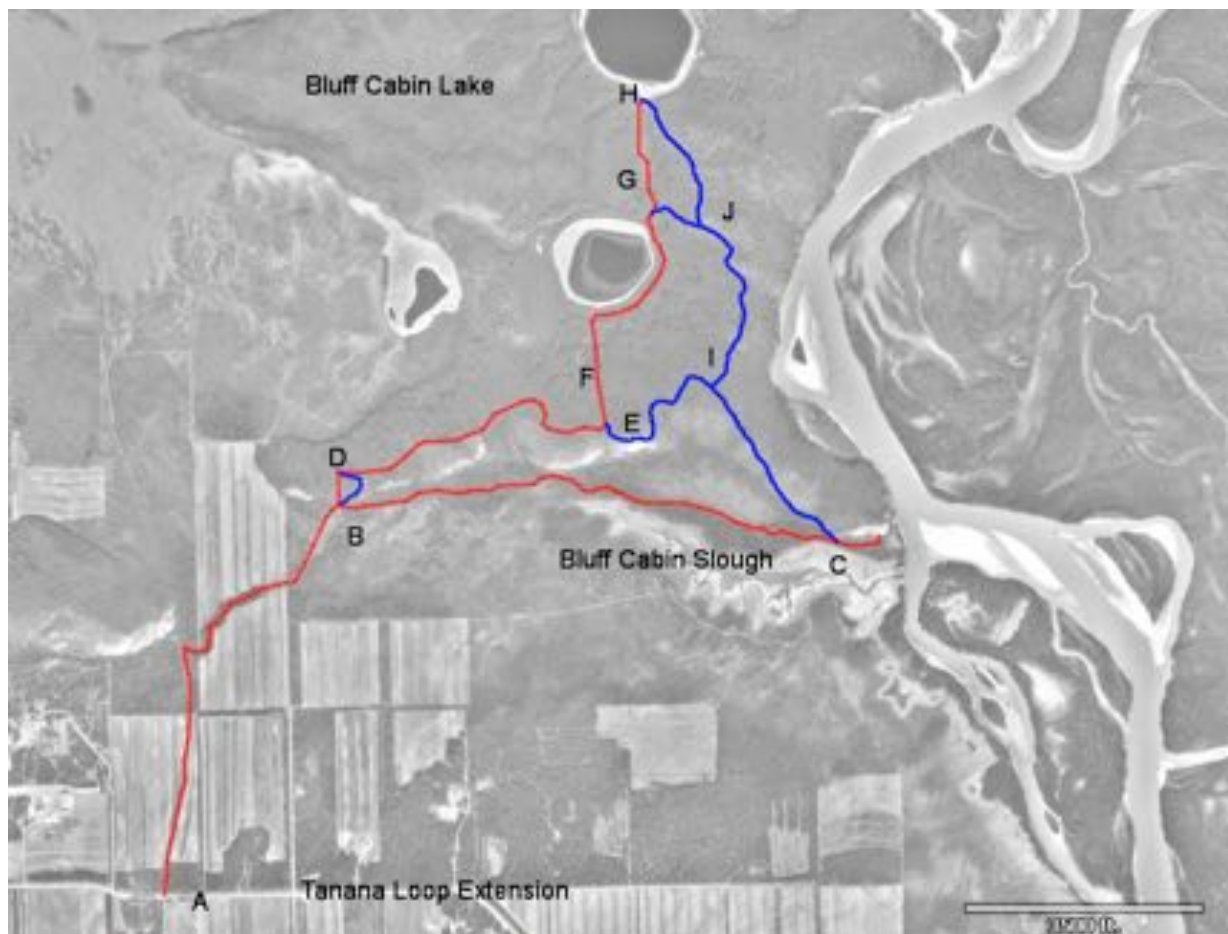
*Red denotes existing location, Blue denotes proposed realignment.*

Tanana Loops Extension (A) to Junction Segment (B), as depicted in the above map: Contractor, MVPs LLC, has brought the damaged tread on this 1.34 mile segment up to grade with imported pit-run gravel, underlain with geofabric.

Bluff Cabin Slough Segment (B-C): Geoblock has not been installed correctly: ruts were not leveled prior to installation, panels are seamed rather than inter-locked, lack of weatherproof plywood backing plates at connections, zip-ties have not been clipped (screw fastening into the backing plates, rather than zip-ties would have reduced the flexing of the geoblock). Trail segment is deeply rutted and entrenched and un-maintainable to ~500yds of terminus.

Bluff Cabin Lakes Segment: At the junction (B), this section has a 24-25% fall-line alignment; after the junction, from point D to point E, the trail is acceptable, but will require limited attention to berms and drains, and maintenance is likely to increase in the future as use increases. At point F, un-maintainable fall-line segment over an underlying seep, showing severe erosion and braiding. At point G, un-maintainable segment, showing severe erosion and braiding. Portions of the trail adjacent to both lakes are in adequate condition.

Bluff Cabin Slough Segment (B-C, as depicted in the above map): Abandon this segment and create realignment, from point E to point C (~1.1 miles). Consider salvaging geoblock for future use.

Bluff Cabin Lakes Segment: Trail at points B-D requires realignment, w/ 25' radius sweep turns at 10-12% grades (0.2 miles); original alignment needs to be physically closed. Trail to points D-E, remove berms and install drains at low points in the trail. Trail after point E needs to be abandoned. A new trail constructed north on Bluff Cabin Ridge, from point I to the northern lake (H, ~1.2 miles), with a spur down to southern lake at point J (~0.2 miles).

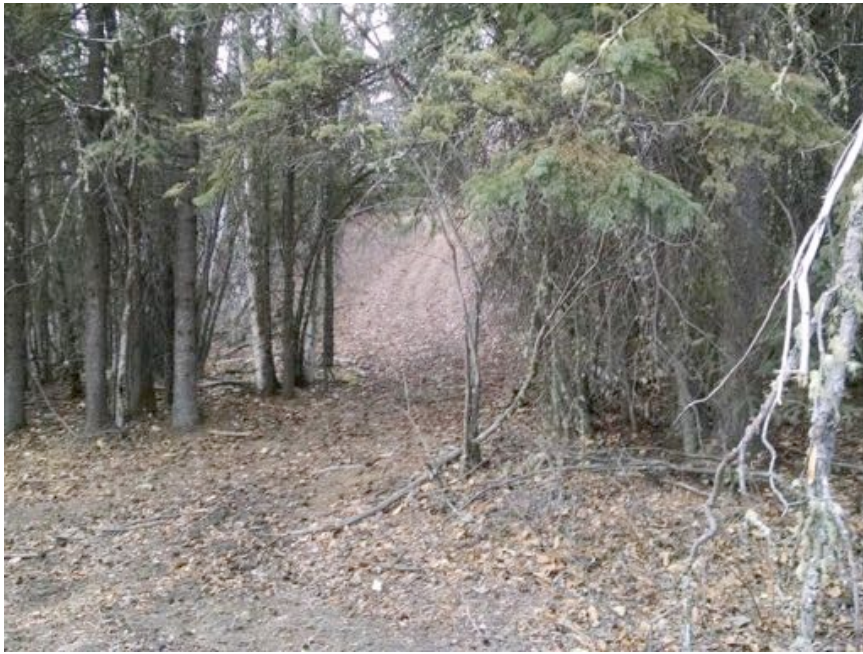
**C.** Proposed junction.
