**Alaska Department of Environmental Conservation  
Village Safe Water Program  
Proposal Form**

Proj No.....: VSW-MTM-2019-37  
Project Title.....: Design Services  
City.....: Metlakatla, Alaska

**Request for Statement of Qualifications**  
**VSW-MTM-2019-37**

## *DISINFECTION BYPRODUCT REDUCTION AND PIPE CORROSION*

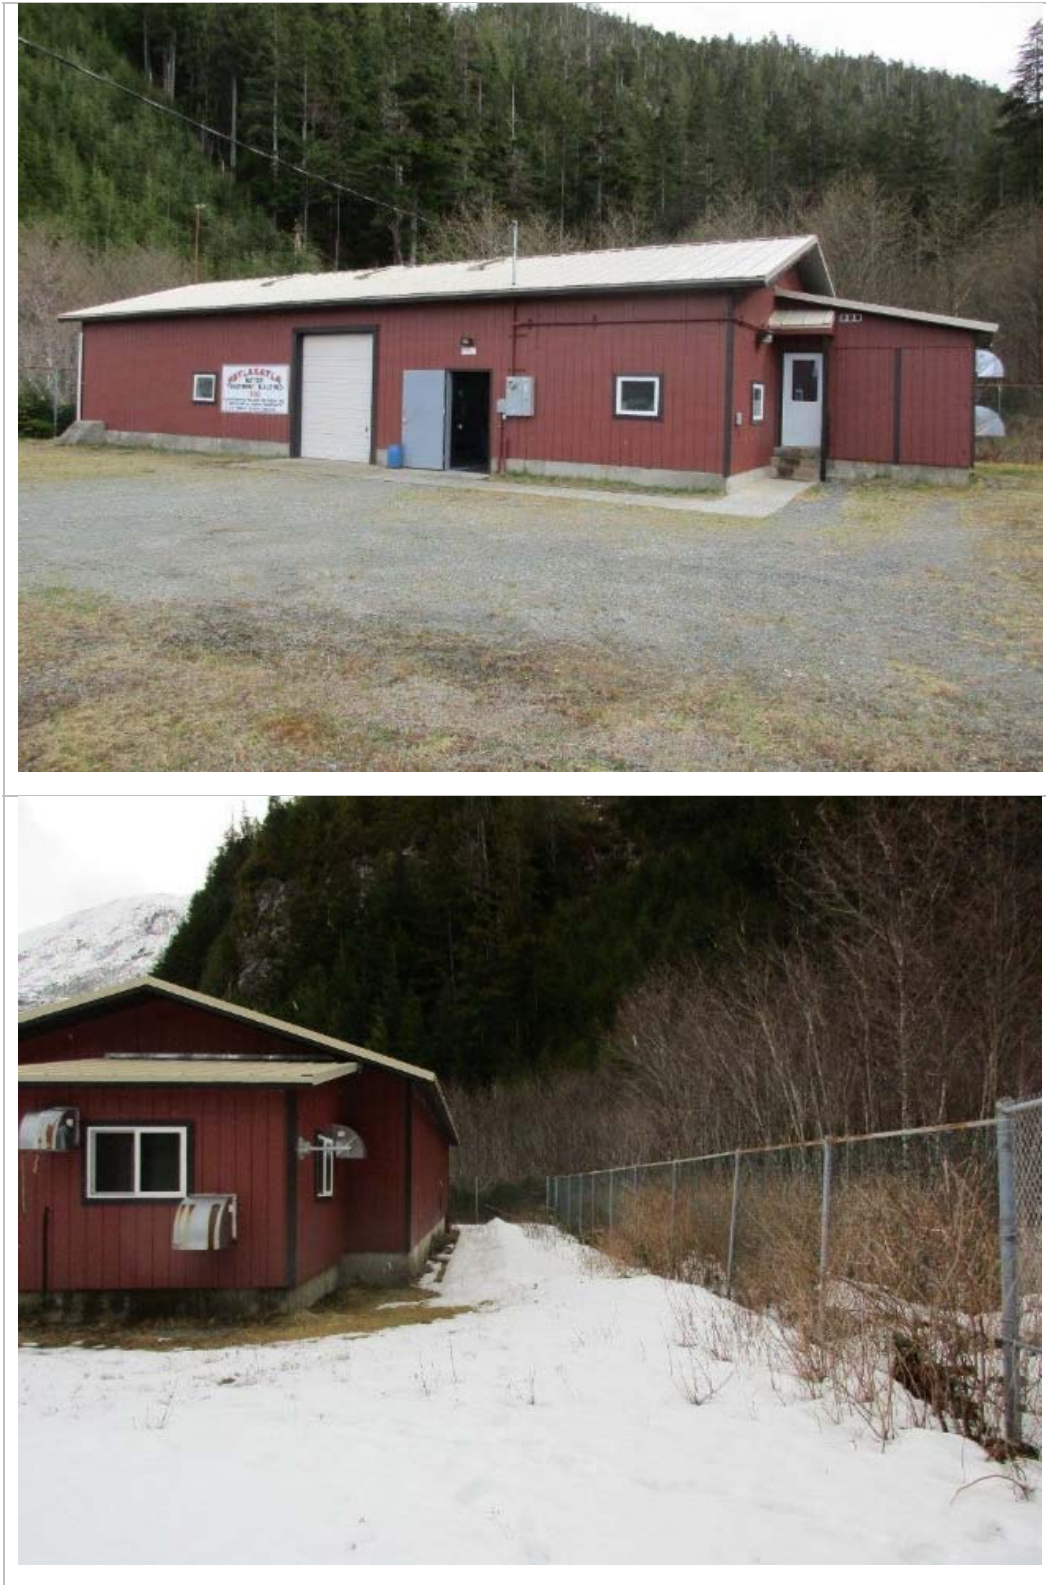
**Figure 4. Photos of MIC WTP, front and back of building**

The existing facilities are in good condition and are adequate for existing treatment, aside from a connex used for onsite storage that personnel indicated is in poor condition. The treatment train of direct filtration, chlorination and contact time in the two 500,000-gallon tanks meets regulatory filtration and disinfection requirements. As discussed in detail in a subsequent section, the WTP has recently experienced excursions of the Haloacetic Acid (HAA5) DBP limits set by the Stage 2 DBP Rule. At the encouragement of the U.S. Environmental Protection Agency (EPA), MIC is flushing the distribution system on a quarterly basis to reduce DBP concentrations. Energy consumption at the WTP is limited, as water flow through the System is driven by gravity. Energy consumed is for the automated valves, instrumentation, coagulant dosing pumps and WTP lights.

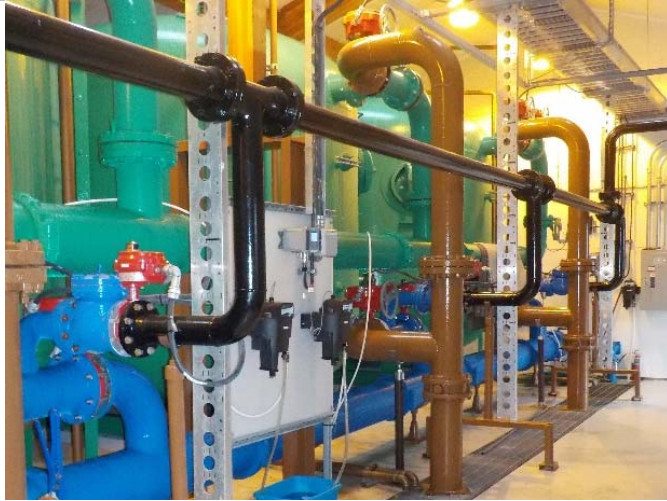
Filter gallery with four dual media pressure filters, piping and turbidimeters

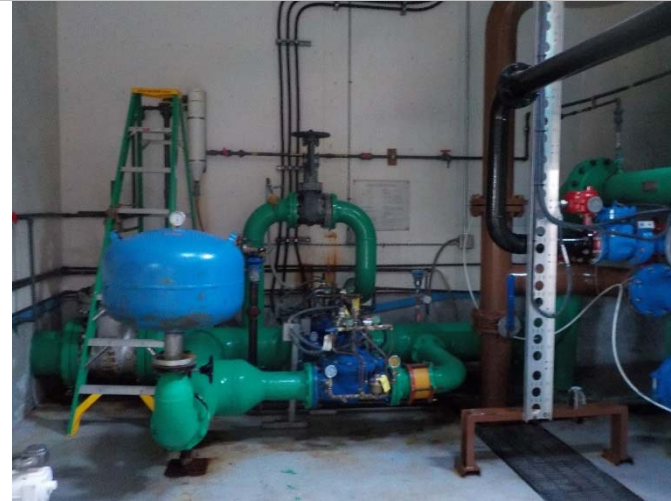
PRVs reduce water pressure to around 150 psi in the plant

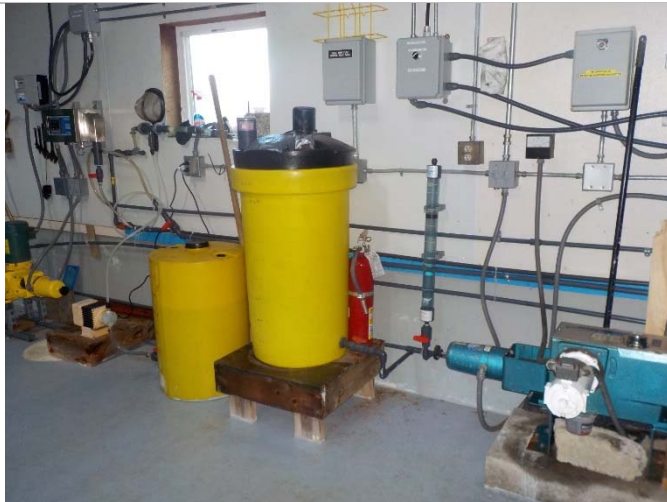
A dilution of coagulant and water is injected upstream of the pressure filters

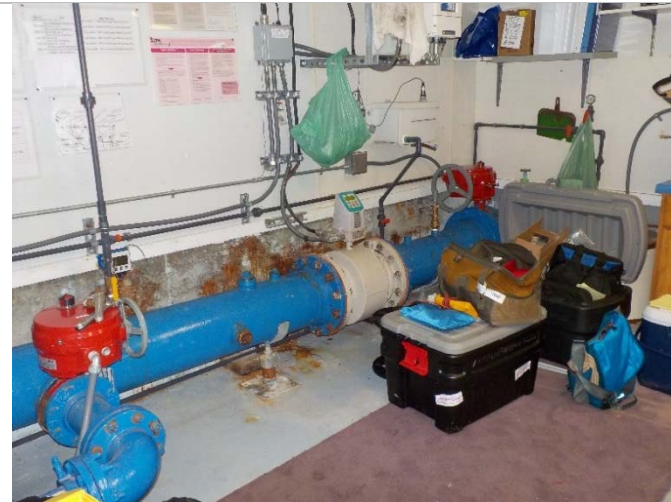
Chlorine is injected upstream of the flow meter prior to the distribution system

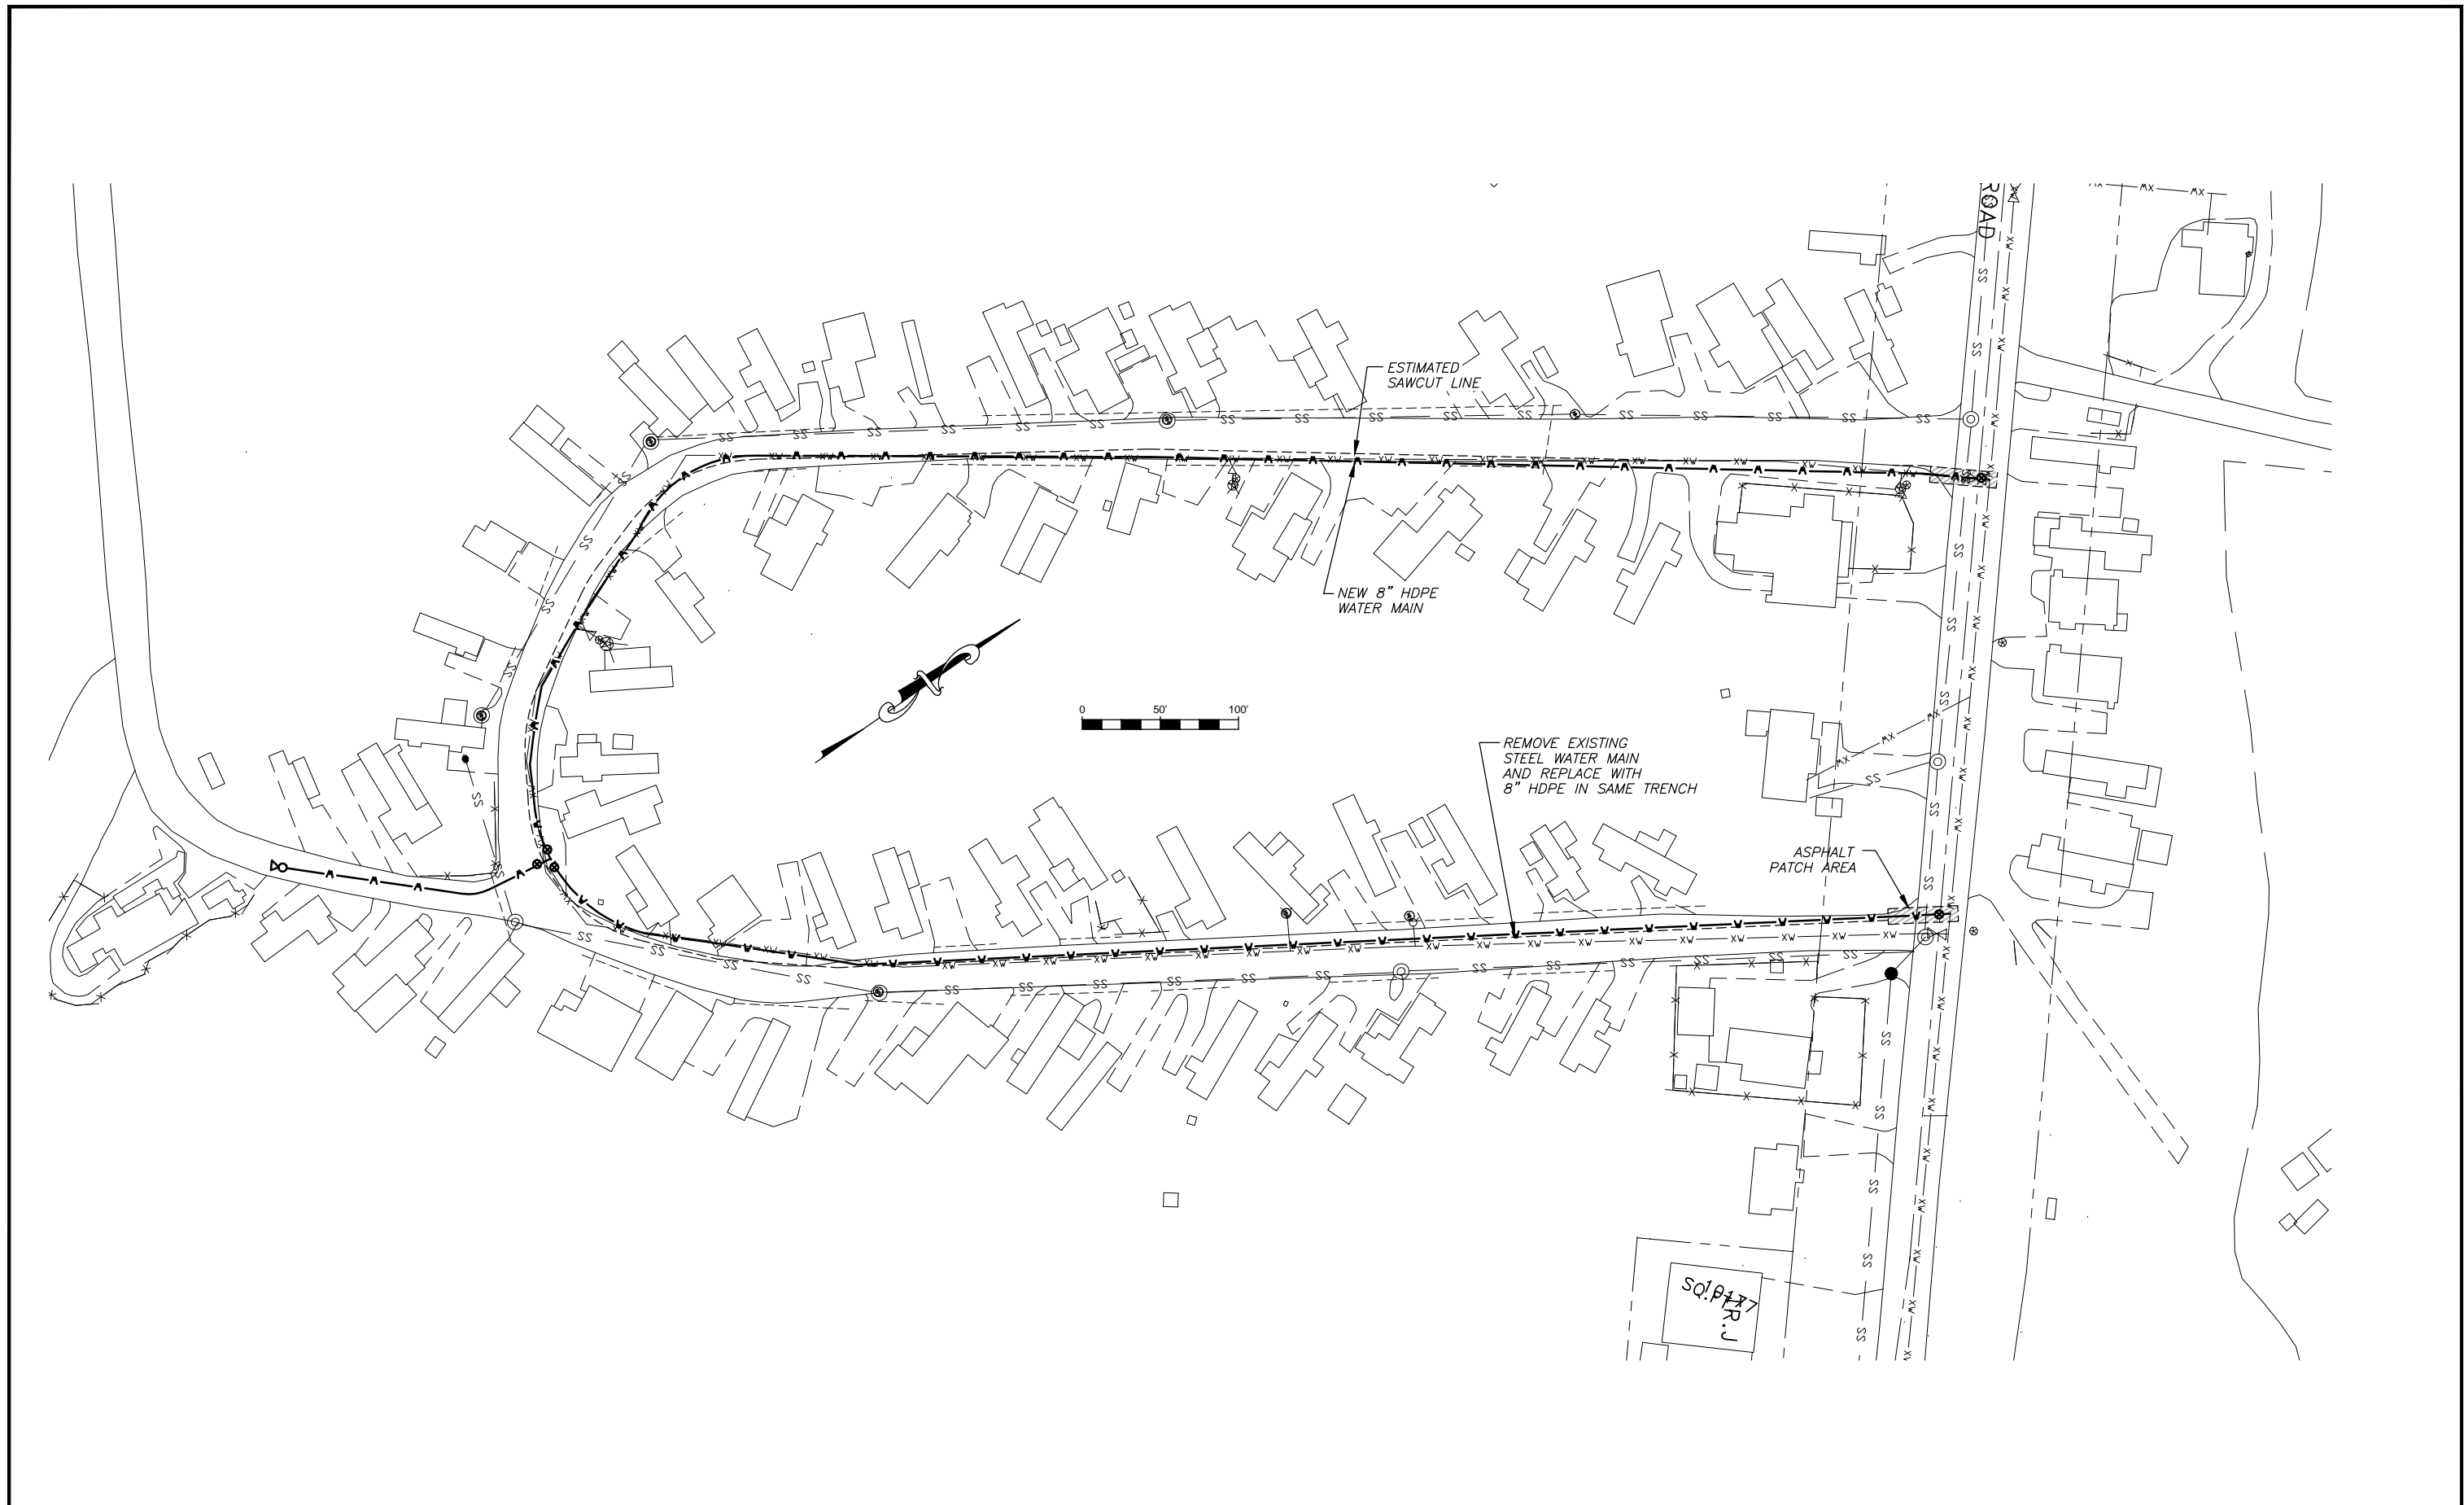
Figure 7. Distribution System Trailer Court Pipe Replacement Upgrades Site Map

Figure 7, below, is a project map showing the area of the distribution system termed the New Trailer Court where the pipe will be replaced.

The distribution piping in the Trailer Court is to be dug up, removed and replaced with new 8" HDPE pipe. The replacement will include approximately 2,100 linear feet of piping, associated valves and connections, D-1 bedding, backfill material, cathodic protection, and a temporary water line to service the affected community during the project. The water main installation on Calvin Street will include approximately 600 linear feet of 8" HDPE water main to be installed with associated valves and connections. Both locations for distribution line upgrades will involve removing the existing asphalt and finishing the surface with an asphalt patching product (EZ Street Cold Patch). Refer to Figure 7 (Trailer Court Upgrades) and Figure 8 (Calvin Street Upgrades) for R&M Engineering-Ketchikan distribution system upgrade preliminary project drawings.

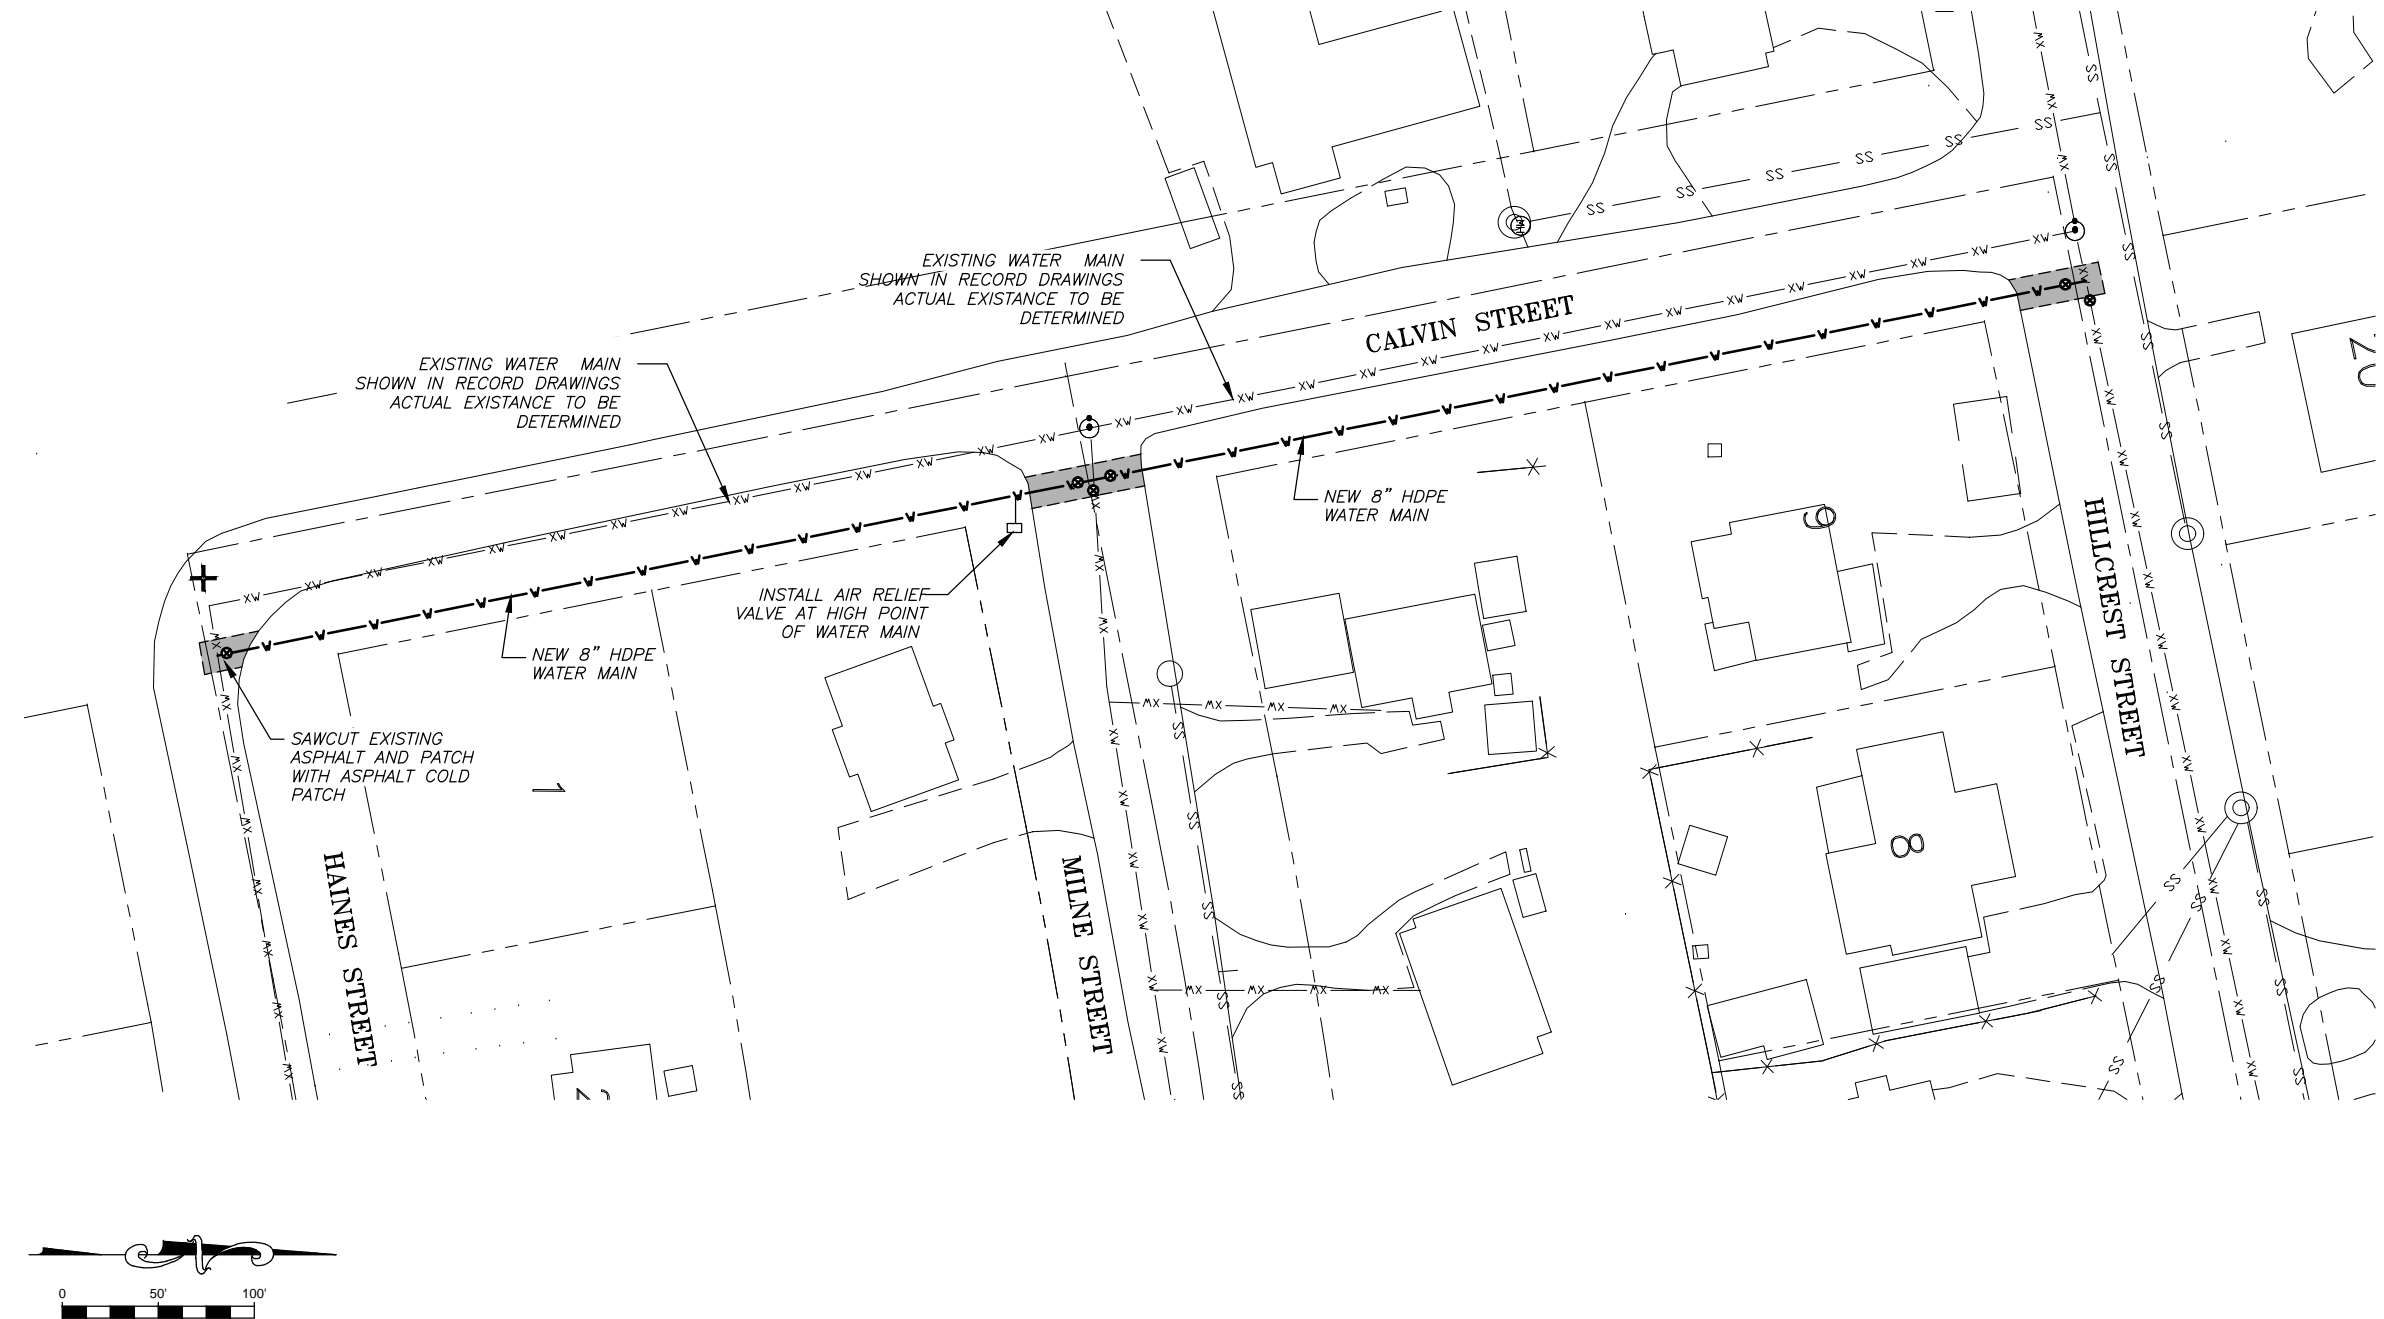
Figure 8. Calvin St. Water Line Upgrades Site Map

As no other pipes are dead ends, there are no alternatives. Figure 8 is a project map showing the area of the distribution system to be connected with a new water line.

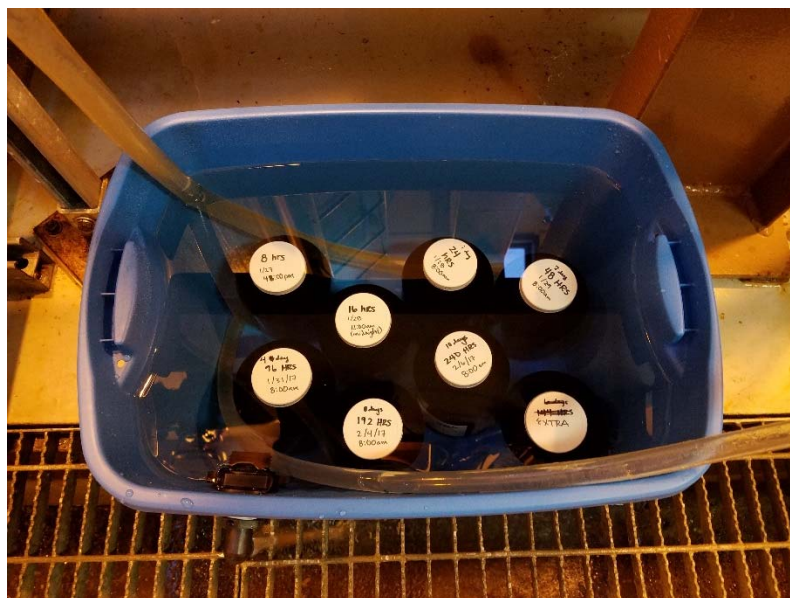
**Figure 10. Photo of DBP study conducted onsite at the MIC WTP**

Concurrent to the tracer study, a study was conducted to determine the DBP formation rate as a function of water age under simulated distribution system conditions. Samples were collected of treated and disinfected water just prior to leaving the MIC WTP. The jars with the samples were placed in a tub and provided a continuous flow of plant water to maintain the temperature of the samples at the treated water temperature. A photo of the sample bottles during the study is shown in Figure 10. After 8 hours, a jar was removed and a sample was collected for total trihalomethanes (TTHM) and HAA5 analysis. Samples were collected after 8 hours, 16 hours, 24 hours, 48 hours, 96 hours, 192 hours, and 240 hours. Figure 11 shows the resulting concentrations of HAA5 DBPs that developed during the study over time. The area highlighted in orange on the graph demonstrates the range of mean HRT to each of the sample locations as determined by the tracer study, while the red horizontal line denotes the HAA5 maximum contaminant level (60 ug/L). As shown, at the calculated HRT for the water in the distribution system (128 to 168 hours), the concentration of HAA5 DBPs expected to develop is close to the limit of 60 ug/L. Additionally, the figure illustrates that HAA5 concentrations jump from 0 to around 40 ug/L within the first 8 hours. Based on these results, neither flushing nor storage tank level control would be an effective means to significantly reduce the HAA5 concentrations. Even if the HRT was significantly reduced (to 16 hours), the HAA5 concentration is expected to be within 67% of the 60 ug/L limit.

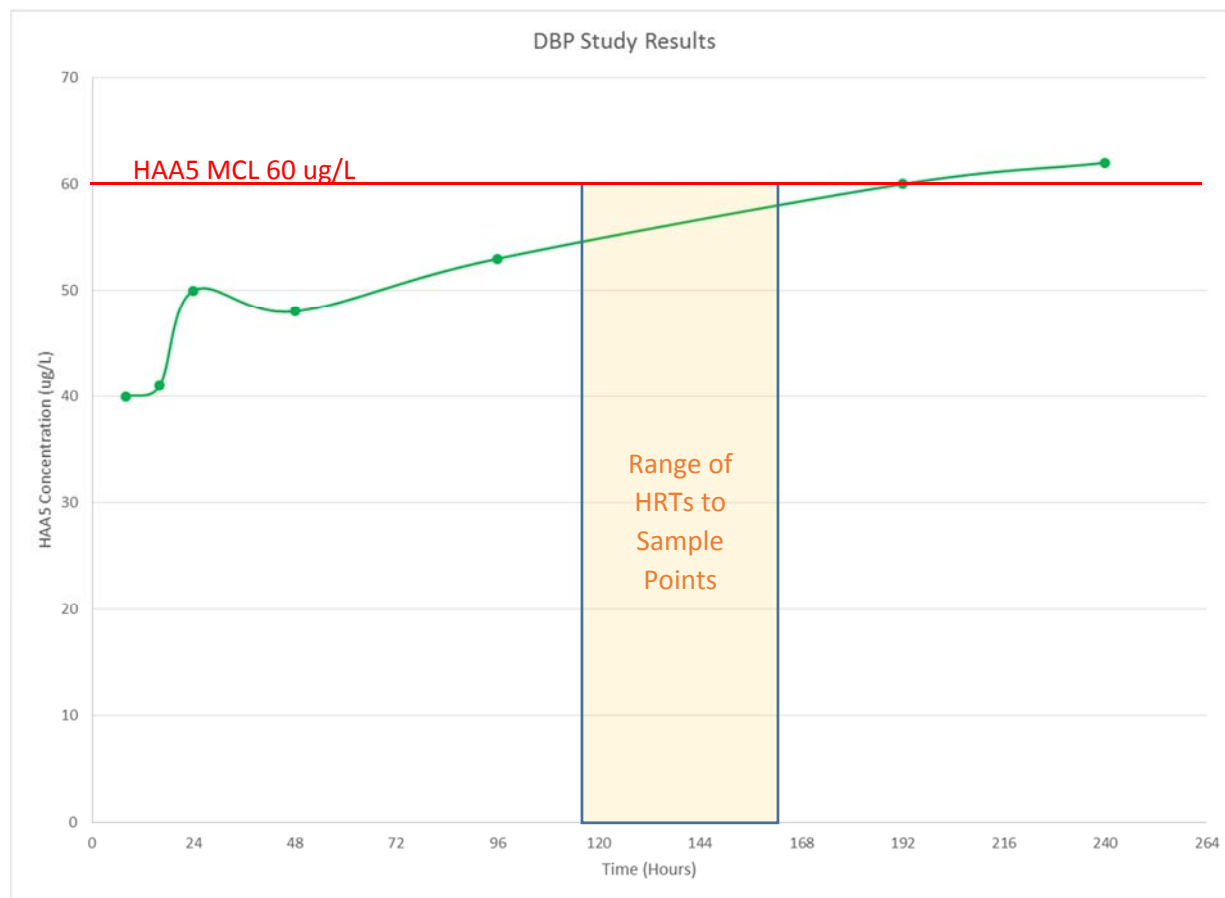
**Figure 11. Results of DBP Study**

Although storage tank level control does not appear to be a highly effective way of controlling HAA5 DBPs as a long term strategy, an evaluation of the contact time in the two 500,000-gallon tanks required to meet disinfection regulations was conducted to determine how low the water surface elevation (WSE) in the tanks could be maintained while still meeting contact time. Communication with plant staff relayed that the WSE in both of the storage tanks is maintained at a minimum of 19.6 feet. The evaluation of contact time determined that the WSE in the tanks could be reduced to 7 feet and still meet disinfection contact time requirements. While this management strategy is not identified as an effective way to ensure that DBP concentrations are below regulatory limits, operating with a lower tank level has the potential to slightly reduce the water age and DBP concentrations in the System.

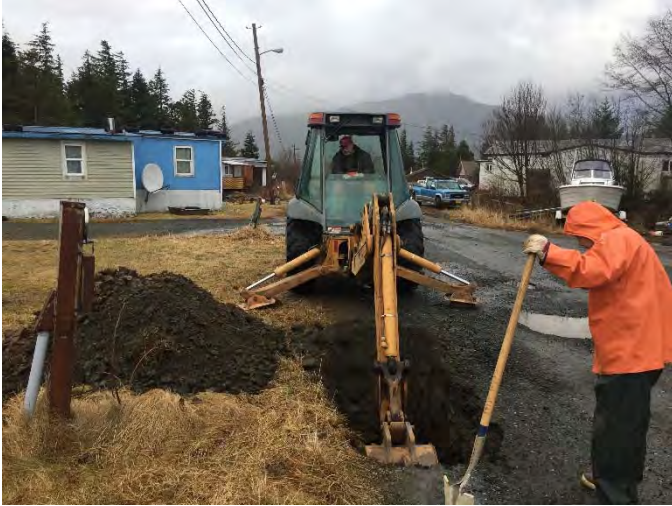
PHOTO B12: 1/26/17 – Dig Site #1 excavation area located on the north side of the New Trailer Court's South Loop Road. (Adjacent to Electric Meter Post #7).

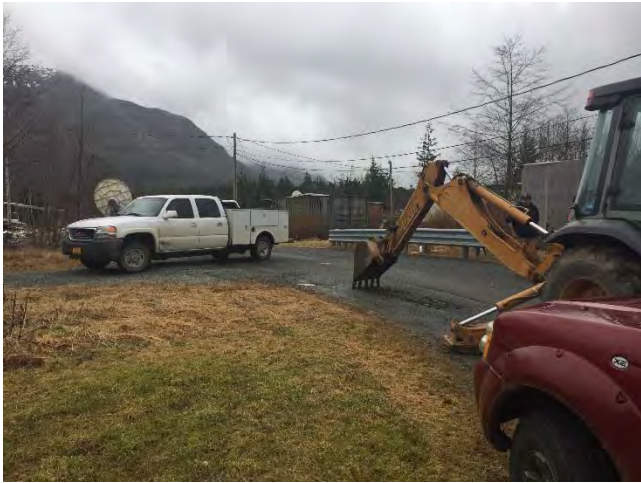
Significantly greater quantities of clay and organic material (see *Figure 3*) was found to be present in this dig location along with the typical flowing groundwater activity. The groundwater level was found to coincide with the top-of-pipe depth at approximately 4.8 feet below grade.

PHOTO B15: 1/26/17 – Dig Site #2 excavation area located on the west end of the New Trailer Court's Loop Road. (Near the southwest corner of the road).

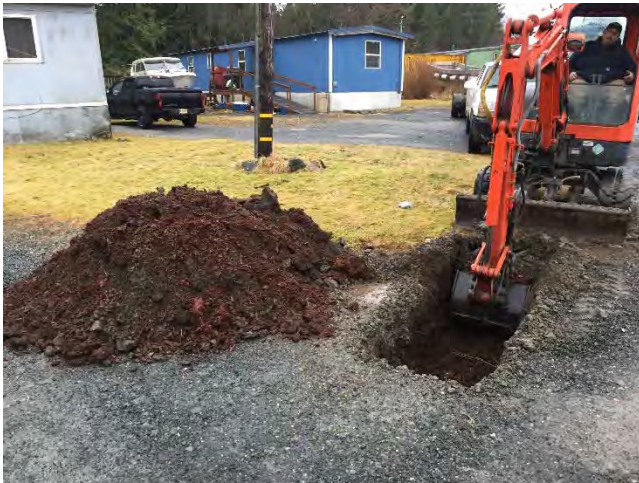
PHOTO B18: 1/27/17 – Excavation of pipe trench commences in late morning (10:45 AM).
