Attachment A
FVF Chenega Condition Report

2018 - 2019 FLEET CONDITION SURVEY

FVF CHENEGA

PREPARED FOR
ALASKA MARINE HIGHWAY SYSTEM

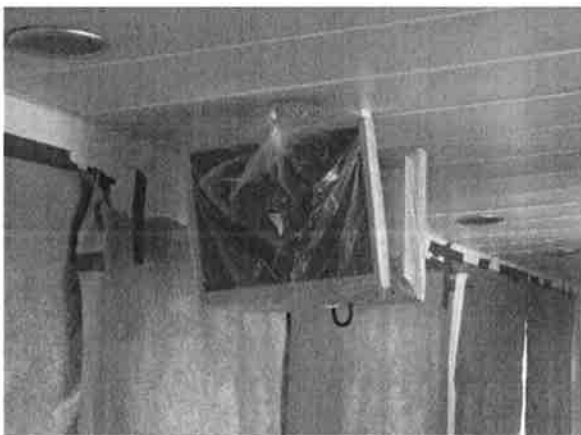
The vessel is equipped with an NC/Mitsubishi Video Information System with monitors located around the passenger spaces (Figure 24). The system displays safety messages and other information and allows the passengers to track the position of the vessel.

Figure 24 Video information system monitor in Snack Bar/Seating on Passenger Deck

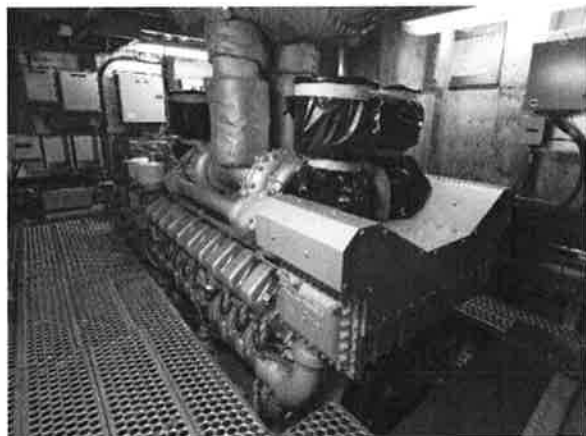
This ferry is powered by four MTU 20V 4000 M73L high-speed diesel engines. Each engine has 20 cylinders arranged in the V configuration (Figure 25).

Figure 25 Engine in Port Engine Room

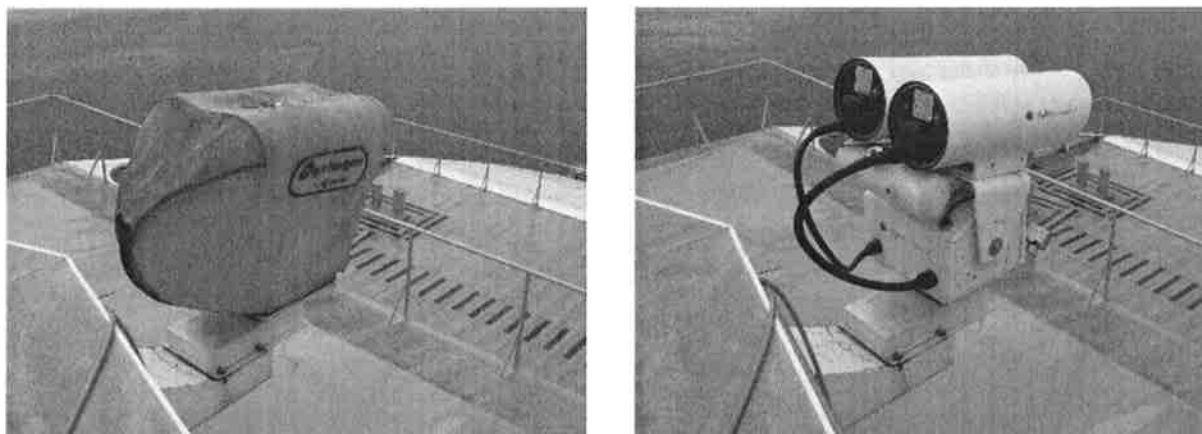
The vessel is equipped with a Night Navigator™ 8450/8520 System (Figure 31). This bridge-mounted system provides a clear image intensified view of the water in the immediate path of the vessel at night. The image is displayed on a monitor.

Figure 31 Night vision system mounted on top of Bridge

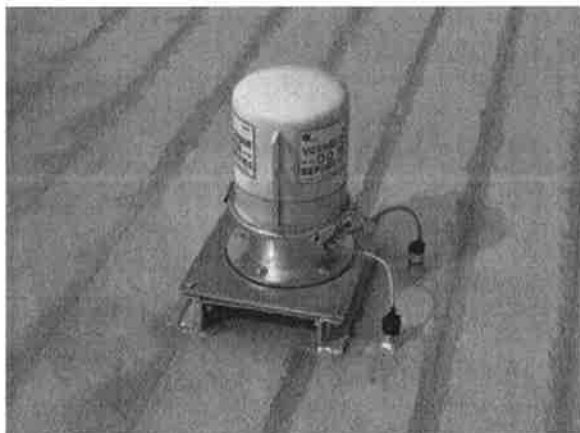
The vessel is equipped with a Rutter VDR 100G3/G3S Recorder (Figure 32).

Figure 32 Voyage Data Recorder on House Top

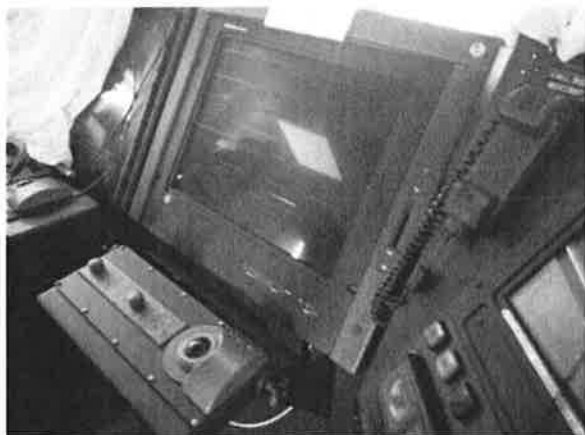
The vessel is equipped with a Raytheon NSC ECDIS (Figure 33).

Figure 33 ECDIS and controls in Pilothouse

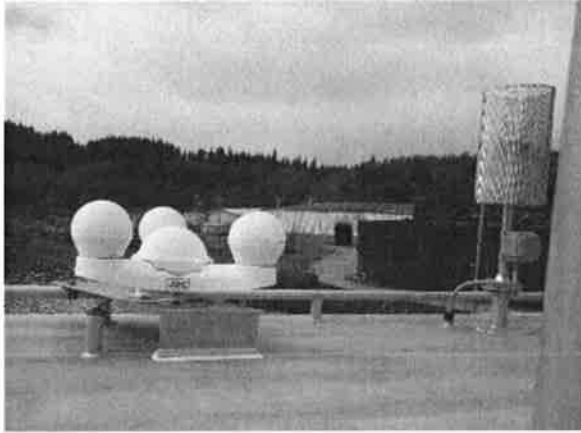
The vessel is equipped with a JRC JLR-7800 Global Positioning System (Figure 34).

Figure 34 GPS transmitter on top of Pilothouse

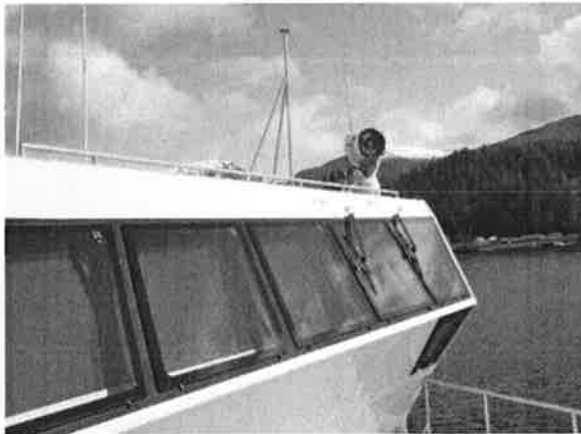
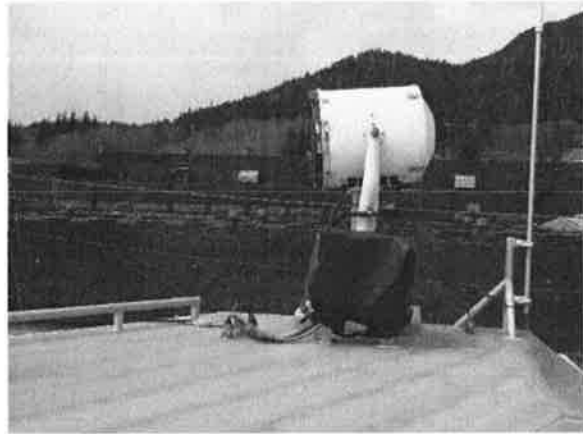
The vessel is equipped with Carlisle & Finch MXE 5111 Searchlight Model XE 9666-ARFV. There are two 1000w Xenon Searchlights located on top of the Pilothouse facing forward (Figure 35). The searchlights are controlled on the bridge at a single station with joystick.

Figure 35 Port (left) and starboard (right) Searchlights on Pilothouse
