Attachment B
FVF Fairweather Condition Report

2018 - 2019 FLEET CONDITION SURVEY
FVF FAIRWEATHER

PREPARED FOR
ALASKA MARINE HIGHWAY SYSTEM

29 APRIL 2019
FILE NO.19041.01
REV.-

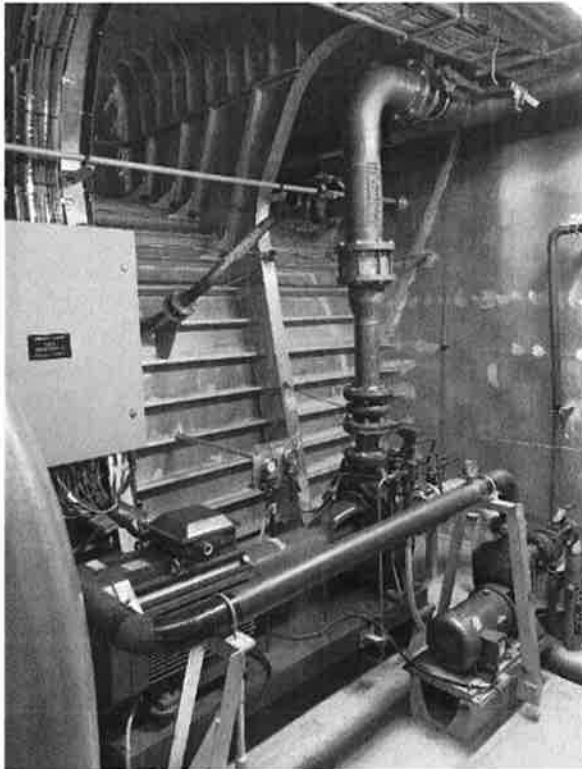
Figure 3 Sprinkler pump in Compartment 2

Seawater is supplied to the system by a self-priming centrifugal pump with a flowrate of 549 US gpm at a pressure of 73 psi. This pump is located in Compartment 2 (Figure 3).

The accommodation spaces sprinkler piping is 90:10 CuNi and is in excellent condition.

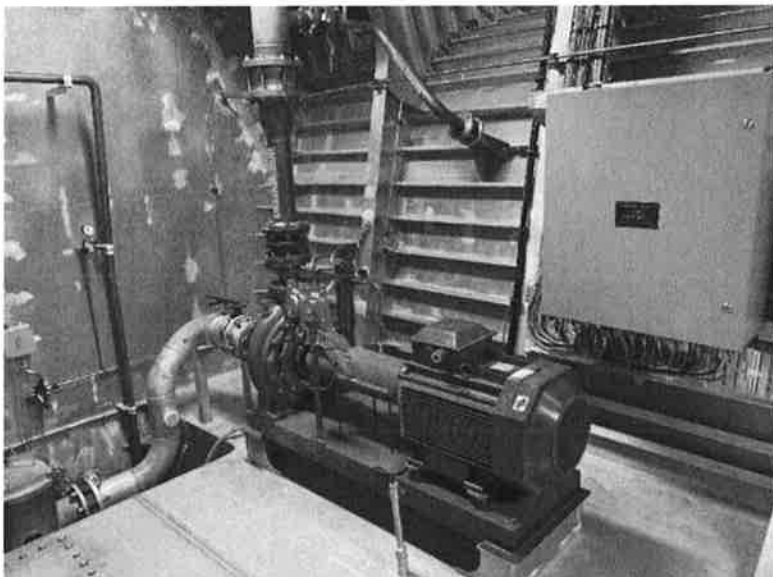
Figure 4 Deluge pump in Compartment 1

Seawater is supplied to the system by a self-priming centrifugal pump with a flowrate of 1128 US gpm at a pressure of 58psi. This pump is located in Compartment 1 (Figure 4). This pump is sized to provide enough water to the two largest adjacent zones on the vehicle deck.

The deluge piping is 90:10 CuNi and is in excellent condition.

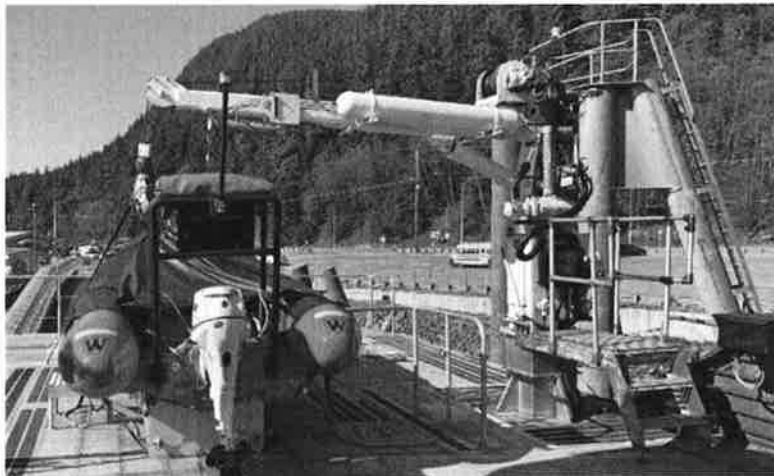
The rescue boat and davit are located on the House Top, port side, and are in excellent condition (Figure 5).

Figure 5 Rescue boat and davit on House Top

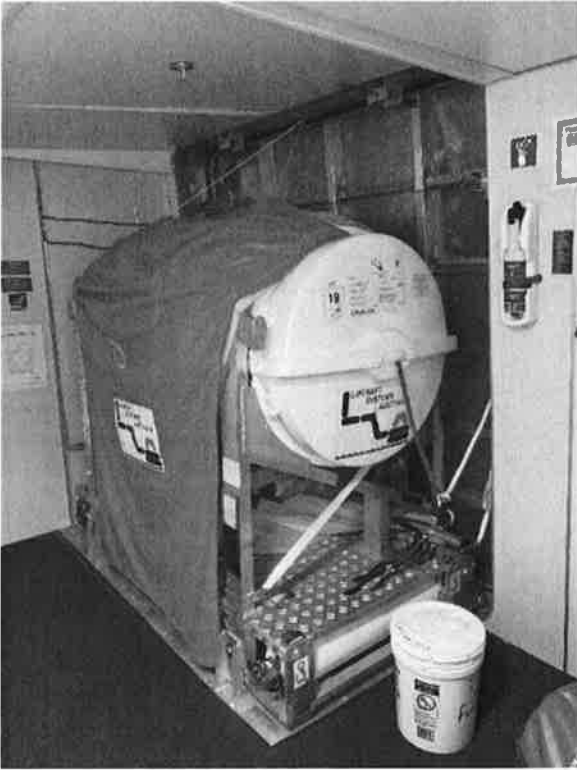
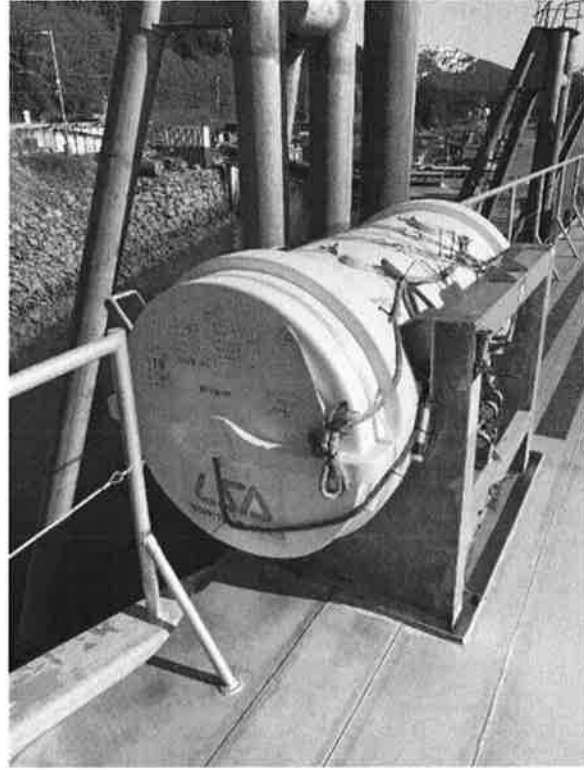
Figure 6 (Left) Slide/Life Raft unit in Starboard MES; (Right) Life Raft unit on House Top, Port

The MES equipment is manufactured and serviced by Liferaft Systems Australia. The equipment is in excellent condition.

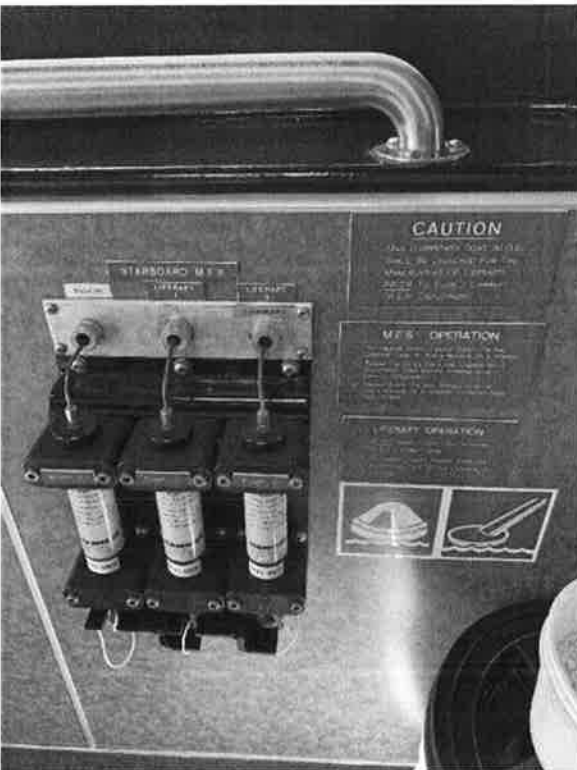
Figure 7 Remote deploying of MES, in Pilothouse

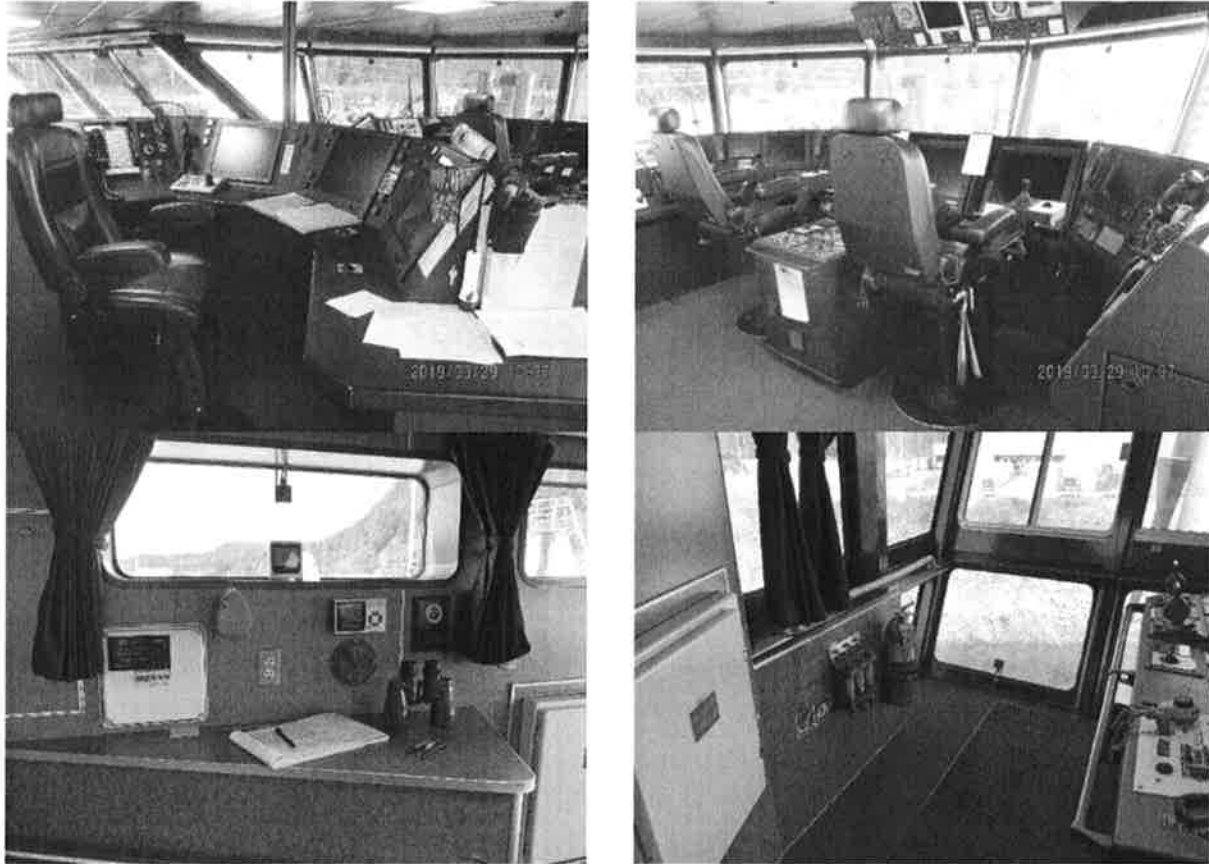
The Pilothouse is generally in excellent condition (Figure 8). The 2014 survey recommended carpet replacement throughout the Bridge Deck. The carpet was replaced and is now in excellent condition.

Figure 8 Pilothouse is in excellent condition

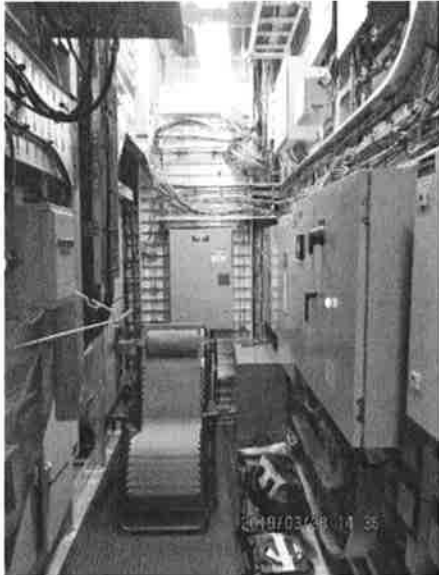
Figure 13 Bridge Electrical Room

The Bridge Electrical Room is in good condition (Figure 13).

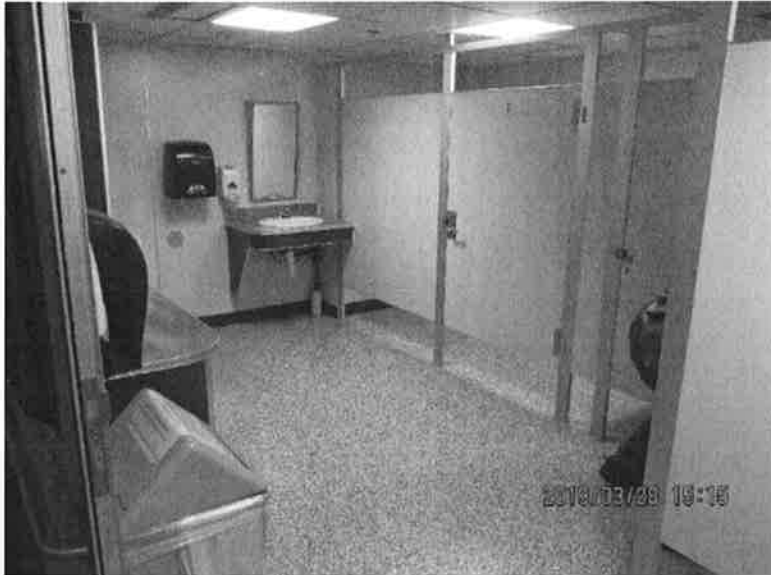
Figure 19 Men's (Port) Amidships Passenger Head

The Amidships Passenger Heads Area is in good condition (Figure 19).

Minor diffuser discoloration is apparent in both the Men's (Port) and Women's (Starboard) Amidships Passenger Heads. There is minor wear around the base of some fixtures, and penetration misalignment is apparent at the base of the sink (Figure 20).

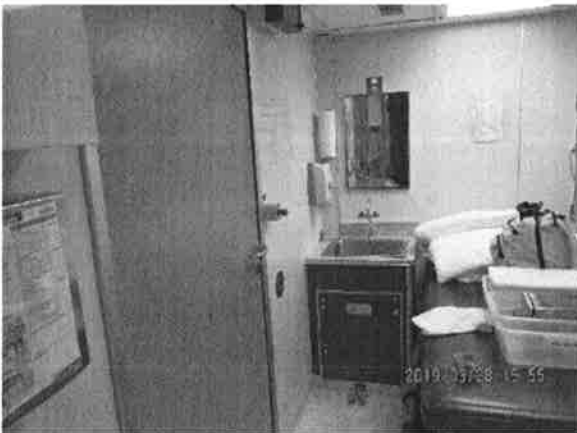
Figure 26 First Aid Room

The First Aid Room is in good condition (Figure 26).

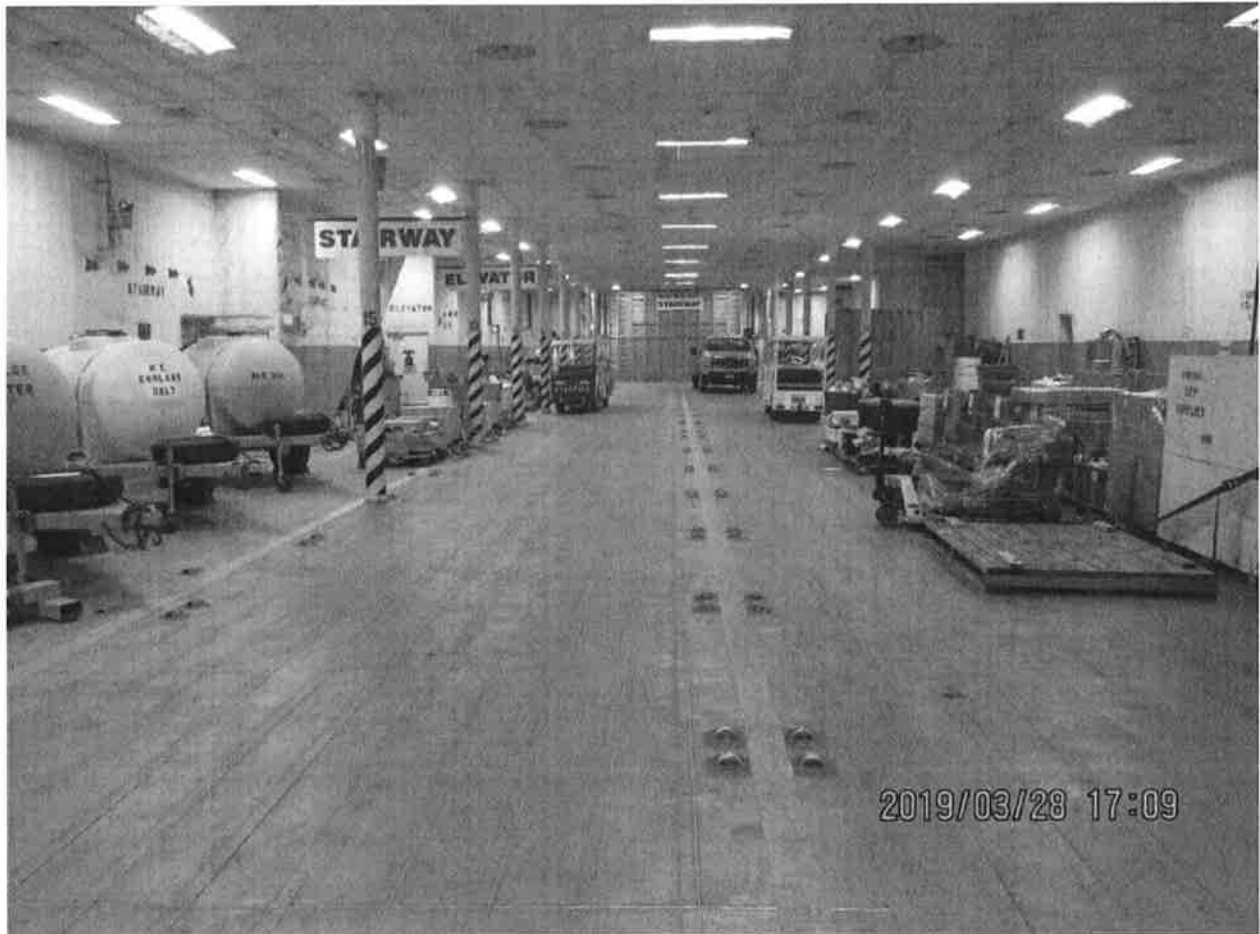
Figure 32 Vehicle Deck, looking aft

The Vehicle Deck is generally in good condition. The bulkheads, lighting, overhead, and structural fire protection appear to be in good condition. Figure 32 shows well maintained bulkheads and lane lines.

During the survey, the crew recommended adding a dedicated passenger gangway to streamline loading/unloading operations (passengers currently load intermittently with the vehicles via the vehicle doors).

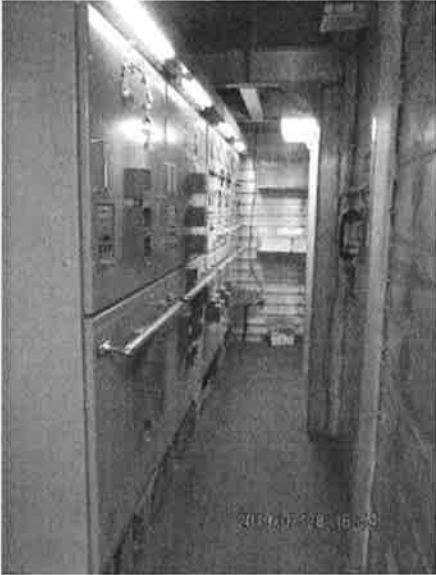
Figure 33 Starboard Switch Room on Vehicle Deck

The Switchboard Rooms are in good condition (Figure 33).

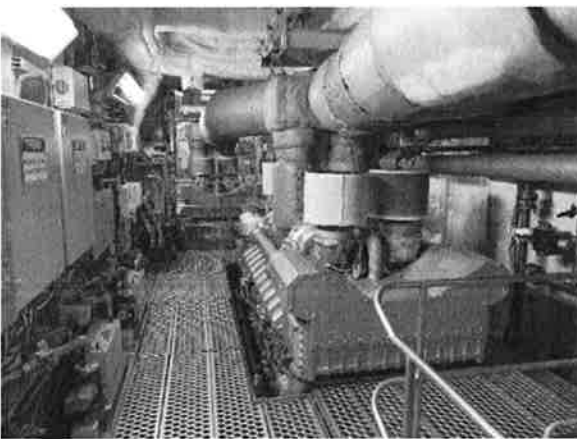
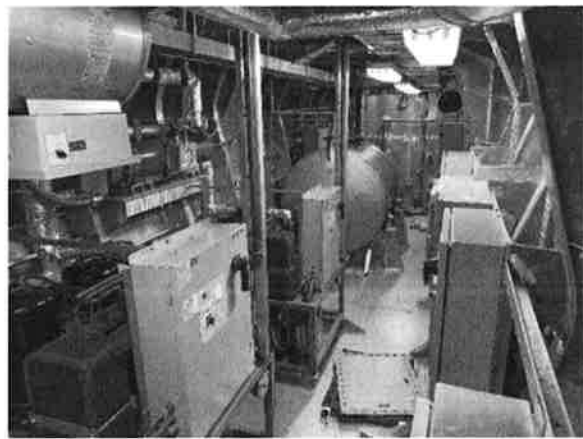
Figure 34 Starboard Engine Room (left) and Port Compartment 2 (right)

These spaces are in good condition. Lighting in these spaces tends to be very good, and most spaces are clean (Figure 34).

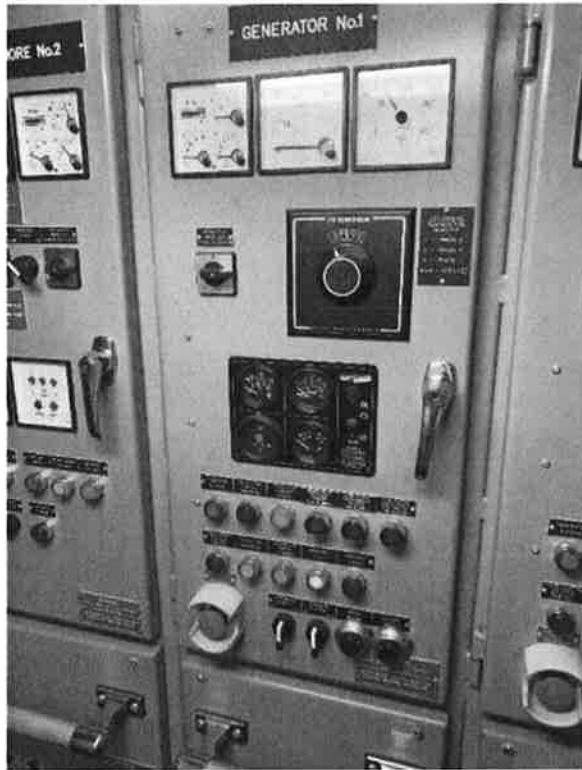
Figure 35 Generator 1 Switchboard in the starboard Switchboard Room

The generators are in excellent condition.

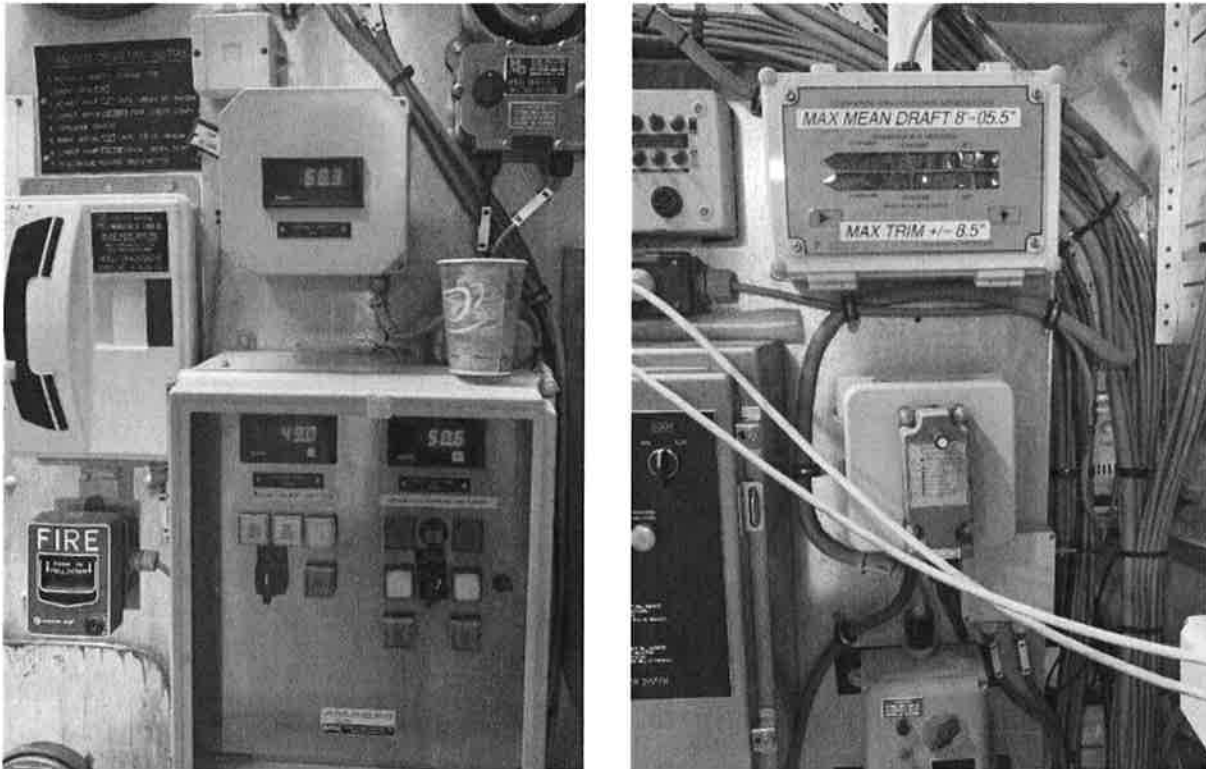
Figure 38 (Left) Tank Level Indicator and (Right) Draft & Trim Monitoring System, at Frame 1 on Vehicle Deck

The vessel is fitted a Weir-Jones ADIS Model 8240 Draft & Trim Monitoring system (Figure 38). This system works by measuring the freeboard at 6 locations around the perimeter of the vessel. The system is also capable of measuring the significant wave height of seas through which the vessel is sailing.

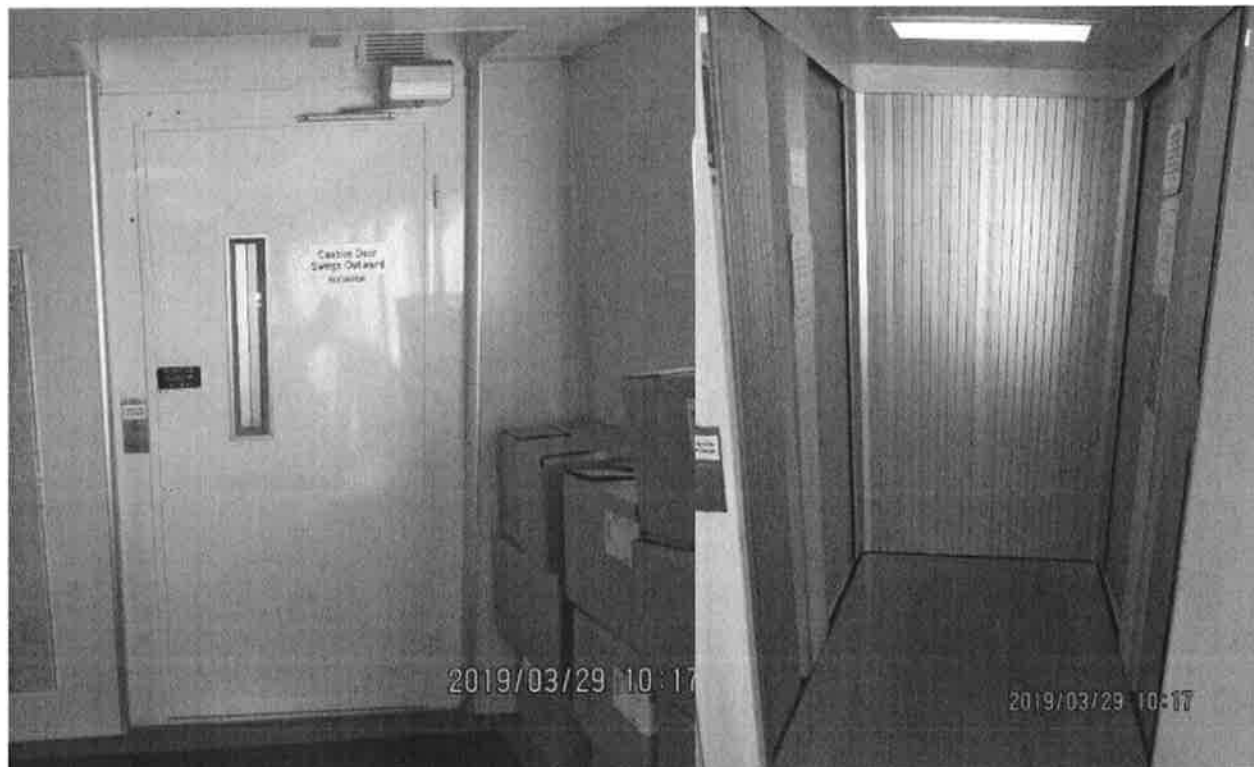
Figure 44 Passenger elevator on Passenger Deck

The Passenger Elevator is in good condition and functions normally. Minor spots and stains are evident on the deck covering and overhead, and minor scratches are evident on the bulkhead (Figure 45). The lighting diffuser is discolored and should be replaced.

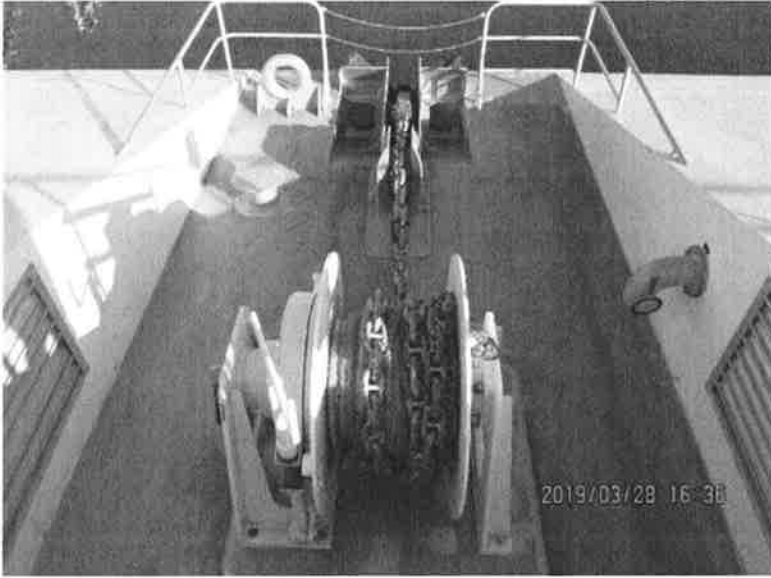
Figure 46 Anchor windlass and chain from Forward Mooring Deck

The anchor windlass and chain are in good condition and function normally (Figure 46).

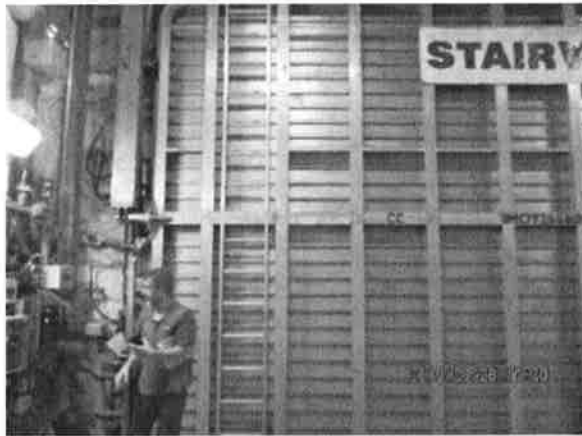
Figure 49 Vehicle Deck stern door and controls

The vehicle deck cargo doors are both in excellent condition with no visual or reported damage. The stern door system functioned as intended (Figure 49).

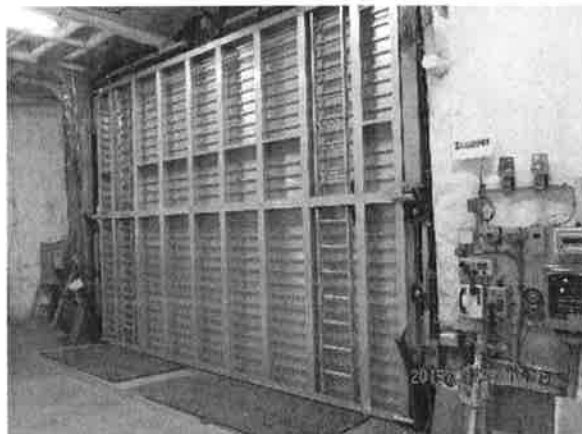
Figure 50 Vehicle deck side door and controls

Side door operation was not witnessed, but there were no reported issues by the crew regarding function (Figure 50).

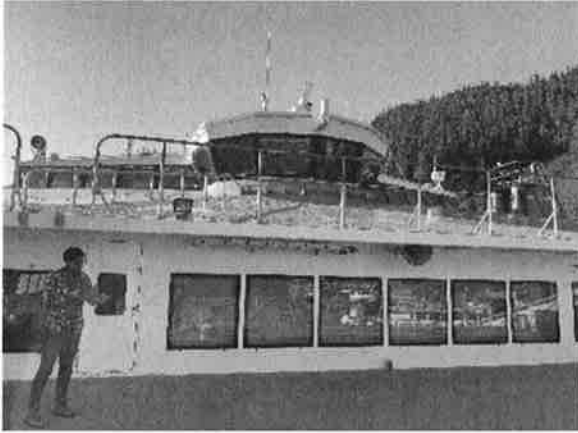
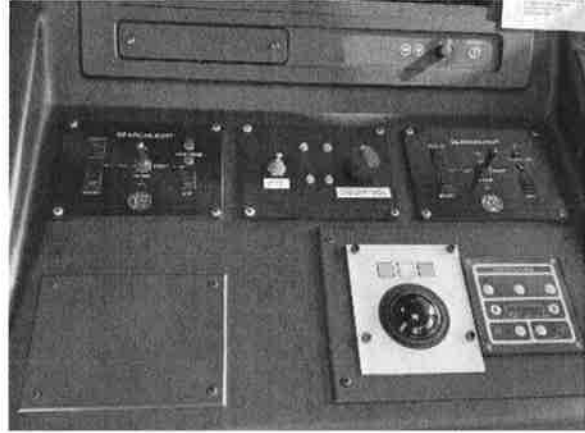
Figure 55 Searchlights on Pilothouse (left); searchlight controls in Pilothouse (right)

The vessel is equipped with Carlisle & Finch MXE 5111 Searchlight Model XE 9666-ARFV. There are two 1000w Xenon Searchlights located on top of the Pilothouse facing forward. The searchlights are controlled on the bridge at a single station with joystick (Figure 55).
