Attachment A
FVF Chenega Condition Report

2018 - 2019 FLEET CONDITION SURVEY

FVF CHENEGA

29 APRIL 2019
FILE NO.19041.01
REV.-

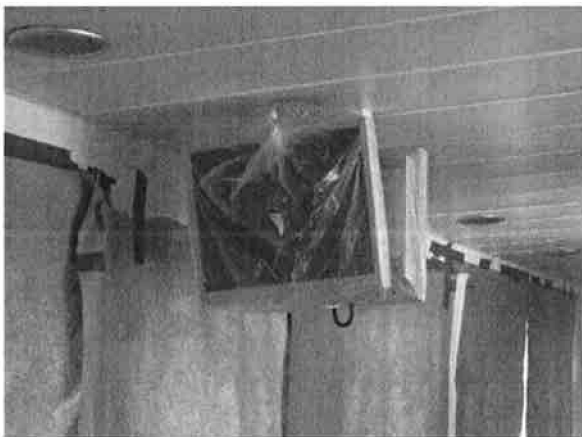
Figure 24 Video information system monitor in Snack Bar/Seating on Passenger Deck

The vessel is equipped with an NC/Mitsubishi Video Information System with monitors located around the passenger spaces (Figure 24). The system displays safety messages and other information and allows the passengers to track the position of the vessel.

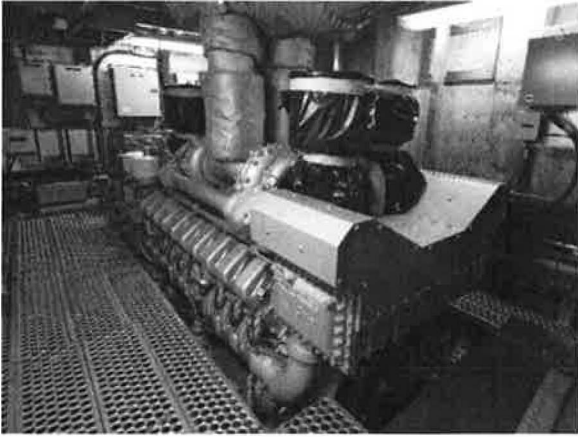
Figure 25 Engine in Port Engine Room

This ferry is powered by four MTU 20V 4000 M73L high-speed diesel engines. Each engine has 20 cylinders arranged in the V configuration (Figure 25).

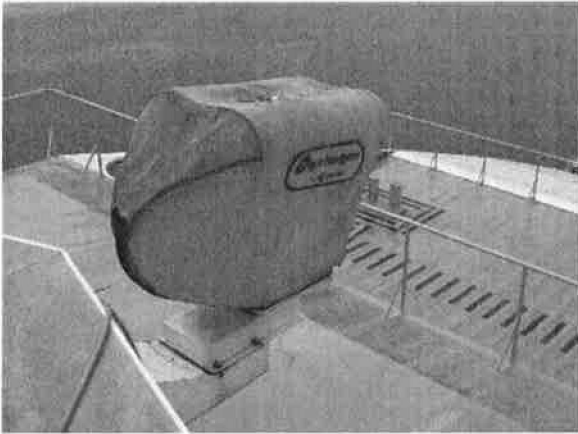
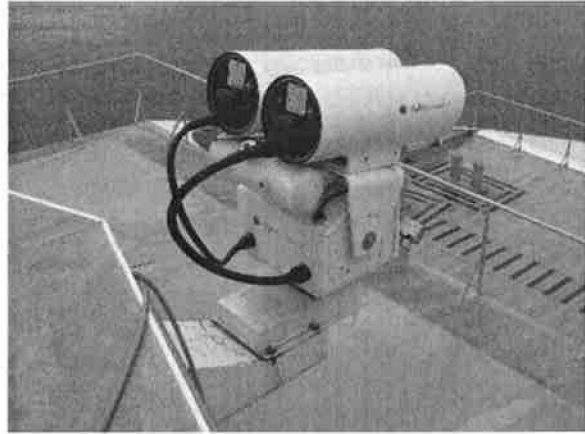
Figure 31 Night vision system mounted on top of Bridge

The vessel is equipped with a Night Navigator™ 8450/8520 System (Figure 31). This bridge-mounted system provides a clear image intensified view of the water in the immediate path of the vessel at night. The image is displayed on a monitor.

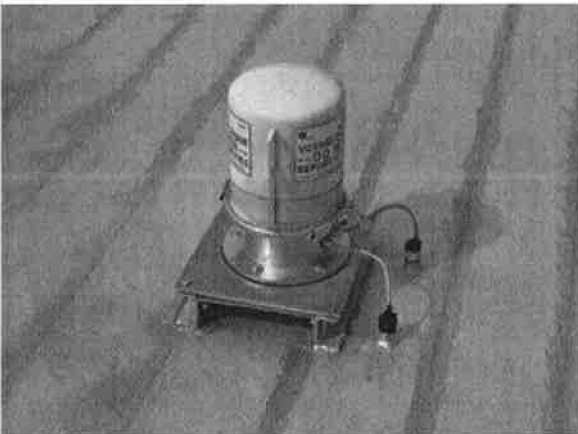
Figure 32 Voyage Data Recorder on House Top

The vessel is equipped with a Rutter VDR 100G3/G3S Recorder (Figure 32).

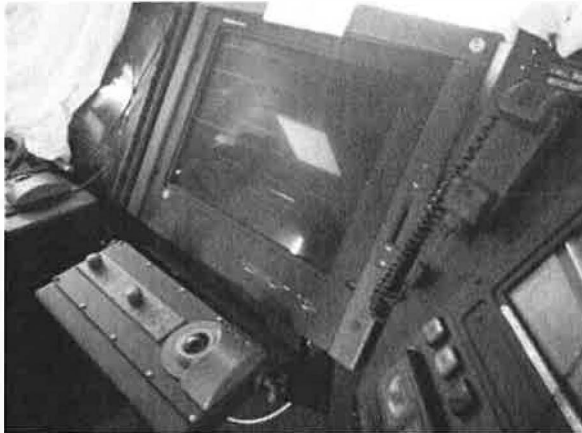
Figure 33 ECDIS and controls in Pilothouse

The vessel is equipped with a Raytheon NSC ECDIS (Figure 33).

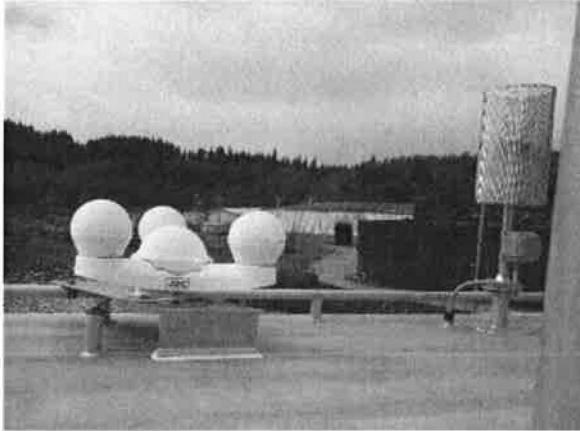
Figure 34 GPS transmitter on top of Pilothouse

The vessel is equipped with a JRC JLR-7800 Global Positioning System (Figure 34).

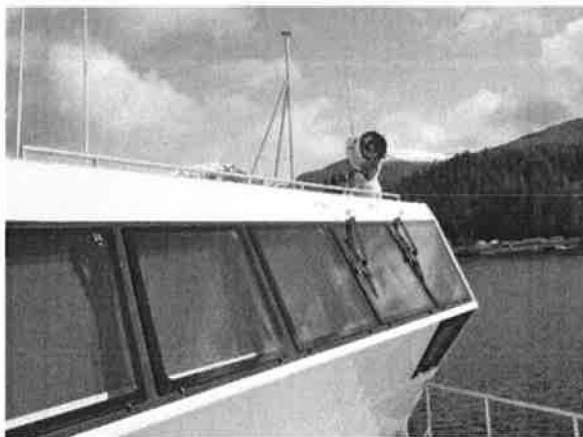
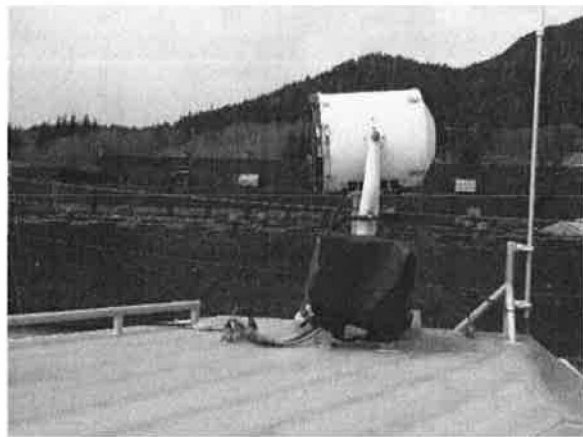
Figure 35 Port (left) and starboard (right) Searchlights on Pilothouse

The vessel is equipped with Carlisle & Finch MXE 5111 Searchlight Model XE 9666-ARFV. There are two 1000w Xenon Searchlights located on top of the Pilothouse facing forward (Figure 35). The searchlights are controlled on the bridge at a single station with joystick.
