**Attachment B  
FVF Fairweather Condition Report**

2018 - 2019 FLEET CONDITION SURVEY  
**FVF FAIRWEATHER**

PREPARED FOR  
**ALASKA MARINE HIGHWAY SYSTEM**

29 APRIL 2019  
FILE NO.19041.01  
REV.-

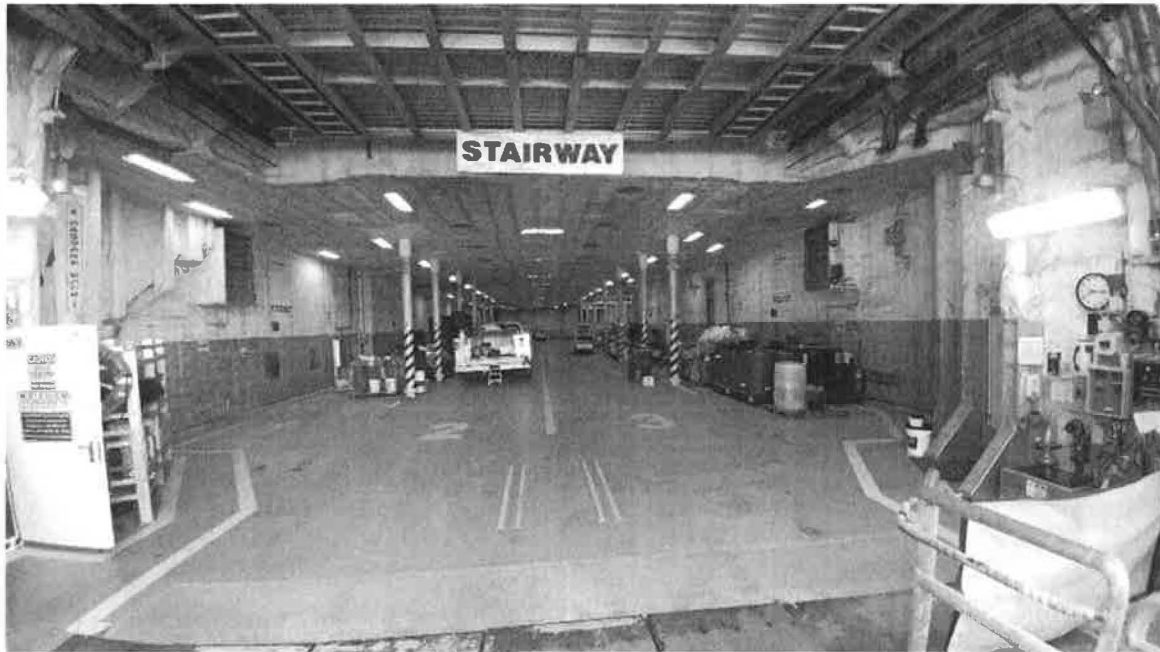
Figure 2 Vehicle deck view from stern door looking forward; insulation visible at sides and overhead

The vehicle deck bulkheads and overhead are entirely covered by insulation (Figure 2). In lower corners and within the scuppers there is no evidence of corrosion or cracking.

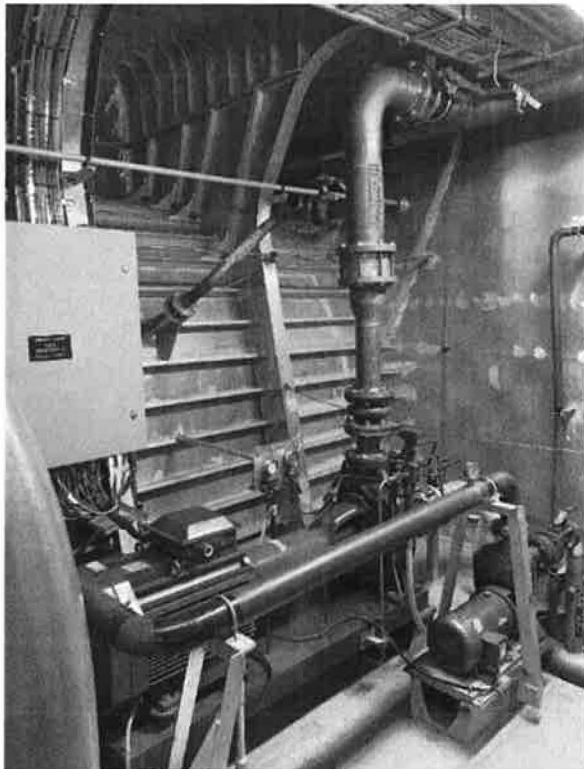
**Figure 3 Sprinkler pump in Compartment 2**

Seawater is supplied to the system by a self-priming centrifugal pump with a flowrate of 549 US gpm at a pressure of 73 psi. This pump is located in Compartment 2 (Figure 3).

The accommodation spaces sprinkler piping is 90:10 CuNi and is in excellent condition.

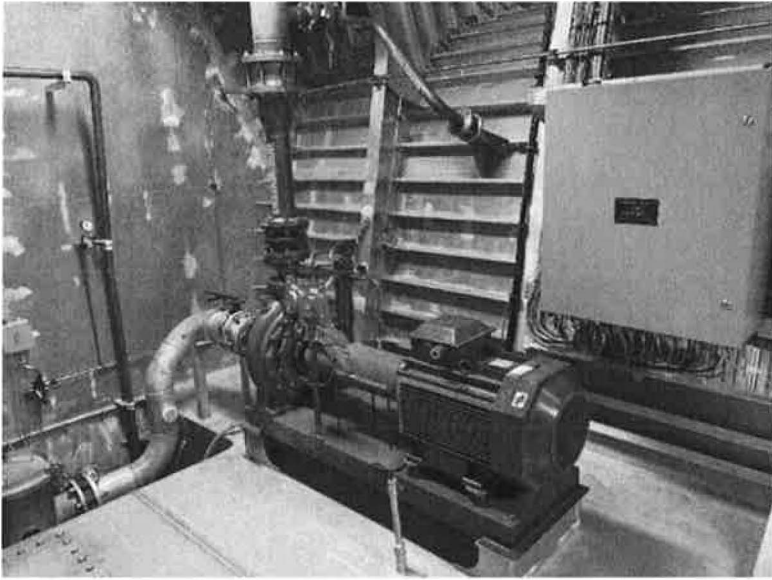
**Figure 4 Deluge pump in Compartment 1**

Seawater is supplied to the system by a self-priming centrifugal pump with a flowrate of 1128 US gpm at a pressure of 58psi. This pump is located in Compartment 1 (Figure 4). This pump is sized to provide enough water to the two largest adjacent zones on the vehicle deck.

The deluge piping is 90:10 CuNi and is in excellent condition.

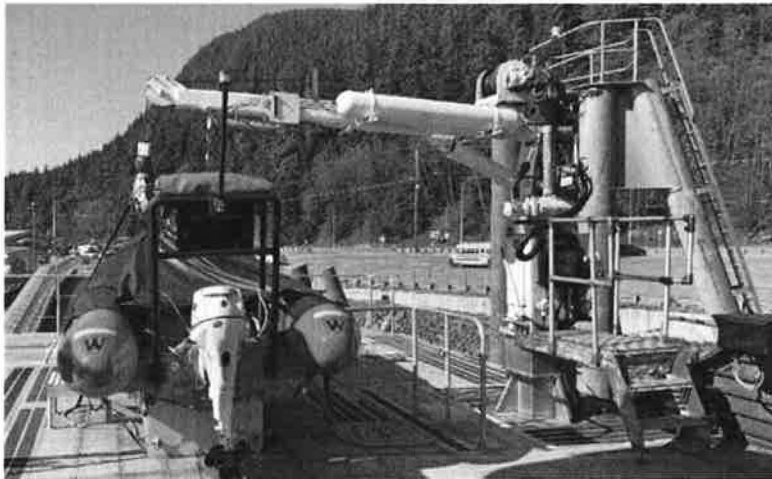
**Figure 5** Rescue boat and davit on House Top

The rescue boat and davit are located on the House Top, port side, and are in excellent condition (Figure 5).

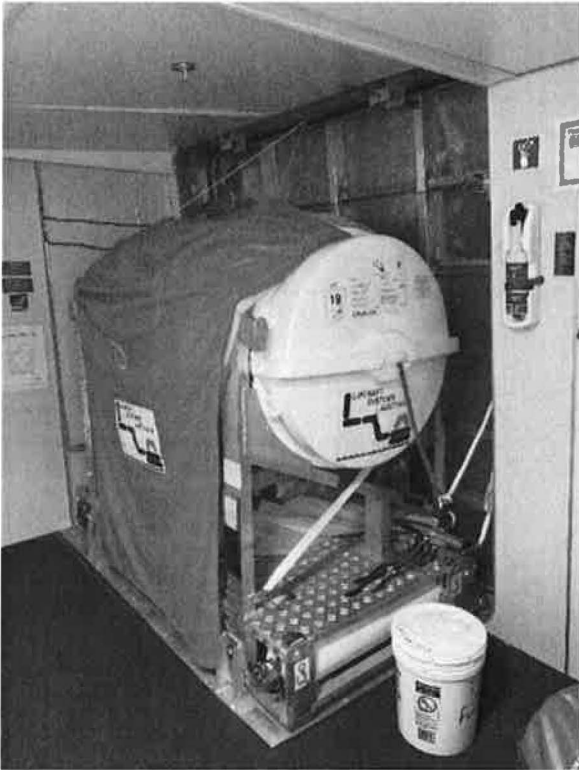
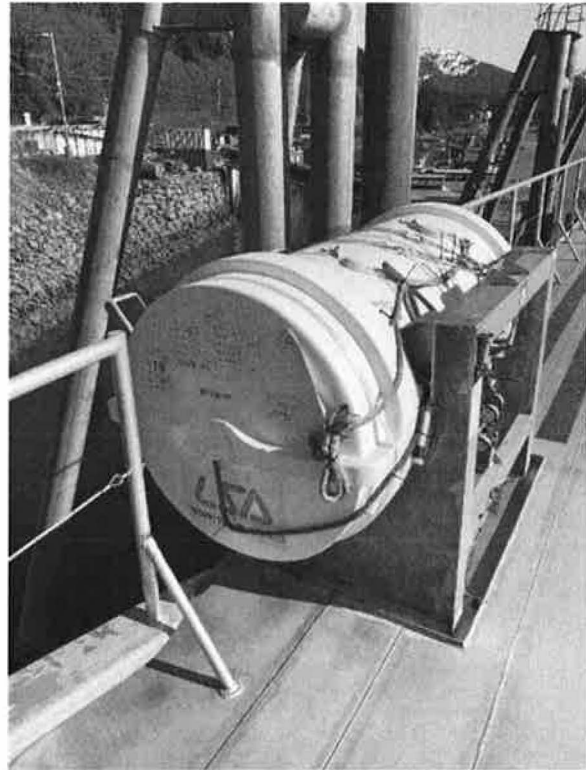
**Figure 6 (Left) Slide/Life Raft unit in Starboard MES; (Right) Life Raft unit on House Top, Port**

- *Two evacuation slide / 100-person self-righting life raft units* (Figure 6). The Slide / Life Raft units are located amidships on the Passenger Deck, port and starboard. The 45.9 ft (14m) slides within these units are twin track evacuation slides designed for transferring people from the vessel to the life rafts. Trained crew can deploy the slides either locally at the muster stations, or by use of remote control from either the Bridge or Operating Station (Figure 7).

The MES equipment is manufactured and serviced by Liferaft Systems Australia. The equipment is in excellent condition.

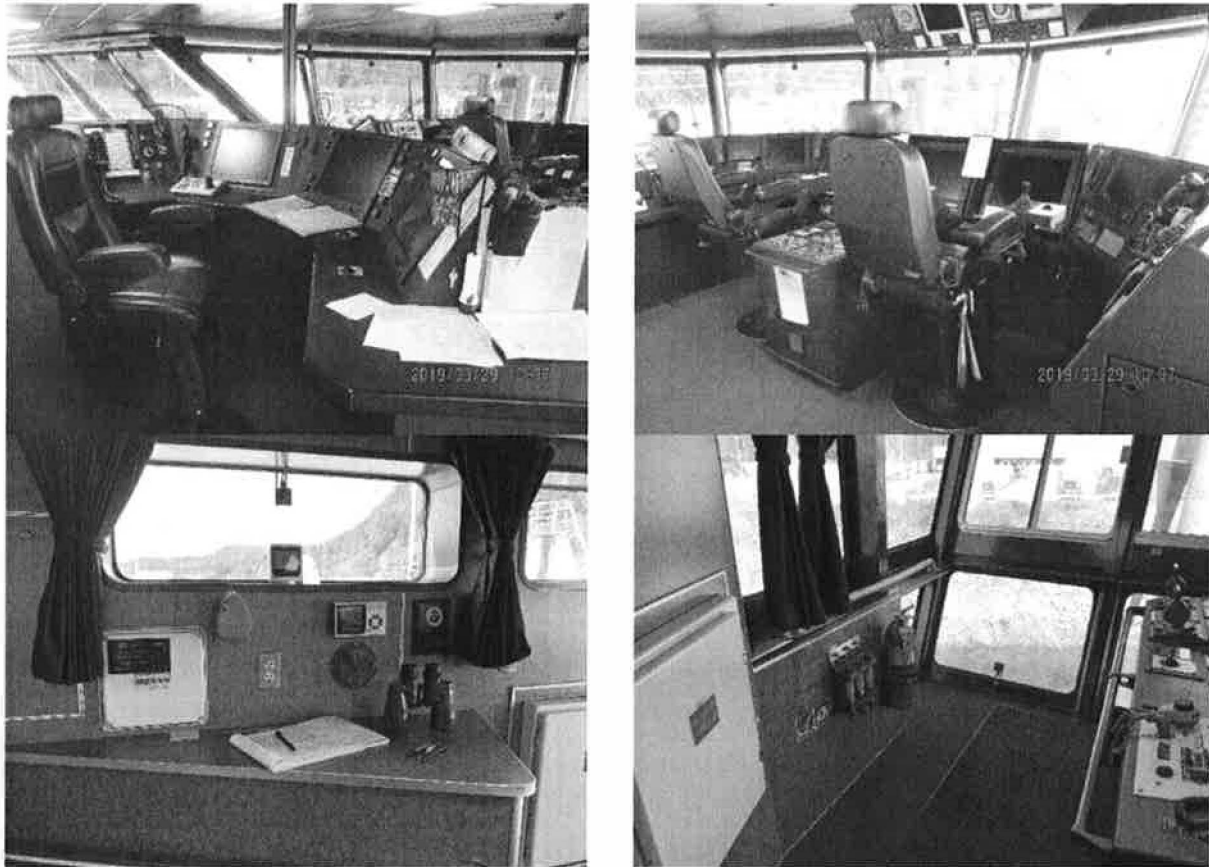
The Pilothouse is generally in excellent condition (Figure 8). The 2014 survey recommended carpet replacement throughout the Bridge Deck. The carpet was replaced and is now in excellent condition.

**Figure 8** Pilothouse is in excellent condition

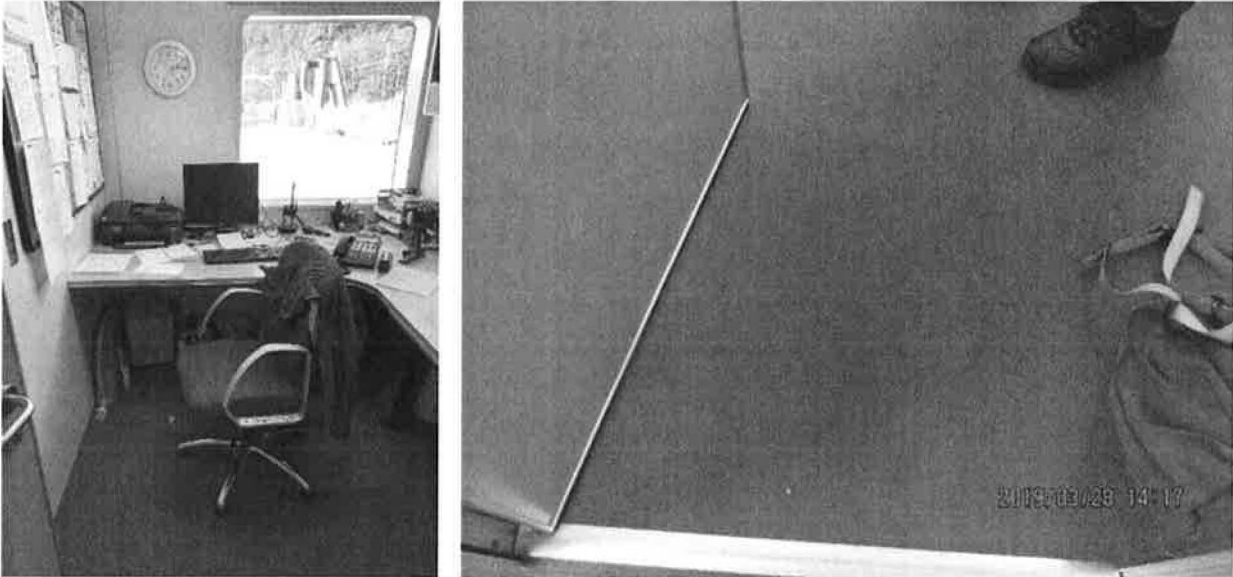
The Ship's Office is in good condition with lightly worn deck covering.

Figure 11 Ship's Office (left) and carpet (right) in good condition

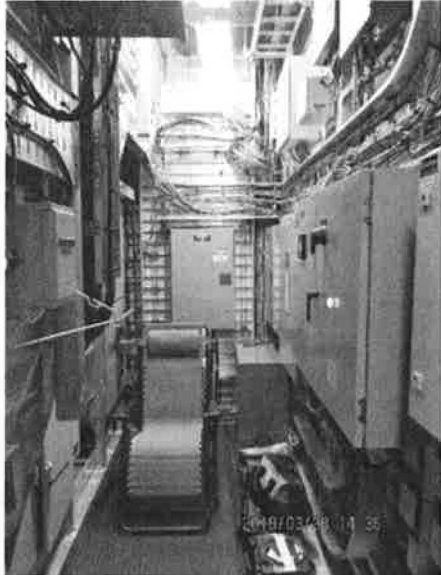
Figure 13 Bridge Electrical Room

The Bridge Electrical Room is in good condition (Figure 13).

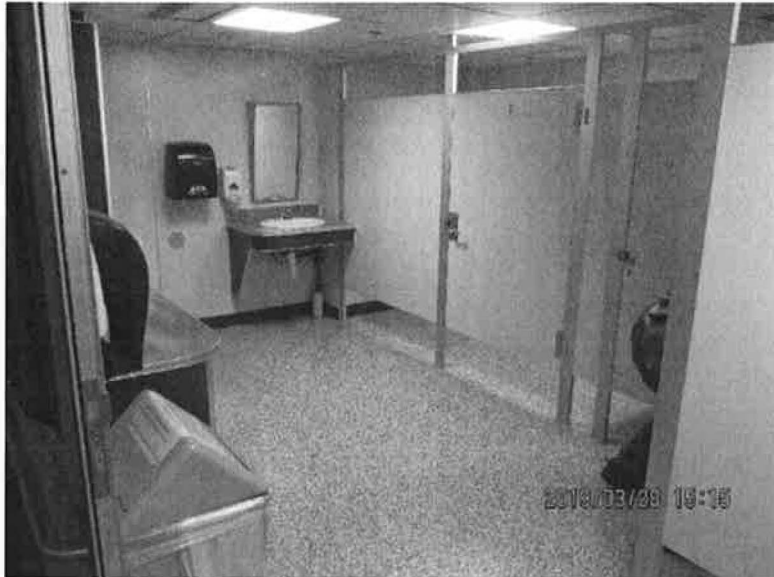
**Figure 19 Men's (Port) Amidships Passenger Head**

The Amidships Passenger Heads Area is in good condition (Figure 19).

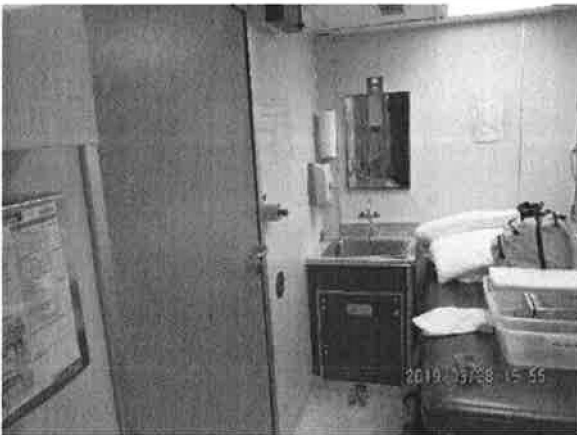
**Figure 26 First Aid Room**

The First Aid Room is in good condition (Figure 26).

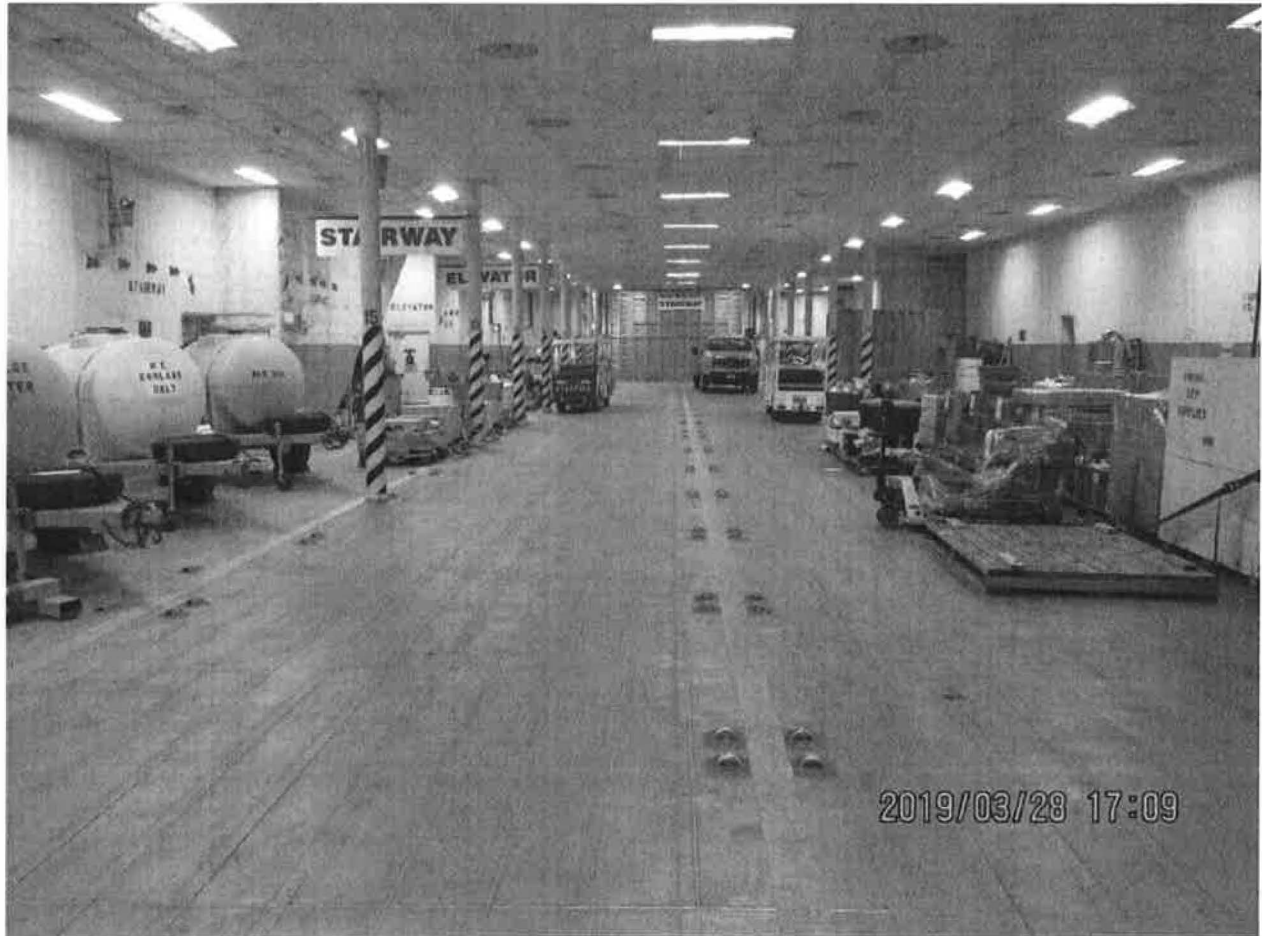
**Figure 32 Vehicle Deck, looking aft**

The Vehicle Deck is generally in good condition. The bulkheads, lighting, overhead, and structural fire protection appear to be in good condition. Figure 32 shows well maintained bulkheads and lane lines.

During the survey, the crew recommended adding a dedicated passenger gangway to streamline loading/unloading operations (passengers currently load intermittently with the vehicles via the vehicle doors).

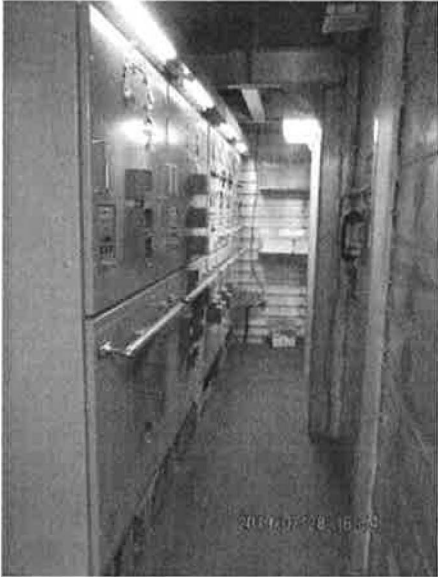
Figure 33 Starboard Switch Room on Vehicle Deck

The Switchboard Rooms are in good condition (Figure 33).

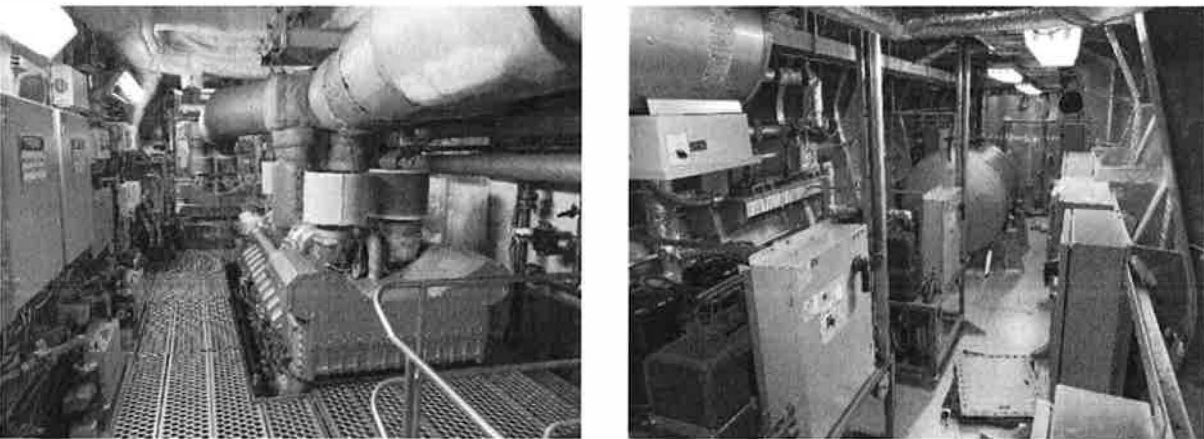
Figure 34 Starboard Engine Room (left) and Port Compartment 2 (right)

These spaces are in good condition. Lighting in these spaces tends to be very good, and most spaces are clean (Figure 34).

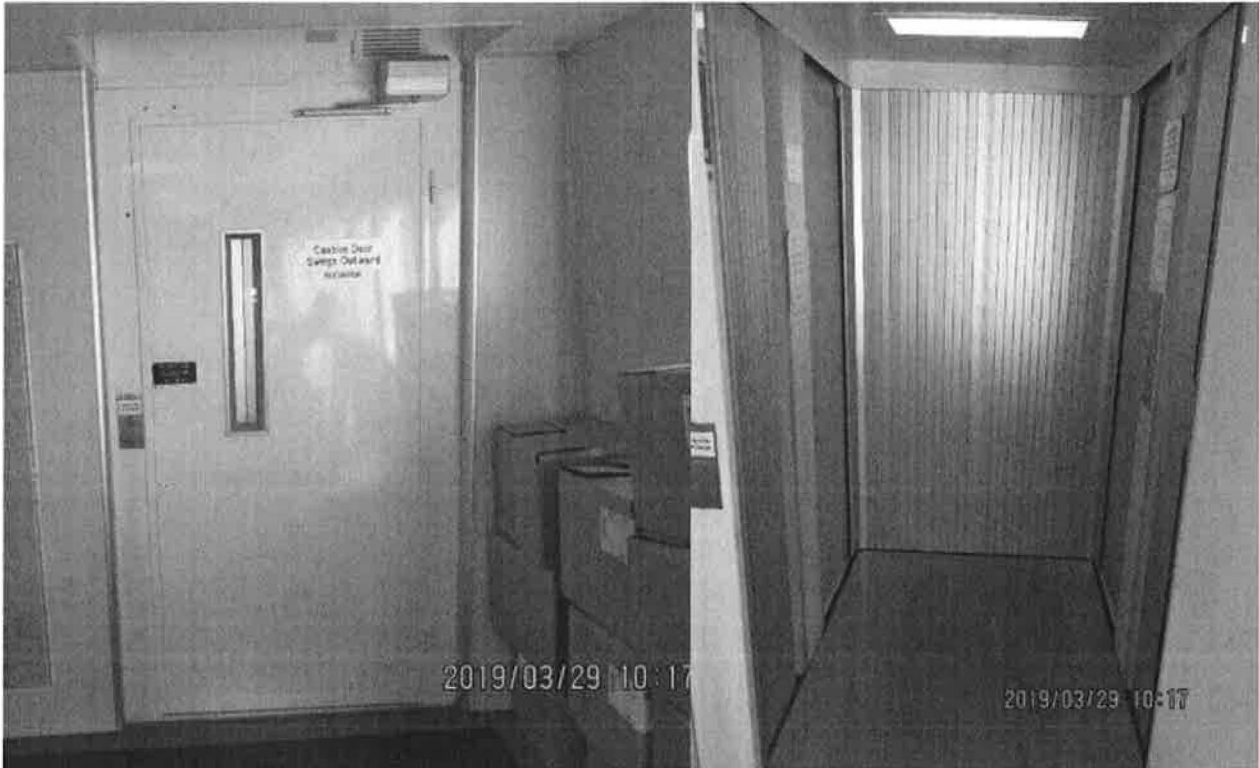
**Figure 44 Passenger elevator on Passenger Deck**

The Passenger Elevator is in good condition and functions normally. Minor spots and stains are evident on the deck covering and overhead, and minor scratches are evident on the bulkhead (Figure 45). The lighting diffuser is discolored and should be replaced.

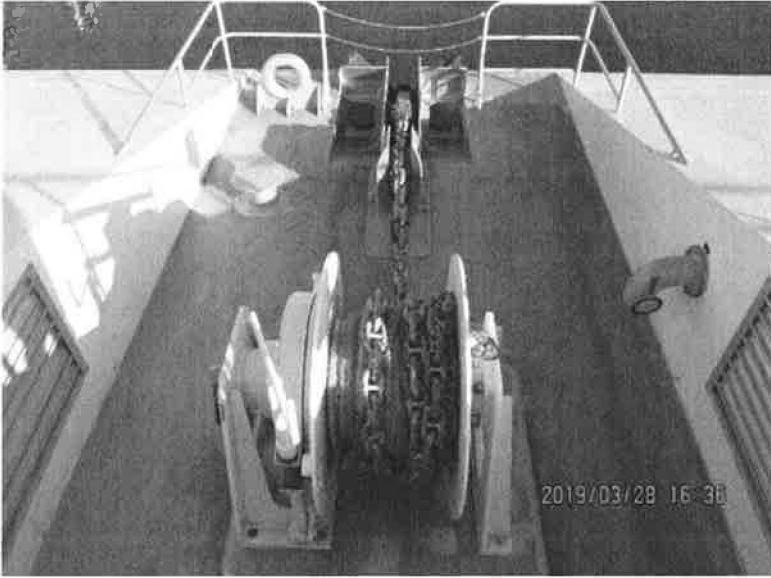
Figure 46 Anchor windlass and chain from Forward Mooring Deck

The anchor windlass and chain are in good condition and function normally (Figure 46).

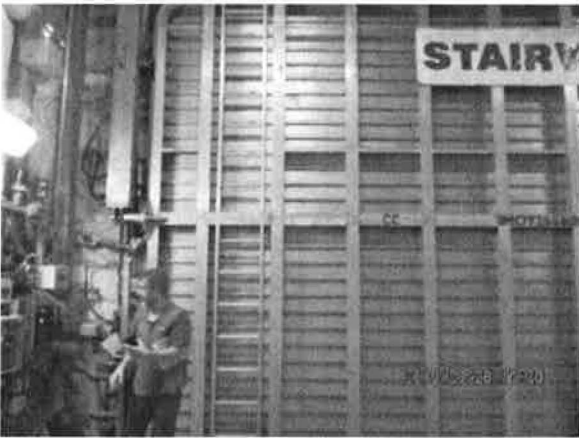
**Figure 49** Vehicle Deck stern door and controls

The vehicle deck cargo doors are both in excellent condition with no visual or reported damage. The stern door system functioned as intended (Figure 49).

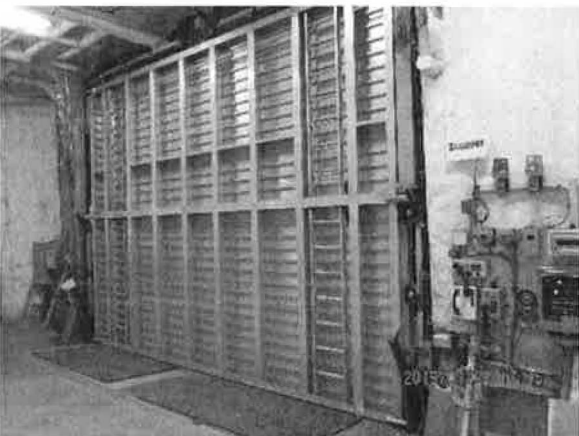
**Figure 50** Vehicle deck side door and controls

Side door operation was not witnessed, but there were no reported issues by the crew regarding function (Figure 50).

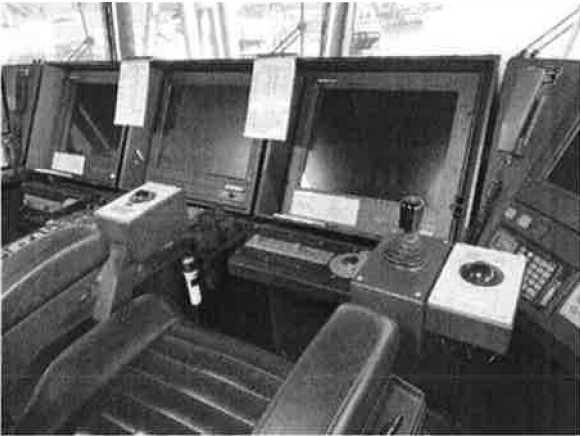
The vessel is equipped with a Raytheon NSC ECDIS (Figure 53).

Figure 53 ECDIS and controls in Pilothouse

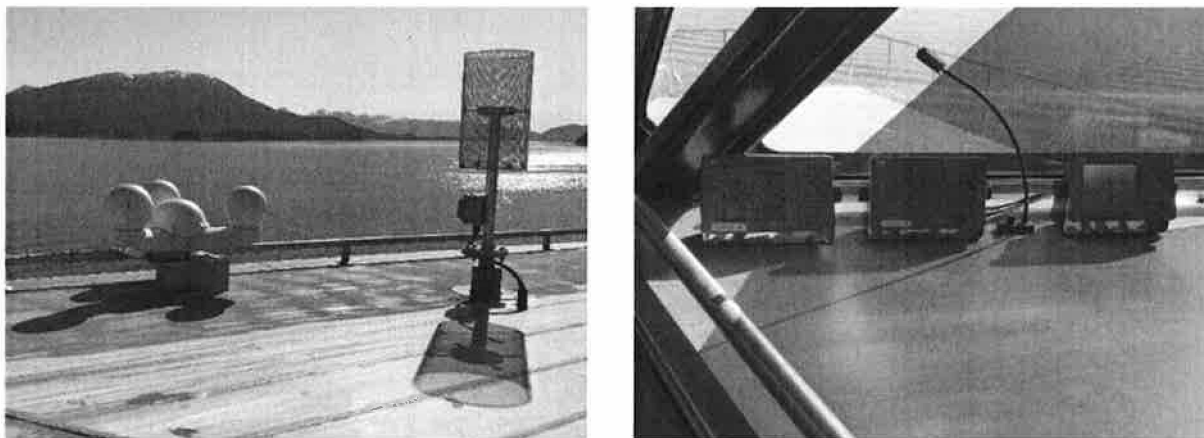
The vessel is equipped with a JRC JLR-7800 Global Positioning System (Figure 54).

Figure 54 GPS transmitter on top of Pilothouse (left) and GPS systems in Pilothouse (right)

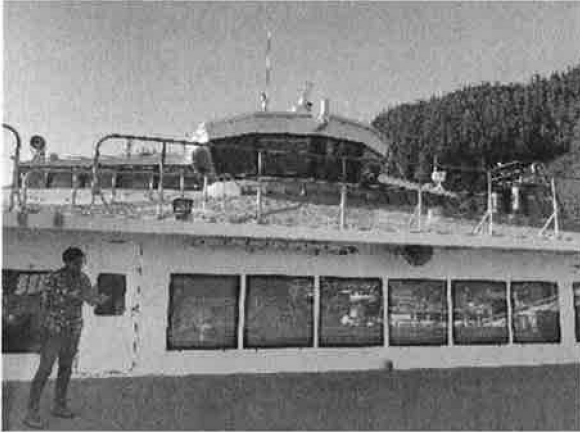
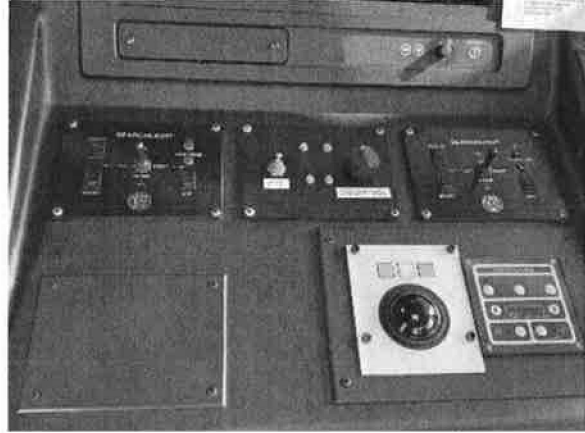
The vessel is equipped with Carlisle & Finch MXE 5111 Searchlight Model XE 9666-ARFV. There are two 1000w Xenon Searchlights located on top of the Pilothouse facing forward. The searchlights are controlled on the bridge at a single station with joystick (Figure 55).

**Figure 55 Searchlights on Pilothouse (left); searchlight controls in Pilothouse (right)**
