PAVEMENT DATA SUMMARY REPORT

TO:	Robert Trousil, P.E. Regional Materials Engineer	Date:	March 6, 2020	
		Telephone No.: Fax No:	(907) 465-4383 (907) 465-3506	
FROM:	Troy Bowthorpe Pavement Management	PROJECT NO:	SFHWY00269

RE: JNU Glacier Avenue, Ross Way to Egan Dr., SR 1R Recon, Pavement Data Summary

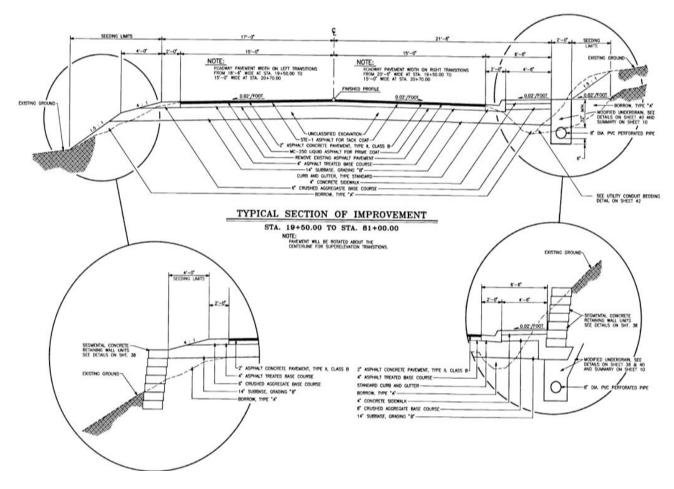
Figure 1: 1994 As-Built construction section

The project area was originally constructed sometime prior to 1959 as a pioneer road, with an unknown as-built pavement section. It was subsequently upgraded in 1994 as shown in Figure 1. The pavement structure as shown in Figure 1, consists of 2" inches (50mm) HMA, 4" inches of Asphalt Treated Base Course, over 14" of "Subbase Grading B". Available construction documents merely indicate what the road was surfaced with prior to 1994, and subsequent 2" pavement Overlay added in 1994. No evidence of major base, subbase or subgrade improvements have been made during or since the 1994 project.
