### 3. Phase 2 (High Criticality of Wall Failure)

Milepost 354.94 Wall #36

ALASKA RAILROAD RETAINING WALL INSPECTION FORM						
Milepost: 354.94 Wall Number: 36			Inspectors: Andy Kubic, Eric Thornley			
Date:	July 29, 2021 1:30 PM		Engineer review required:		Date Forwarded:	
Nearest Hwy Intersection:	Parks Highway at Denali Park			Nearest RR Crossing:		
GPS Coordinates	-148.95979, 63.81798 WGS 1984					
Nearest Siding:	Healy Siding			Fiber Optic location: East Side of Tracks		
Authorized Track Speed	Passenger: 15		Freight: 15		Overhead Utilities: None	
Track & Slope						
Wall Condition Rating <b>Poor</b>			Rating scale: 5-Excellent, 4-Good, 3-Adequate, 2-Marginal, 1-Poor (see back for rating description)			
Line & Surface:	CWR/Ballast		Tangent/Curve: Tangent			
Tie condition:	Good					
Tie type:	Concrete					
Distance from end of tie to wall (feet)	South End:	6.5		North End:	6.5	
Distance from end of tie to toe (feet)	South End:			North End:		
Culverts:	No					
Ditchline:	Gravel

Milepost 355.22 Wall #41

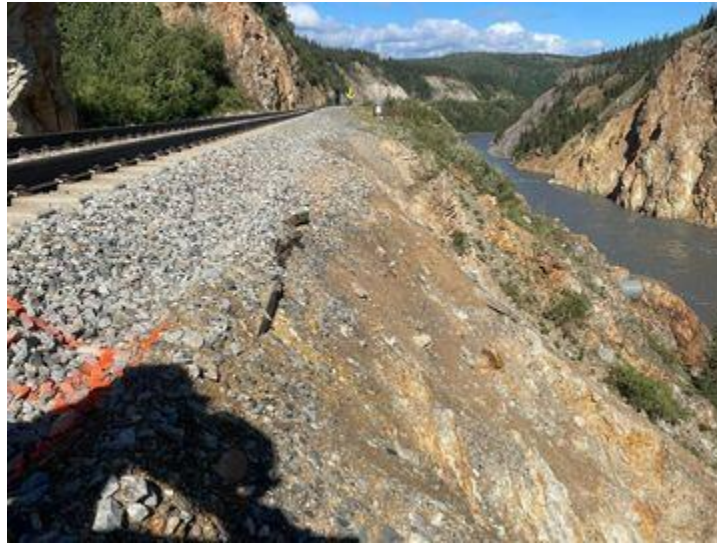
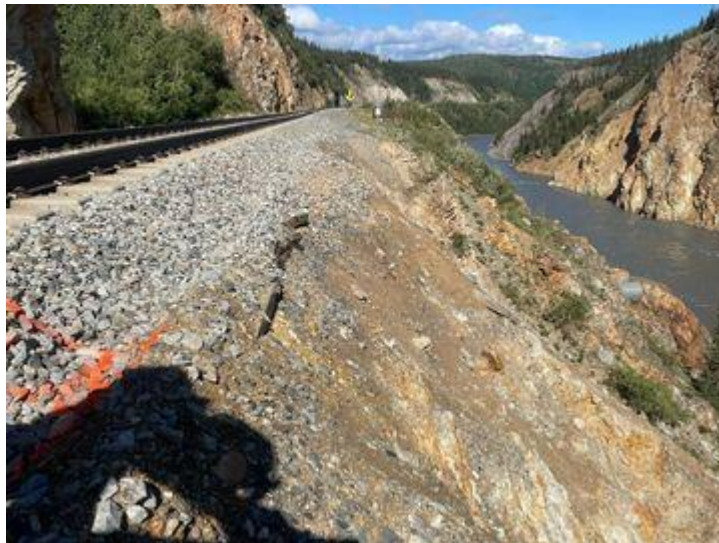
Photo of Approach to Wall Start Looking Up Station

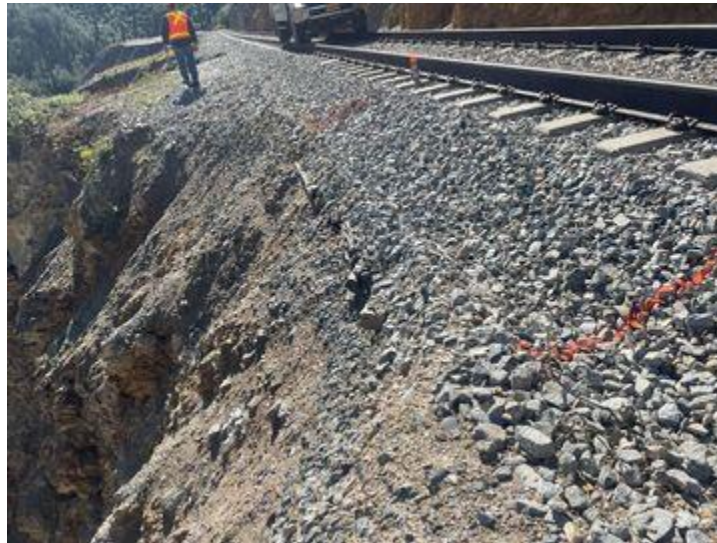
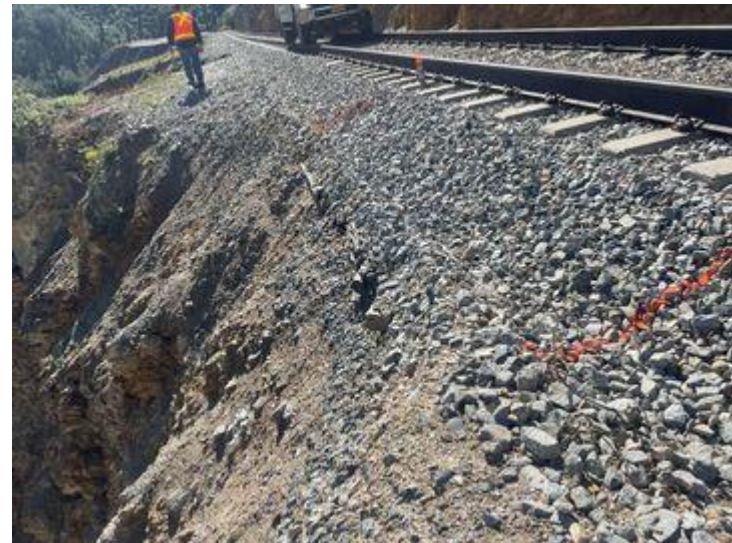
Photo of Approach to Wall Start Looking Down Station

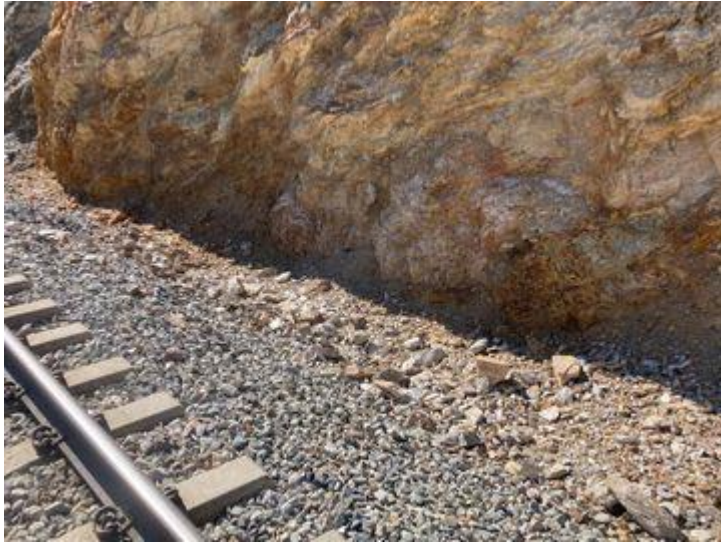
Comments:	Center Point of Wall/Track Centerline 360 Photo 1	Date:	7/29/2021
		Photo:	3
Wall # 36 Wall Condition Rating: Poor		MP #:	354.94

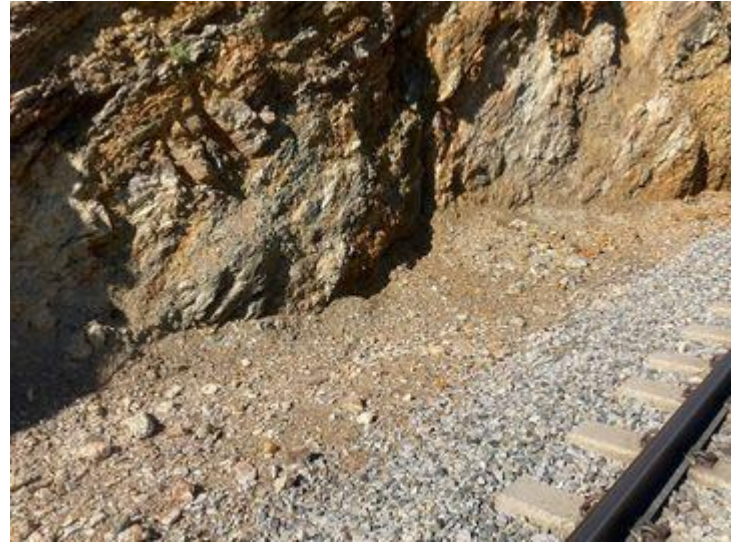
Comments:	Center Point of Wall/Track Centerline 360 Photo 2	Date:	7/29/2021
		Photo:	4
Wall # 36 Wall Condition Rating: Poor		MP #:	354.94

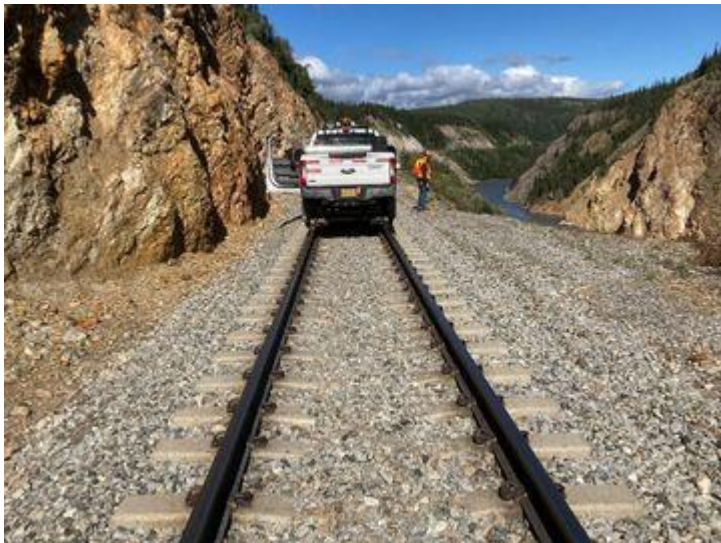
Comments:	Center Point of Wall/Track Centerline 360 Photo 3	Date:	7/29/2021
		Photo:	5
Wall # 36 Wall Condition Rating: Poor		MP #:	354.94

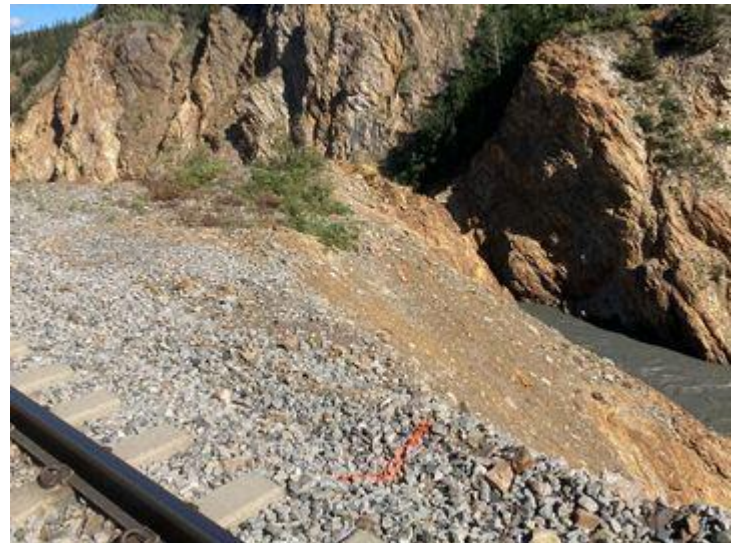
Comments:	Center Point of Wall/Track Centerline 360 Photo 4	Date:	7/29/2021
		Photo:	6
Wall # 36 Wall Condition Rating: Poor		MP #:	354.94

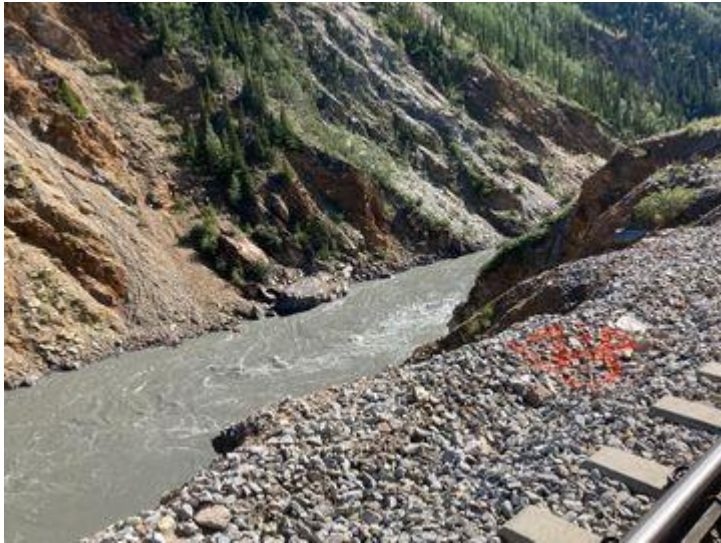
Comments:	Center Point of Wall/Track Centerline 360 Photo 5	Date:	7/29/2021
		Photo:	7
Wall # 36 Wall Condition Rating: Poor		MP #:	354.94

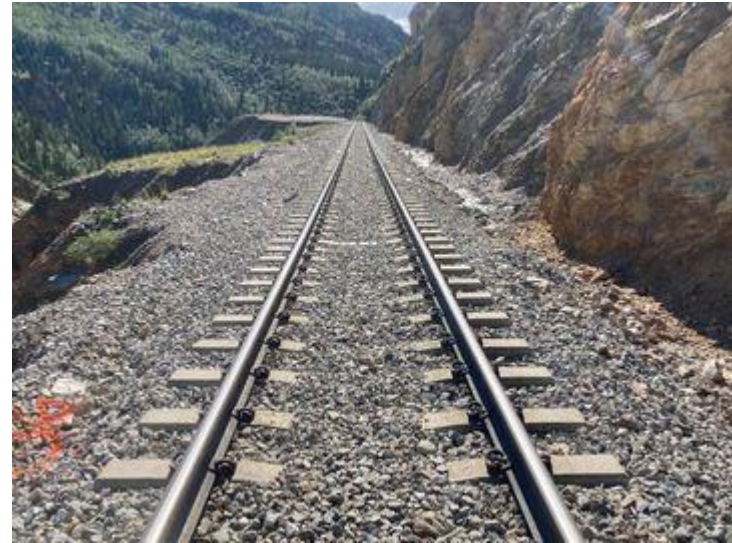
Comments:	Center Point of Wall/Track Centerline 360 Photo 6	Date:	7/29/2021
		Photo:	8
Wall # 36 Wall Condition Rating: Poor		MP #:	354.94

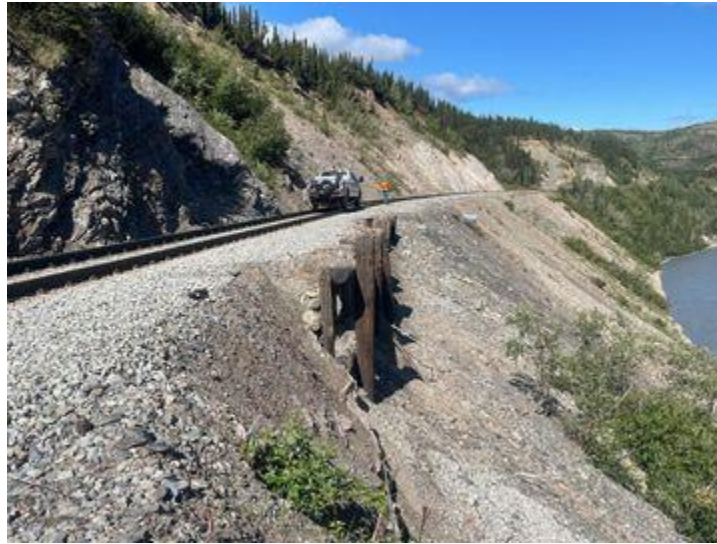
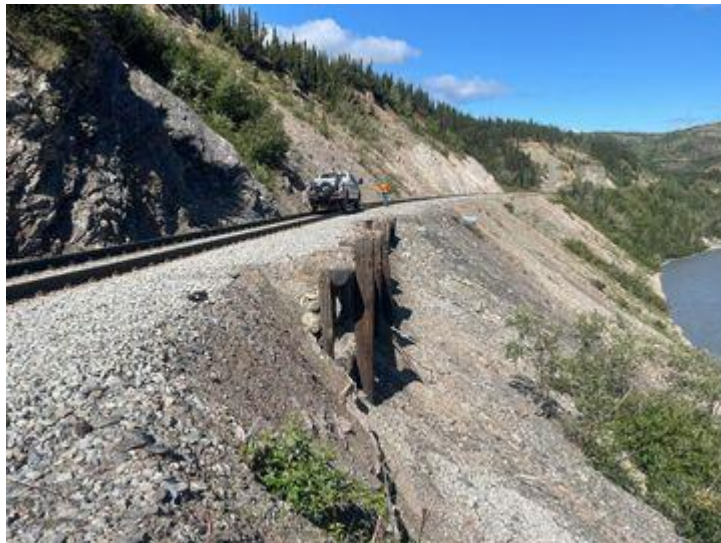
Photo of Approach to Wall Start Looking Up Station

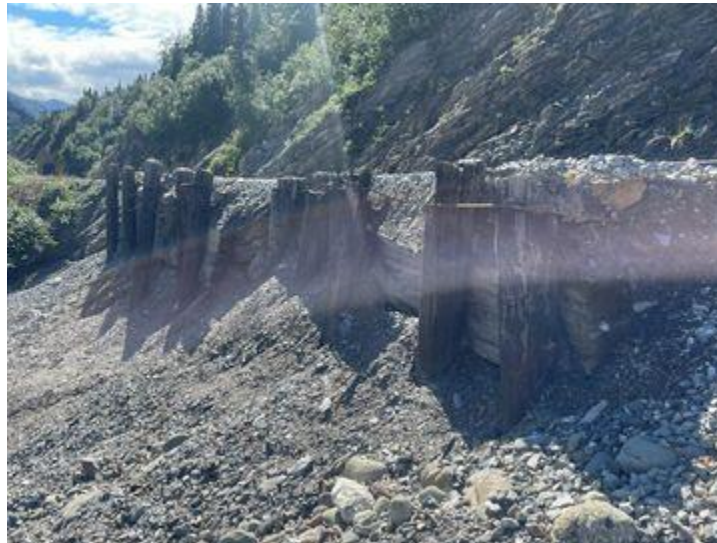
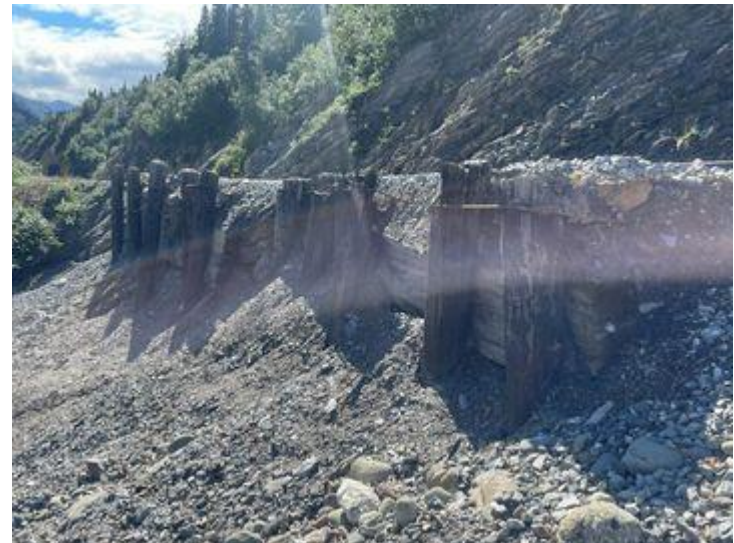
Photo of Approach to Wall Start Looking Down Station

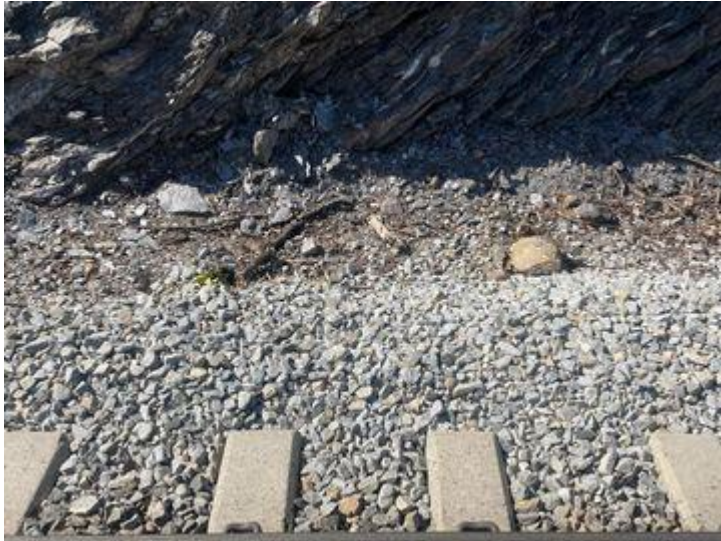
Comments:	Center Point of Wall/Track Centerline 360 Photo 1	Date:	7/29/2021
		Photo:	3
Wall # 41 Wall Condition Rating: Poor		MP #:	355.22

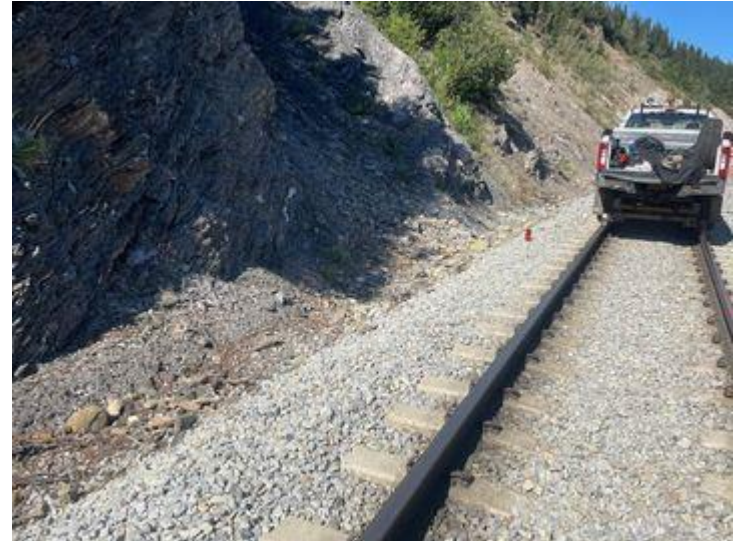
Comments:	Center Point of Wall/Track Centerline 360 Photo 2	Date:	7/29/2021
		Photo:	4
Wall # 41 Wall Condition Rating: Poor		MP #:	355.22

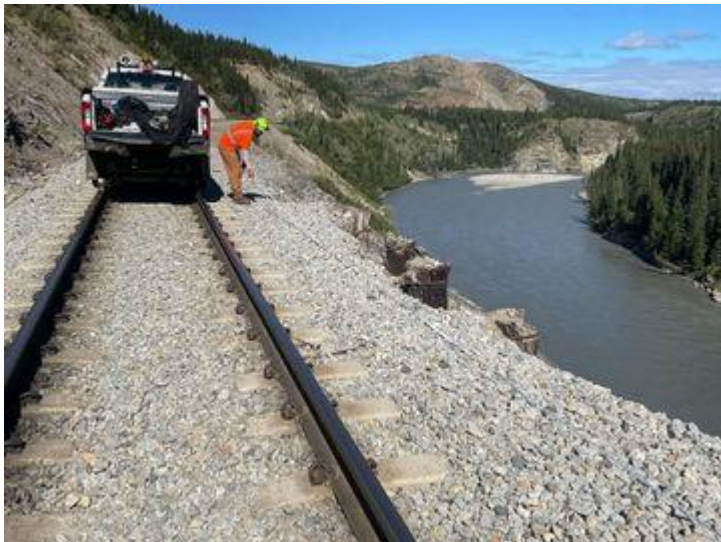
Comments:	Center Point of Wall/Track Centerline 360 Photo 3	Date:	7/29/2021
		Photo:	5
Wall # 41 Wall Condition Rating: Poor		MP #:	355.22

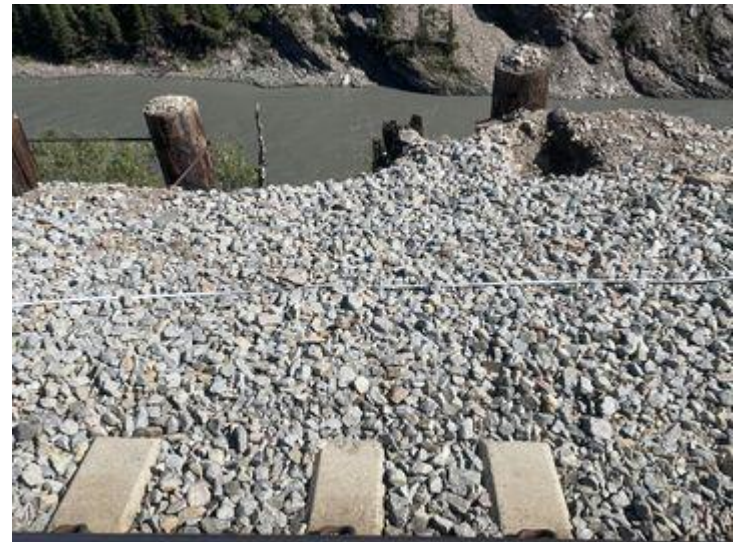
Comments:	Center Point of Wall/Track Centerline 360 Photo 4	Date:	7/29/2021
		Photo:	6
Wall # 41 Wall Condition Rating: Poor		MP #:	355.22

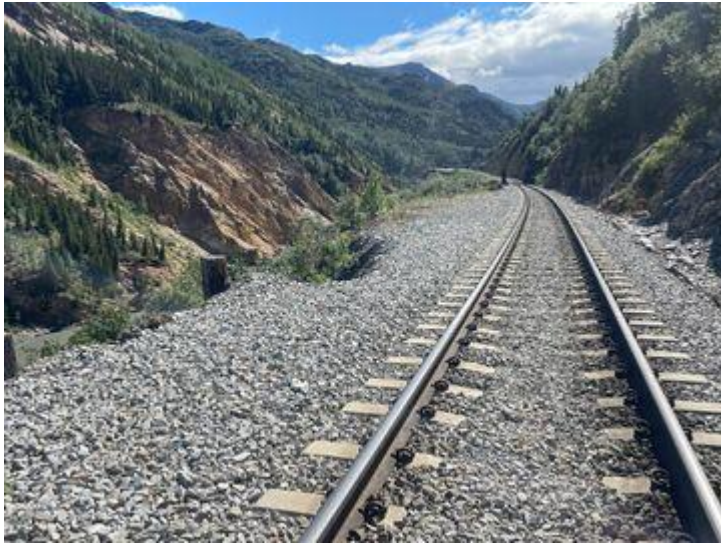
Comments:	Center Point of Wall/Track Centerline 360 Photo 5	Date:	7/29/2021
		Photo:	7
Wall # 41 Wall Condition Rating: Poor		MP #:	355.22

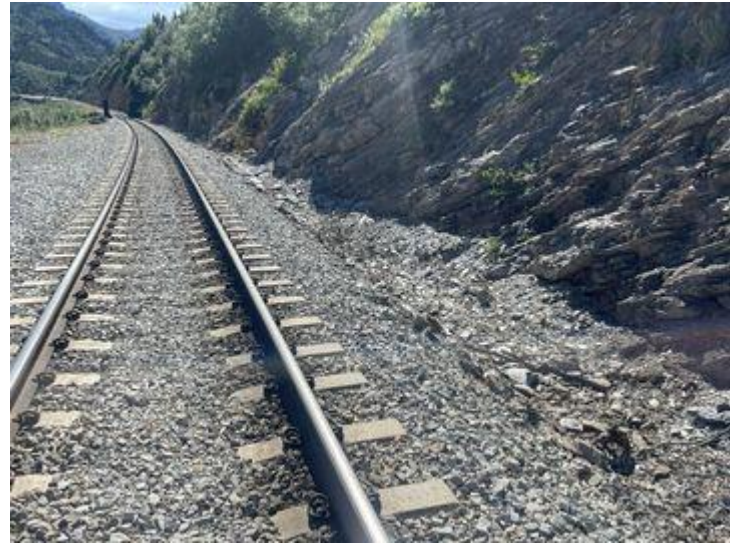
Comments:	Center Point of Wall/Track Centerline 360 Photo 6	Date:	7/29/2021
		Photo:	8
Wall # 41 Wall Condition Rating: Poor		MP #:	355.22

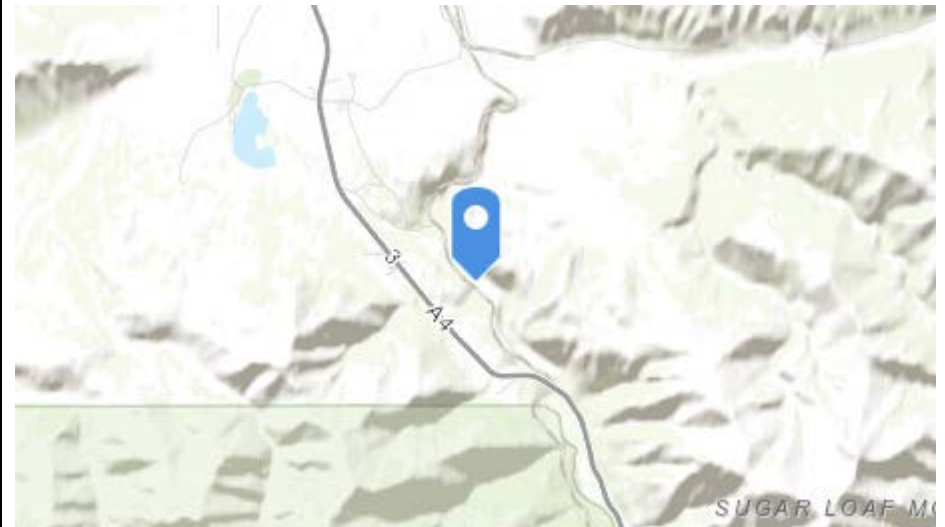
Comments:		Date:	7/28/2021	Comments:	Wall Location	Date:	7/28/2021
		Photo:	1			Photo:	2
Wall #38	Wall Condition Rating: Adequate	MP #:	354.95	Wall #38	Wall Condition Rating: Adequate	MP #:	354.95

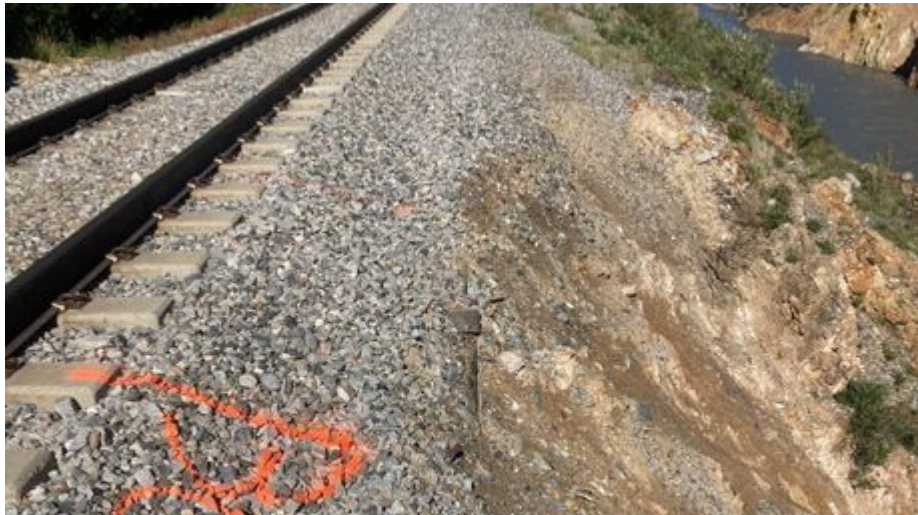
Comments:	Photo of Approach to Wall Start Looking Up station	Date:	7/28/2021	Comments:	Photo of Approach to Wall End Looking Down Station	Date:	7/28/2021
		Photo:	3			Photo:	4
Wall #38	Wall Condition Rating: Adequate	MP #:	354.95	Wall #38	Wall Condition Rating: Adequate	MP #:	354.95

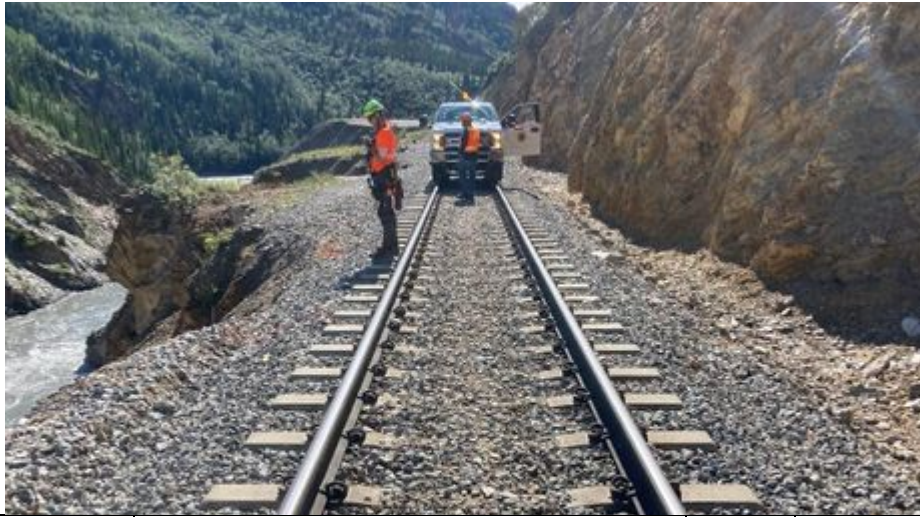
Photo:	5
--	--	--------	---

Comments:	Center Point of Wall from Track Centerline	Date:	7/28/2021
-----------	--	-------	-----------

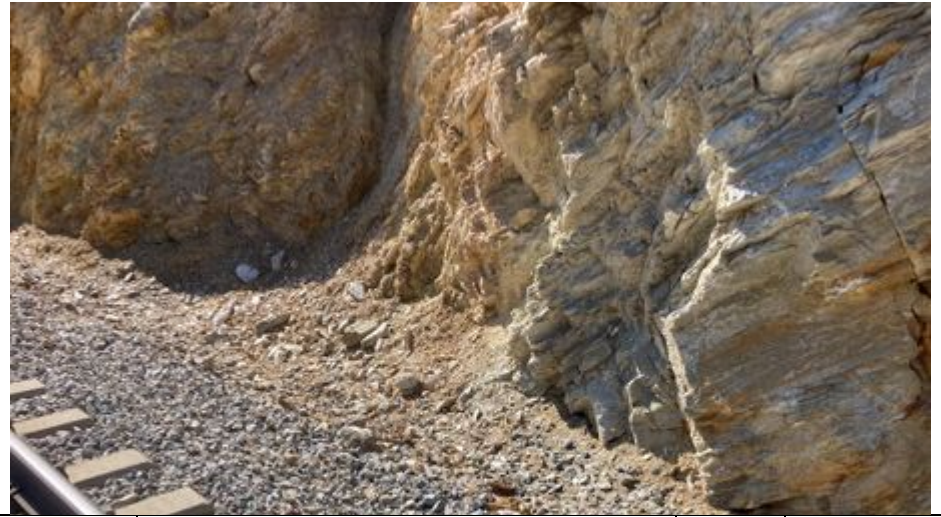
Photo:	6
--	--	--------	---

Comments:	Center Point of Wall from Track Centerline	Date:	7/28/2021
-----------	--	-------	-----------

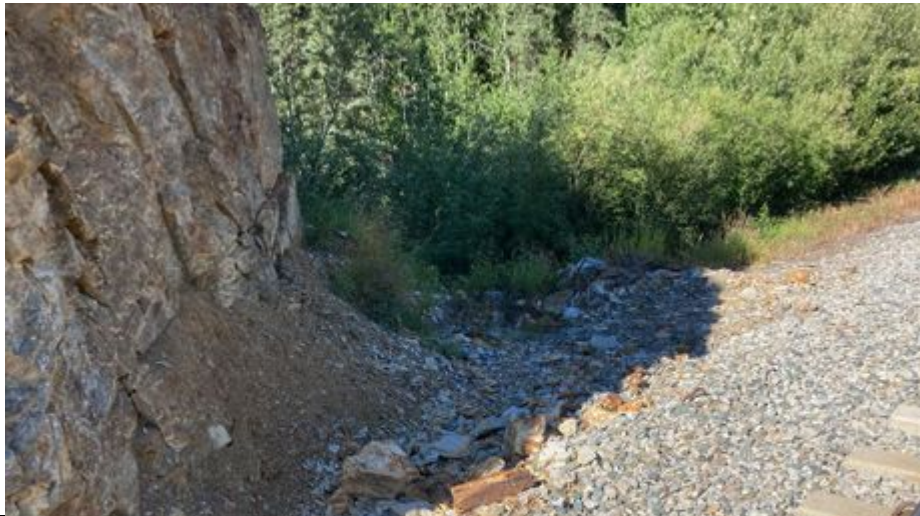
Photo:	7
--	--	--------	---

Comments:	Center Point of Wall from Track Centerline	Date:	7/28/2021
-----------	--	-------	-----------

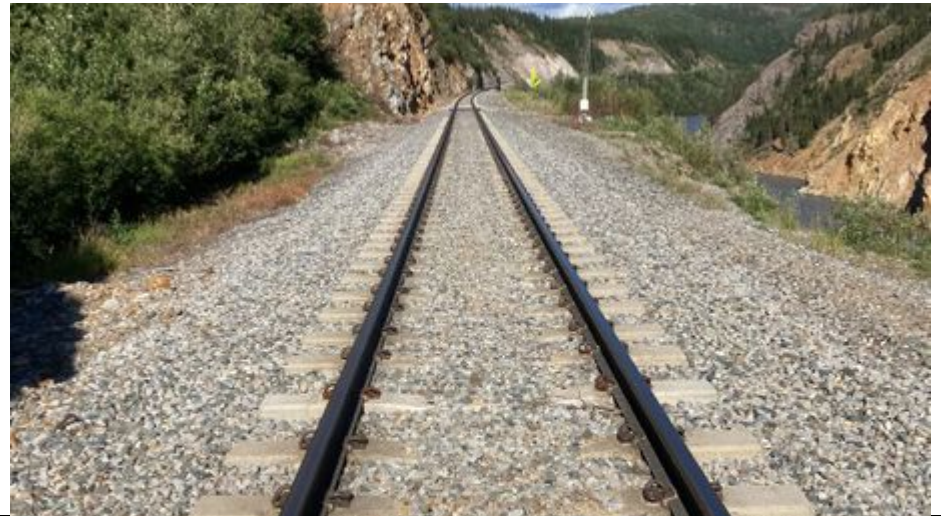
Photo:	8
--	--	--------	---

Comments:	Center Point of Wall from Track Centerline	Date:	7/28/2021
-----------	--	-------	-----------

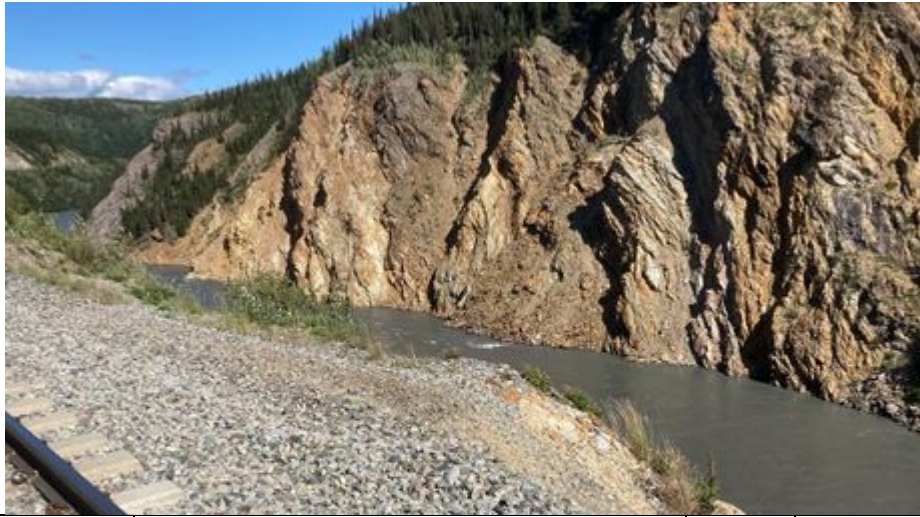
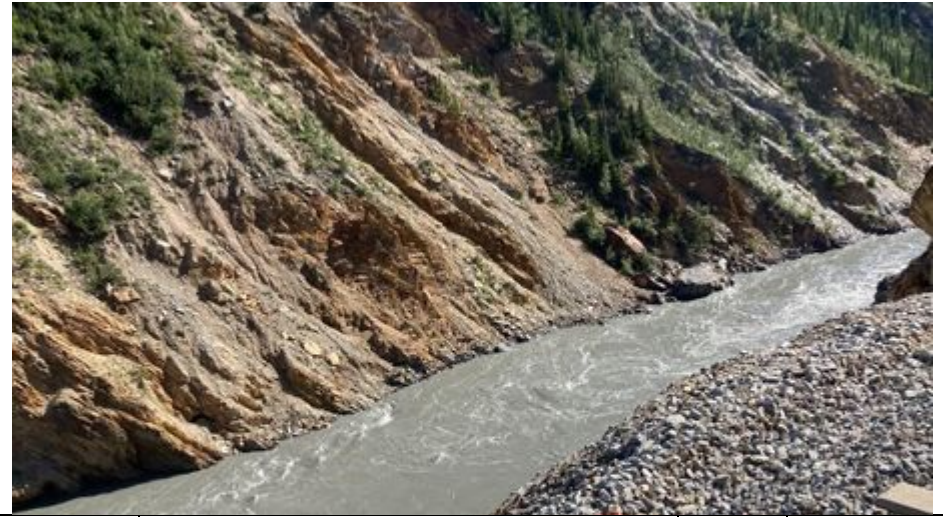
Comments:	Center Point of Wall from Track Centerline	Date:	7/28/2021	Comments:	Center Point of Wall from Track Centerline	Date:	7/28/2021
		Photo:	9			Photo:	10
Wall #38	Wall Condition Rating: Adequate	MP #:	354.95	Wall #38	Wall Condition Rating: Adequate	MP #:	354.95
