RE: Project Name: Hooper Bay Roof and Envelope
Project Number: 0252123001
Project Location: Hooper Bay, Alaska

Addendum # Two (2)

**ASBESTOS SURVEY
ALASKA ARMY NATIONAL GUARD
HOOPER BAY FEDERAL SCOUT ARMORY
HOOPER BAY, ALASKA
APRIL 1996**

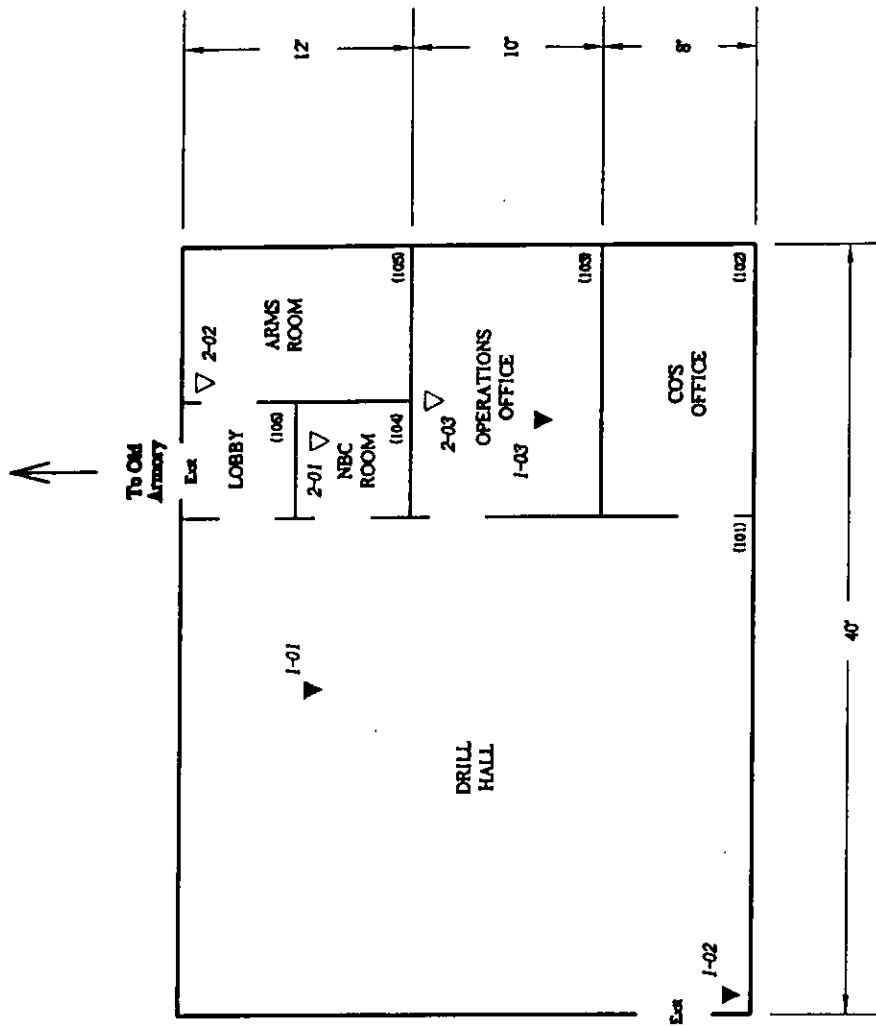
Sampling Locations

Sample locations and descriptions are summarized and presented in Table 4. Locations for these samples are shown in Figures 1, 3, and 5. Locations of asbestos containing materials are shown in Figures 4.

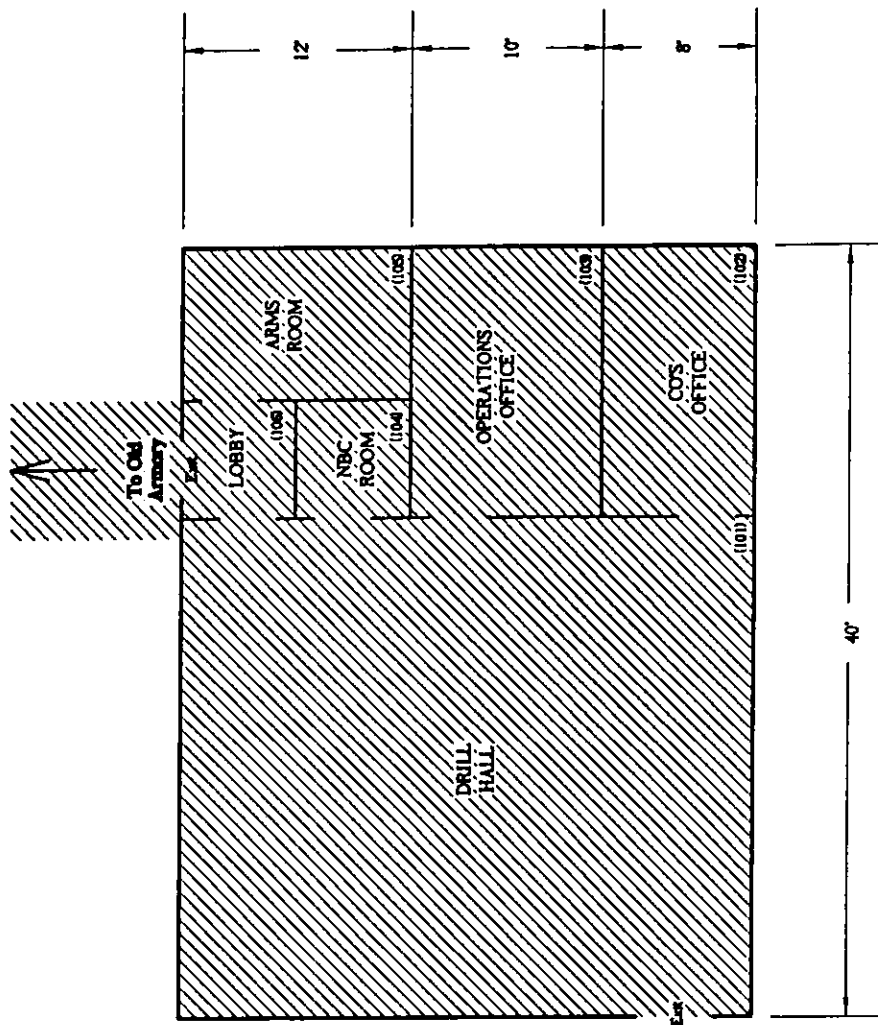
FIGURE 4

HA	ACM	Description	Location	Quantity	Friable	Response Actions	*Repair	O&M	Remove	Replace	
1	Yes	12" x 12", Floor Tile, Tan	Throughout building and in connecting hallway	1350 SF	NO	O&M Program	\$163	\$16	\$8,924	\$7,385	
Totals							\$163	\$16	\$8,924	\$7,385
