RE: Project Name: Hooper Bay Interior Restoration
Project Number: 0252123012
Project Location: Hooper Bay, Alaska

Addendum Two (2)

**ASBESTOS SURVEY
ALASKA ARMY NATIONAL GUARD
HOOPER BAY FEDERAL SCOUT ARMORY
HOOPER BAY, ALASKA
APRIL 1996**

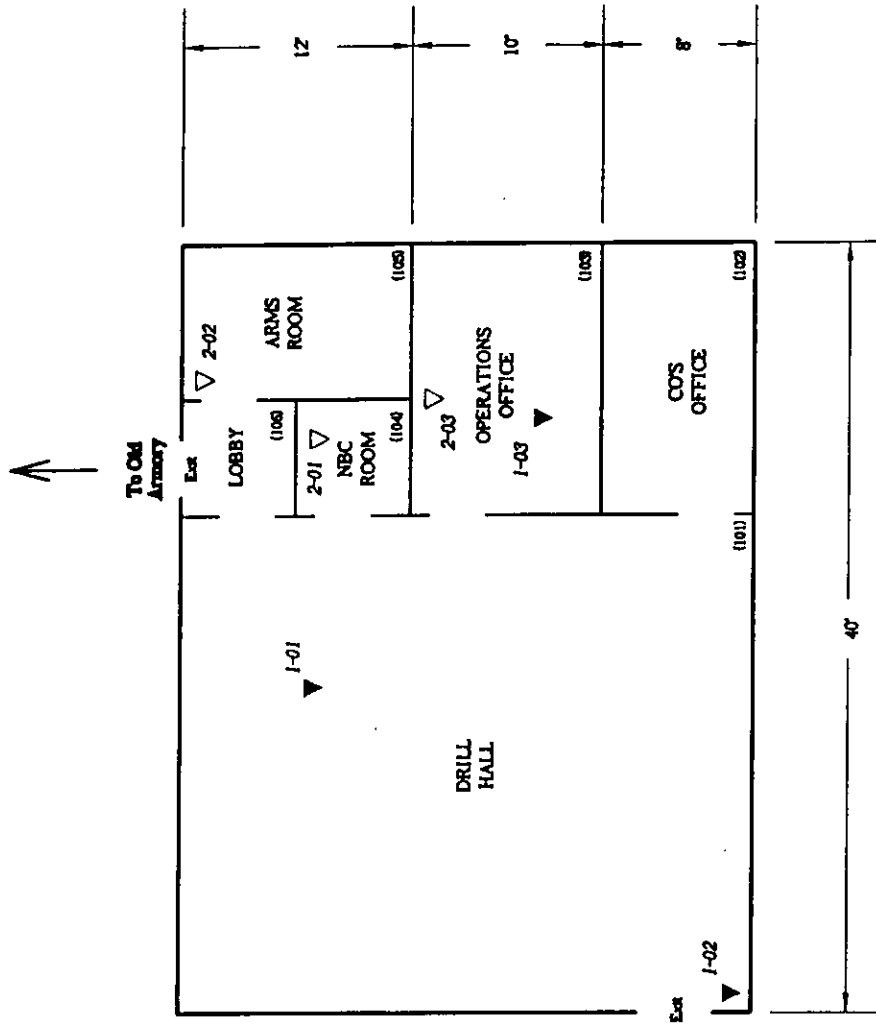
Sample locations and descriptions are summarized and presented in Table 4. Locations for these samples are shown in Figures 1, 3, and 5. Locations of asbestos containing materials are shown in Figures 4.

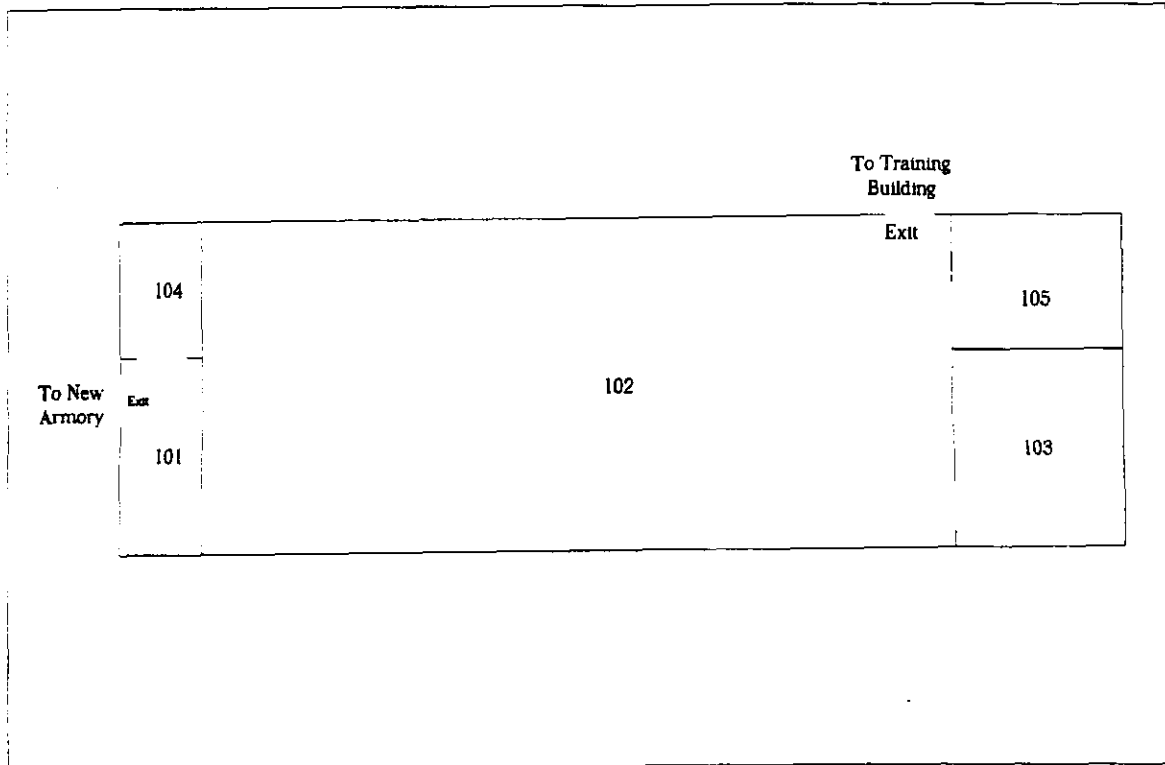
Photo No. 2

Approximately 1,200 square feet of gypsum board ceiling is located throughout the Old Armory. Samples HB-01-2-01 through 2-03 were collected from this homogeneous area (sample locations are shown in Figure 1 and a picture of the material is shown in Appendix A, Photo No 2).

The interior walls were either wood or gypsum board. Approximately 2,400 square feet of gypsum board is located throughout the Old Armory. Samples HB-01-2-01 through 2-03 were collected from this homogeneous area (sample locations are shown in Figure 1 and a picture of the material is in Appendix A, Photo No. 2). Metal walls were present in all other parts of the building and were not sampled.

Rolled Flooring, Brown
Building No. 1 HA No. 1
Old Armory
Hooper Bay, Alaska
