December 15, 2021

RE: Kodiak Airport Buildings Limited Hazardous Materials Assessment Report

◆
NORTECH is pleased to provide R&M Consultants with the following limited Hazardous Materials Assessment (HMA) Report for buildings located at Lot 5A and Lot 3 of the 1400 Block at the Kodiak Airport. This report documents **NORTECH**'s methods, sample locations and materials, assessment results, and demolition considerations for both buildings within the proposed project scope.

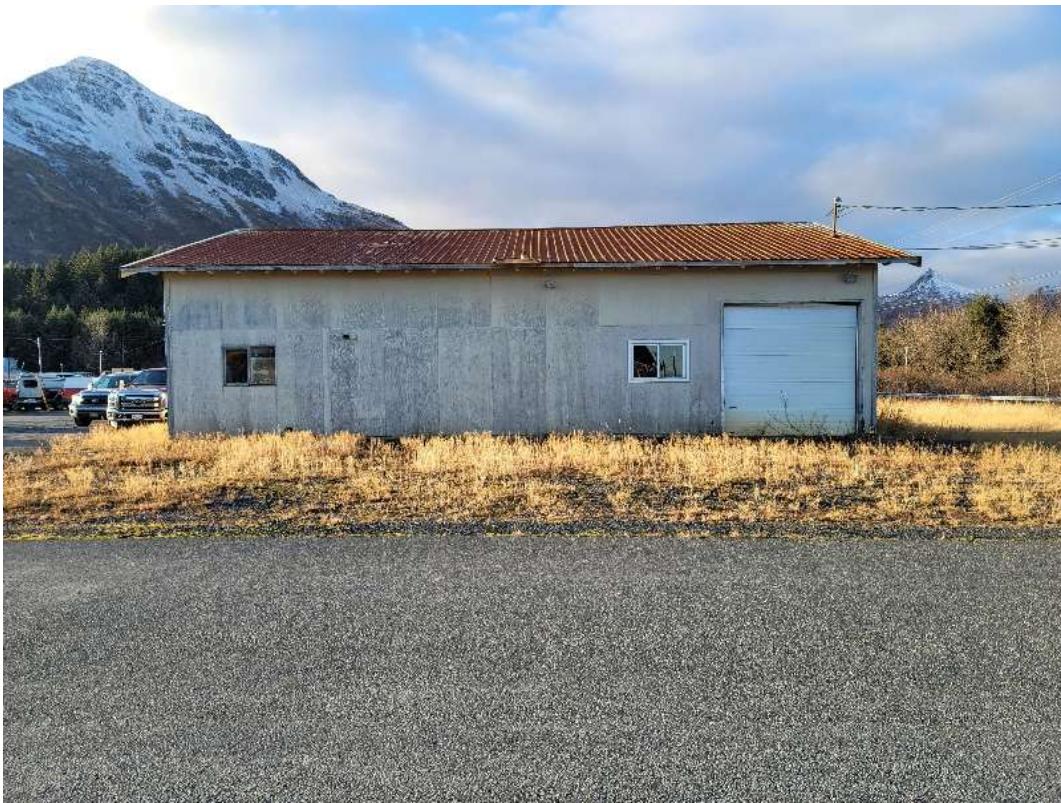
Photo 9: Exterior of building on Lot 5A.

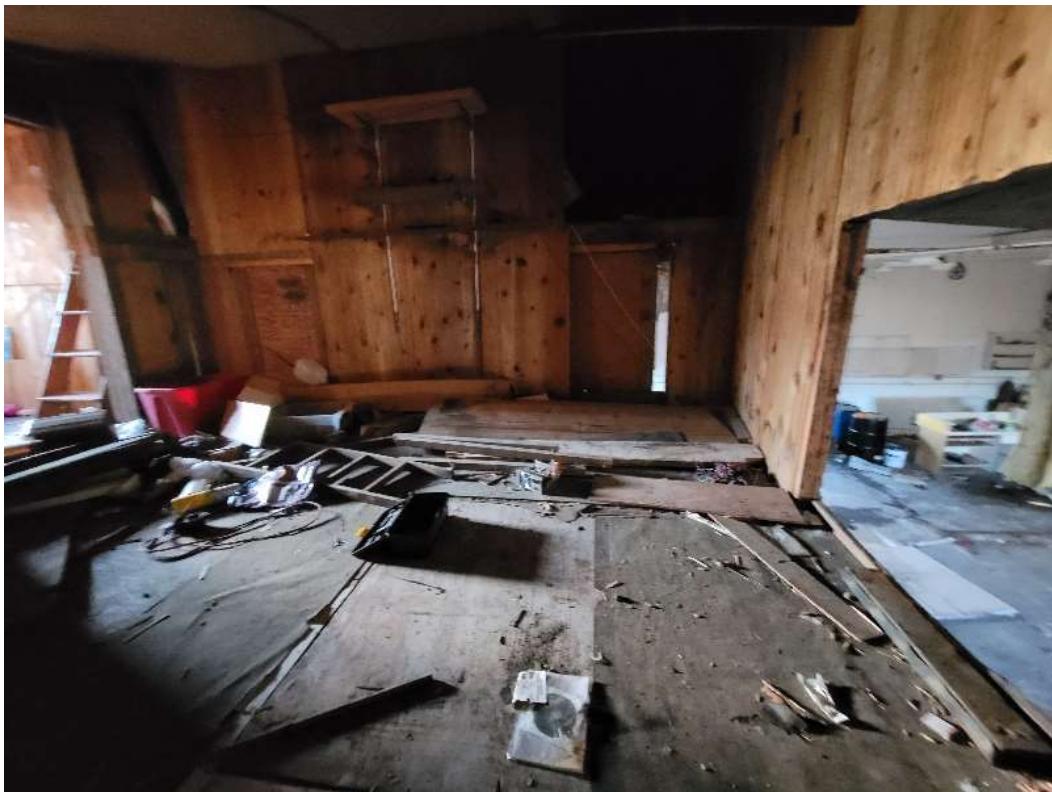
Photo 10: Interior of the main building on Lot 5A. The room to the right appears to be a former shop area, the room to the left appears to have been used as a living space.
