2023 FLEET CONDITION SURVEY

# M/V MATANUSKA.

PREPARED FOR ALASKA MARINE HIGHWAY SYSTEM

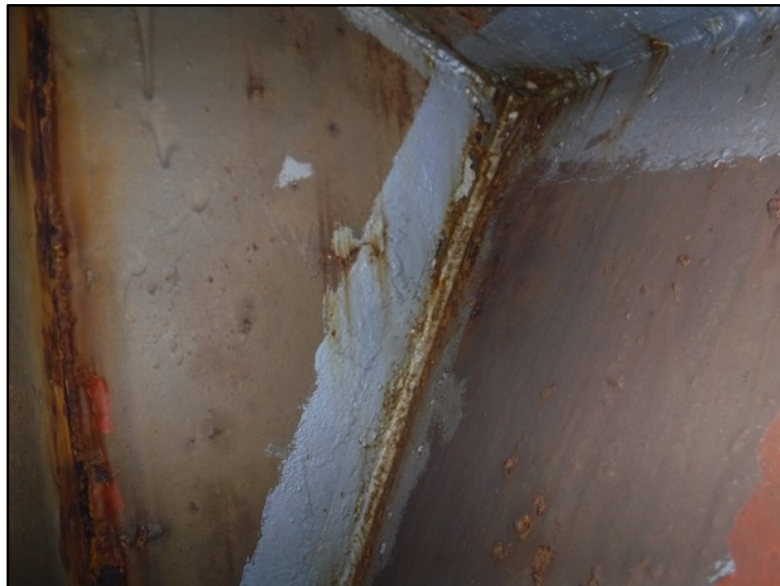
**General Remarks:** There is corrosion on the forward bulkhead on the starboard side (see Photo 5) and on the aft bulkhead, under the aft ladder (see Photo 6). In addition, there is minor corrosion on welds in the port side upper section, near the aft bulkhead (see Photo 7). Coatings in the remainder of the void remain in satisfactory condition.

**Photo 7: Minor Corrosion on Welds in Upper Section**

**Recommendations for Future:** No touch up currently needed. The corrosion areas on the forward and aft bulkheads will most likely need to be touched up in the next 1-2 years. Continue to inspect the No. 1 Deep Ballast on an annual basis.

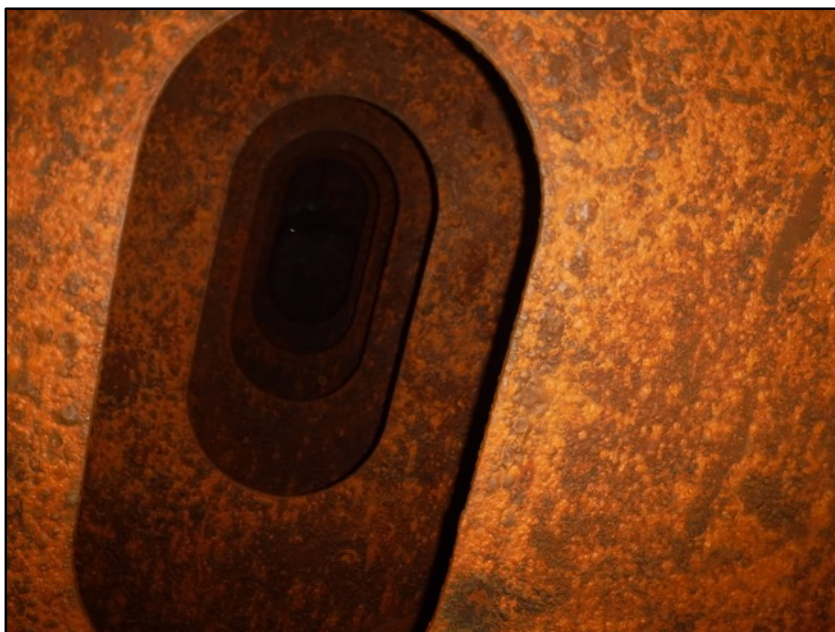
**Photo 8: Mud Caked on Walls of No. 2 Double Bottom**

**General Remarks:** The No. 2 Double Bottom Ballast is extremely dirty and caked in mud, so it is difficult to assess the condition of the coatings. The coatings appear to remain intact underneath the mud.

**Recommendations for Future:** No touch up currently needed. We recommend cleaning the No. 2 Double Bottom Ballast in the future so that a better assessment of the coatings can be completed.

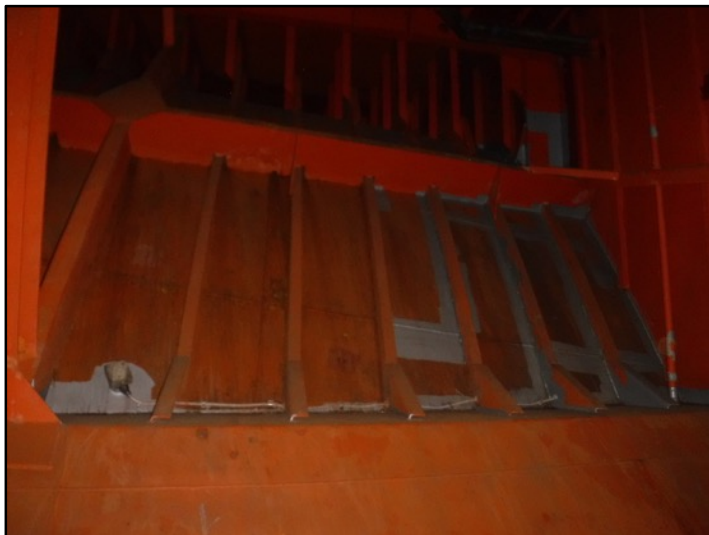
**Photo 9: Existing Coating System in No. 3 Void**

**Existing Coating System:** Unknown red coating (see Photo 9). Areas have been touched up with what appears to be Intershield 300 epoxy.

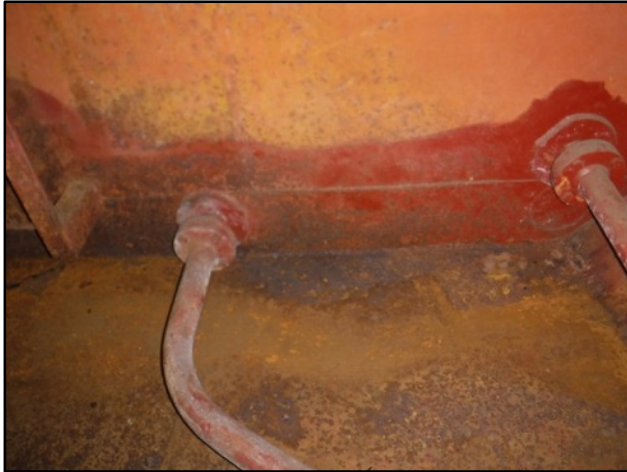
**General Remarks:** There is corrosion on the deck of the void near the forward and aft bulkheads, (see Photos 10 and 11). Coatings in the remainder of the void remain in satisfactory condition.

**Photo 10: Corrosion on Deck near Forward Bulkhead**

**Recommendations for Future:** No touch up currently needed. The corrosion on the deck near the forward and aft bulkheads will most likely need to be touched up in the next 1-2 years. Continue to inspect the No. 3 Void on an annual basis.

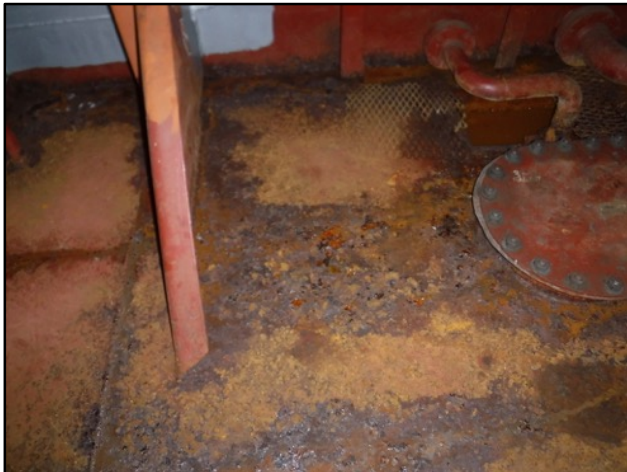
**Photo 11: Corrosion on Deck near Aft Bulkhead**

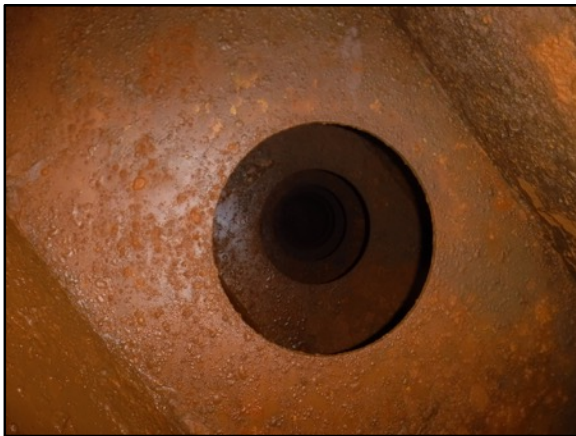
**Photo 12: Port Wing Ballast**

**Existing Coating System:** Appears to be a bitumastic coal tar epoxy coating underneath the dirt and mud (see Photos 12-14).

**General Remarks:** The No. 3 Wing Ballasts and Center Line Double Bottom Ballast are extremely dirty and caked in mud. However, the coatings appear to remain intact underneath.

**Recommendations for Future:** No touch up currently needed. We recommend cleaning the No. 3 Wing Ballasts and No. 3 Center Line Double Bottom Ballast in the future so that a better assessment of the coatings can be completed. Continue to inspect on an annual basis.

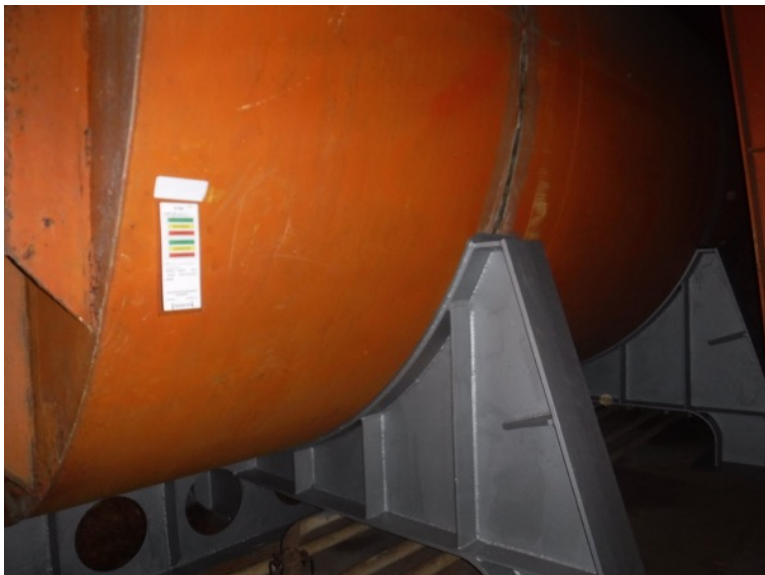
**Photo 15: Existing Coating System in No. 4 Void**

**Existing Coating System:** Unknown red coating. Touch up has been done with what appears to be Intershield 300 (see Photo 15).

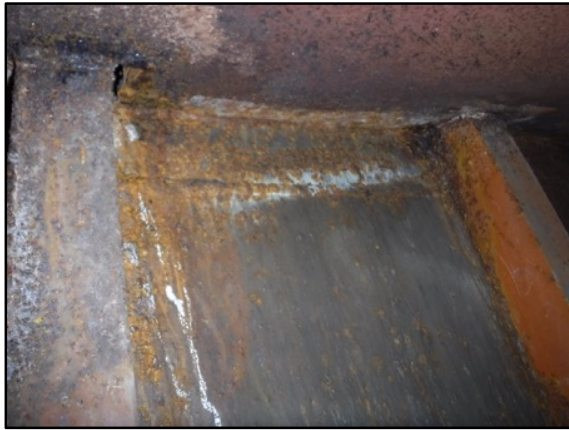
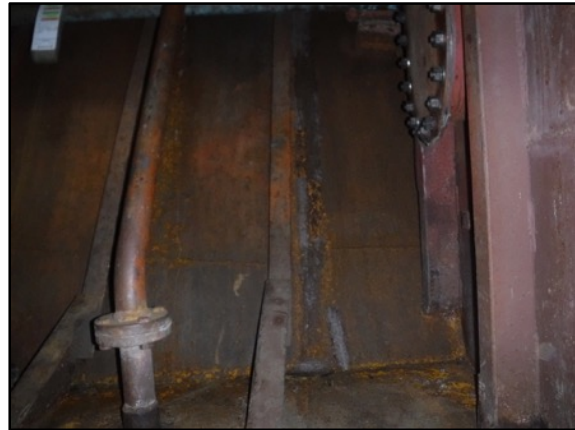
**General Remarks:** There is corrosion on welds and the skin plate on the starboard side above the wing ballast, mostly near the aft bulkhead (see Photos 16 and 17). There is also corrosion on the sides of the pipe alley (see Photo 18). Finally, there is corrosion on the deck near the forward and aft bulkheads (see Photo 19) The coatings in the remainder of the void remain in satisfactory condition.

**Photos 16 & 17: Corrosion on Skin Plate Above Starboard Wing Ballast**

**Recommendations for Future:** At next availability, we recommend power tool cleaning (as per SSPC-SP 15) the corrosion areas on the welds and skin plate above the starboard wing ballast and applying 2 coats and a stripe coat of Intershield 300 epoxy. We also recommend power tool cleaning the walls of the pipe alley and coating with 2 coats of Intershield 300. This area is difficult to access, so if power tool cleaning is not possible, Interbond 600 could be used to seal up the corrosion areas. The corrosion on the deck, near the forward and aft bulkheads, will also most likely need to be touched up in the next 1-2 years. Continue to inspect the No. 4 Void on an annual basis.

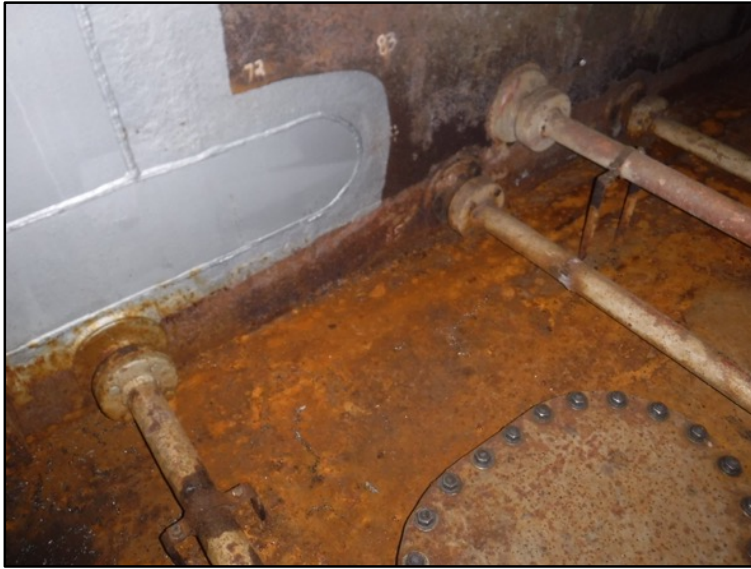
**Photo 19: Corrosion on Deck Near Forward Bulkhead**

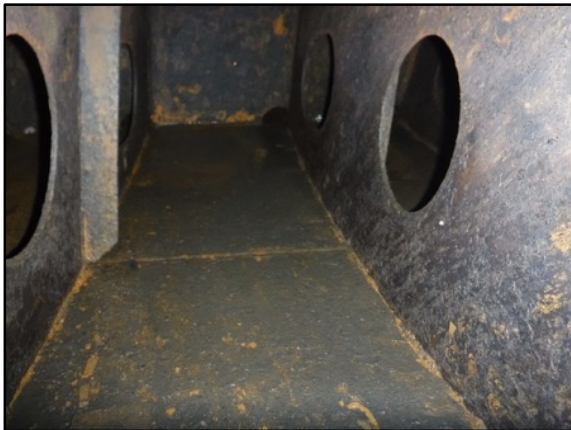
**Photo 20: No. 4 Port Wing Ballast**

**Existing Coating System:** Appears to be bitumastic coal tar coating underneath dirt and mud (see Photos 20-22).

**General Remarks:** The No. 4 Port Wing Ballast is not as dirty as the others, which are coated in dirt and mud. The coatings appear to remain intact underneath the mud.

**Recommendations for Future:** We recommend cleaning the No. 4 Wing Ballasts and No. 4 Double Bottom Ballast in the future so that a better assessment of the coatings can be completed. Continue to inspect on an annual basis.

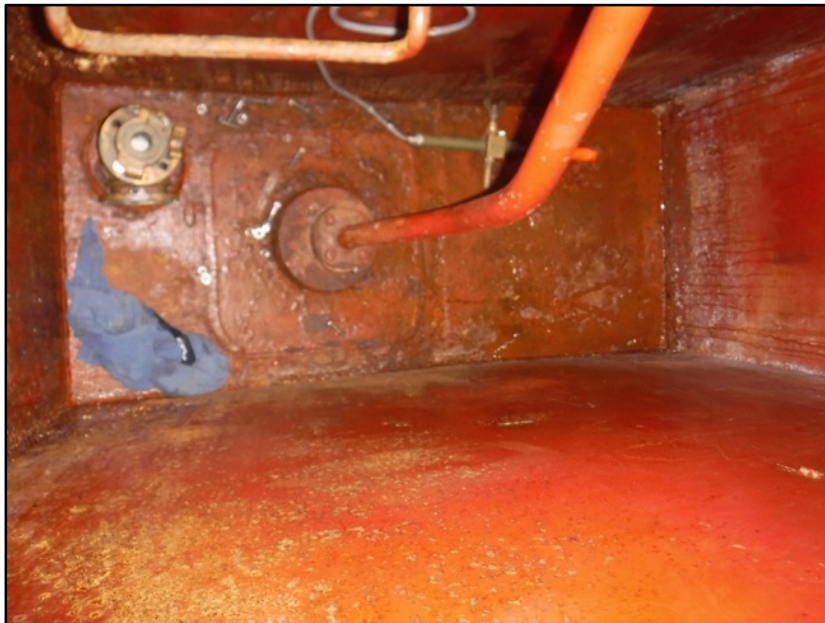
**Photo 23: Existing Coating System in No. 4 Transducer Void**

**Existing Coating System:** The No. 4 Transducer Void is coated in an unknown red coating (see Photo 23).

**General Remarks:** The deck of the Transducer Void is dirty, but the coatings remain in satisfactory condition.

**Recommendations for Future:** No touch up is currently needed. Continue to inspect the No. 4 Transducer Void on an annual basis.

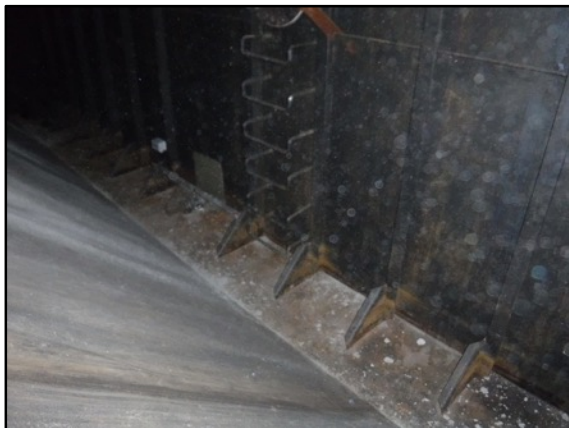
**Photo 24: No. 5 Port Void**

**Existing Coating System:** The No. 5 Voids, Wing Voids, and Double Bottom are coated in what appears to be a bitumastic coal tar epoxy system (see Photos 24 and 25). The overhead of the No. 5 Voids is covered with an insulating material.

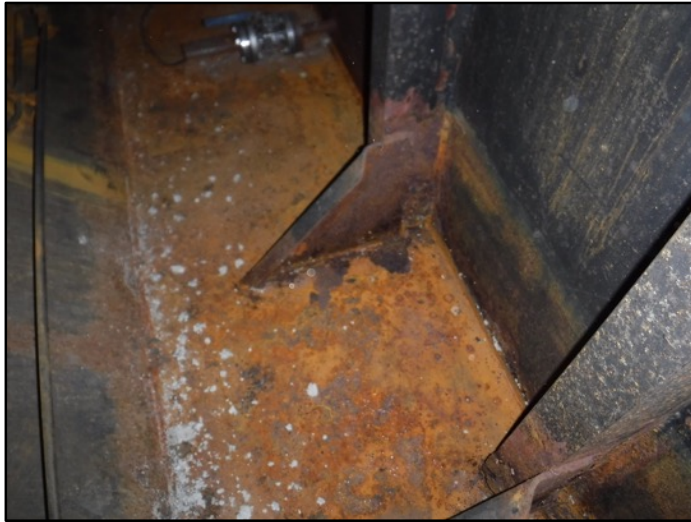
**General Remarks:** There is corrosion on the deck of the No. 5 Starboard Void, near the center line bulkhead (see Photo 26). The coatings in the Wing Voids remains in satisfactory condition (see Photos 27 and 28). In the No. 5 Double Bottom, there is minor corrosion on the welds on the deck (see Photo 29).

**Photo 26: Corrosion near Centerline Bulkhead in No. 5 Starboard Void**

**Recommendations for Future:** No touch up currently needed. The deck of the No. 5 Starboard Void, near the center line bulkhead, should be touched up in the next 1-2 years. The welds on the deck of the No. 5 Double Bottom will also most likely need to be touched up in the next 2-3 years. Continue to inspect the No. 5 Voids, Wing Voids, and Double Bottom on an annual basis.

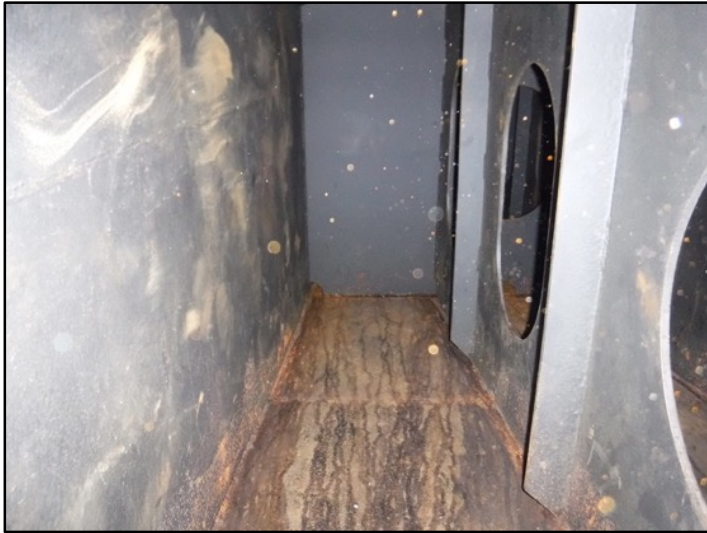
**Photo 29: Minor Corrosion on Welds on Deck of No. 5 Double Bottom**

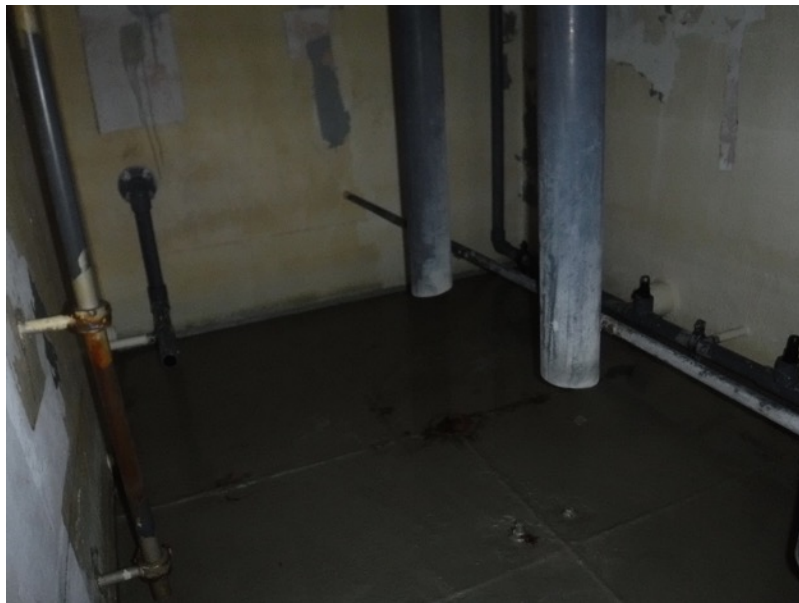
**Photo 30: Existing Coatings in V-1 Sewage Tank**

**Existing Coating System:** The V-1 Sewage tank is coated in an unknown off white epoxy system (see Photo 30). There are multiple areas where touch up has been done over the years.

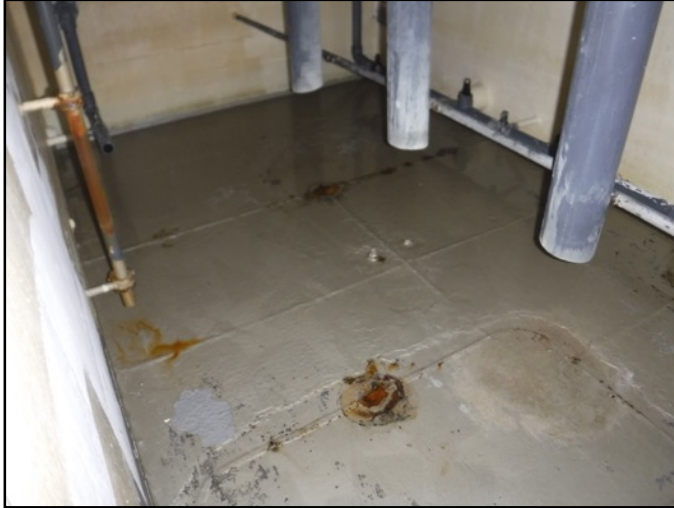
**General Remarks:** Overall, the coatings in the V-1 Sewage Tank remains in satisfactory condition. There are two small delamination spots on welds on the deck of the of the tank (see Photo 31).

**Photo 31: Delamination Spots on Deck of V-2 Sewage Tank**

**Recommendations for Future:** No touch up and repair currently needed. The delamination spots on the deck of the V-1 Sewage Tank will most likely need to be touched up in the next 1-2 years. Continue to inspect the Sewage Tanks on an annual basis.

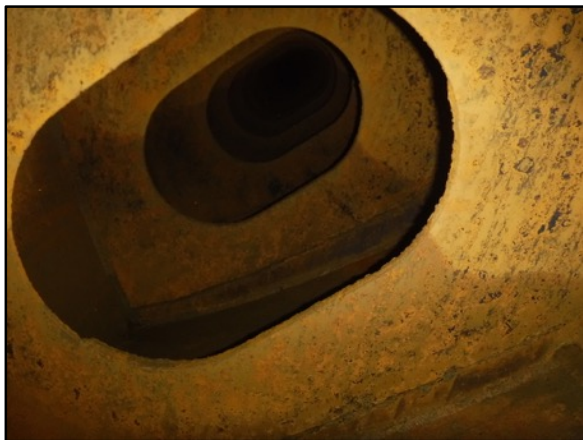
**Photo 32: No. 8 Port Wing Ballast**

**Existing Coating System:** Appears to be a bitumastic coal coating underneath dirt and mud (see Photos 32 and 33).

**General Remarks:** Both Wing Ballasts are coated in mud. Underneath the mud, the coatings appear to remain intact.

**Recommendations for Future:** No touch up currently needed. We recommend cleaning the No. 8 Wing Ballasts in the future, so that a better assessment of the coatings can be completed. Continue to inspect the No. 8 Port and Starboard Wing Ballasts on an annual basis.

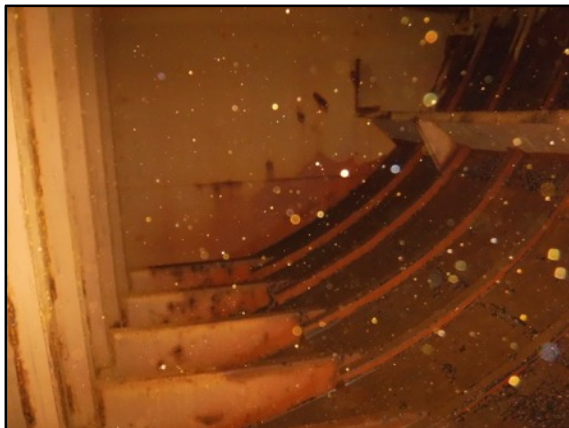
**Photo 34: No. 9 Port Wing Void**

**Existing Coating System:** The existing coating appears to be a red epoxy system, but it is very difficult to see underneath the dirt and mud (see Photos 34 & 35).

**General Remarks:** Both wing voids are very dirty, but coating appears to remain intact underneath.

**Recommendations for Future:** No touch up is currently needed. We recommend cleaning the No. 9 Wing Voids in the future, so that a better assessment of the coatings can be completed. Continue to inspect the No. 9 Port and Starboard Wing Voids on an annual basis.

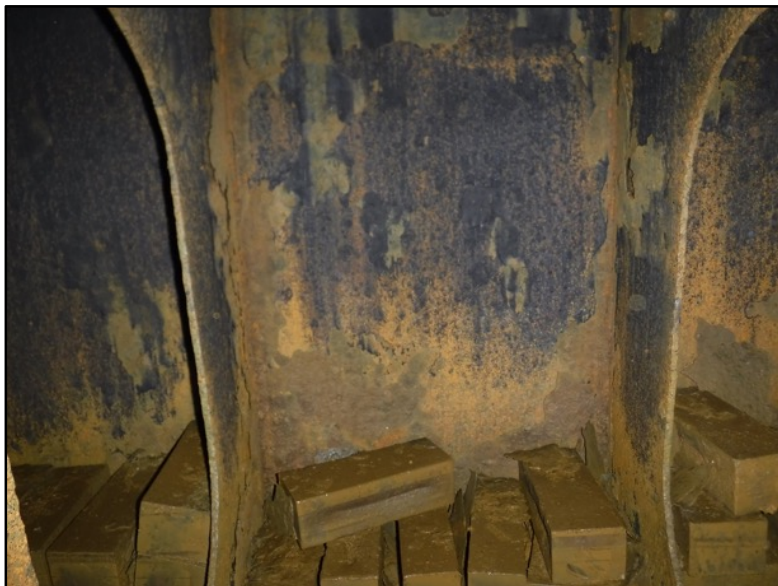
**Photo 36: Existing Coating System in No. 9 Double Bottom Ballast**

**Existing Coating System:** Appears to be a bitumastic coal tar underneath dirt and mud (see Photo 36).

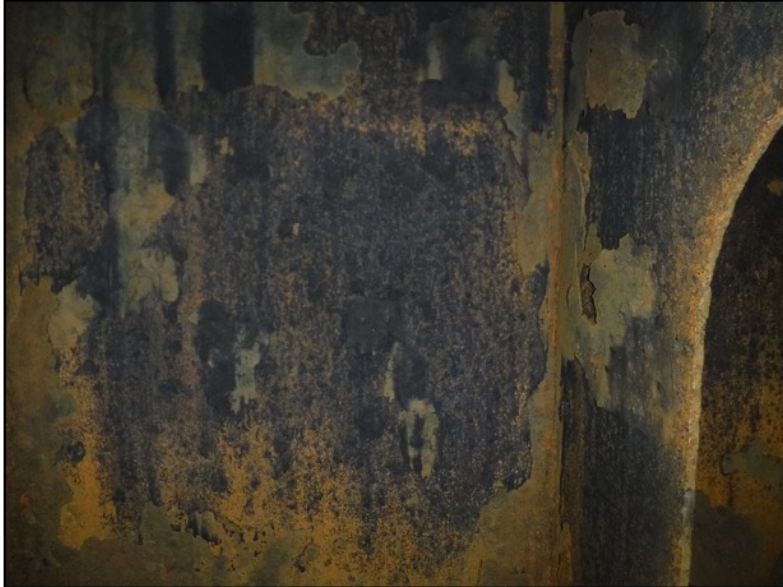
**General Remarks:** The No. 9 Double Bottom Ballast is extremely dirty and caked with mud. There are spots throughout the double bottom where the coating appears to be delaminating (see Photo 37). In order to get a good look at the condition of the coating, these areas would need to be cleaned.

**Photo 37: Coating Delamination Spots**

**Recommendations for Future:** We recommend cleaning the No. 9 Double Bottom Ballast in the near future, so that a better assessment of the coatings can be completed. Continue to inspect on an annual basis.

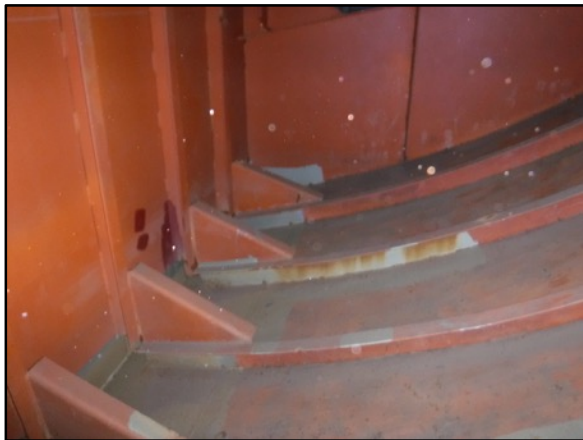
**Photo 38: No. 10 Port Void**

**Existing Coating System:** Appears to be a red epoxy system with Inteshield 300 touch up in lower sections of both voids (see Photos 38 and 39).

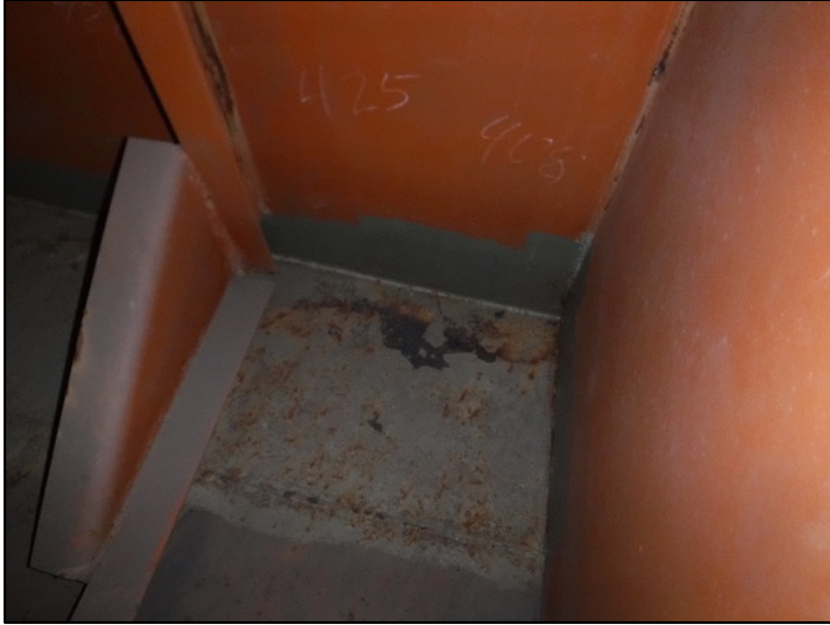
**General Remarks:** There is corrosion and delamination spots on the deck of the Cross Flood (see Photo 40). In addition, there is corrosion on the deck in the lower section of both voids, mostly near the forward bulkheads (see Photo 41). There is also a delamination spot in the lower

middle section of the No. 10 Starboard Void (see Photo 42). Otherwise, the coatings remain in satisfactory condition.

**Photo 42: Delamination Spot in Middle Lower Section of No. 10 Starboard Void**

**Recommendations for Future:** At the next availability, we recommend power cleaning (as per SSPC-SP 15) the corrosion areas on the deck of Cross Flood and corrosion/delamination spots in the lower section of the No. 10 Port and Starboard Voids. We then recommend that these areas be coated with two coats and a stripe coat of Intershield 300. Continue to inspect the No. 10 Port and Starboard Voids on an annual basis.

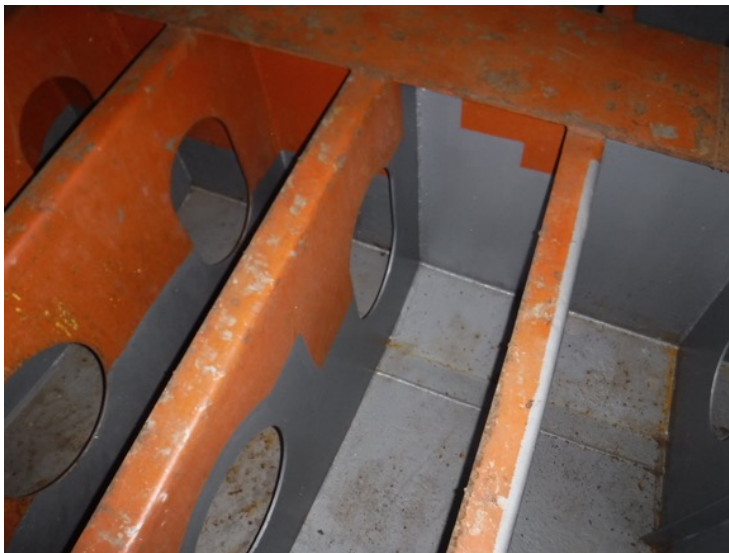
**Photo 43: No. 10 Center Line Void**

**Existing Coating System:** Unknown red epoxy system. The lower section has been touched up with what appears to be Inteshield 300 (see Photo 43).

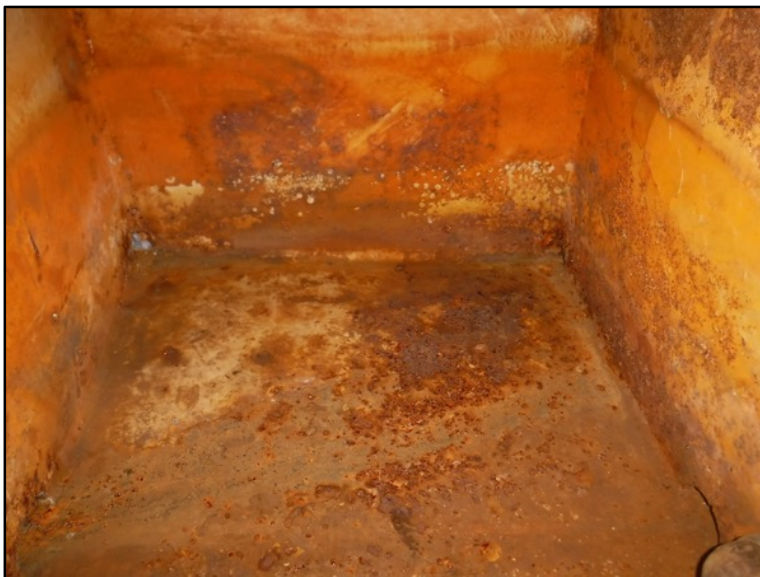
**General Remarks:** There are coating delamination spots and corrosion on the deck in the middle section (see Photo 44). There is also minor corrosion on the deck of the Cross Flood in

the forward section of the void (see Photo 45). Otherwise, the coatings in the void remain in satisfactory condition.

**Photo 45: Corrosion on Deck of Cross Flood**

**Recommendations for Future:** At the next availability, we recommend power tool cleaning (as per SSPC-SP 15) the corrosion/delamination areas on the deck in the middle section and corrosion areas on the deck of the Cross Flood in the forward section. The recommended coating system in these areas would be two coats and a stripe coat of Intershield 300. Continue to inspect the No. 10 Center Line Void on an annual basis.

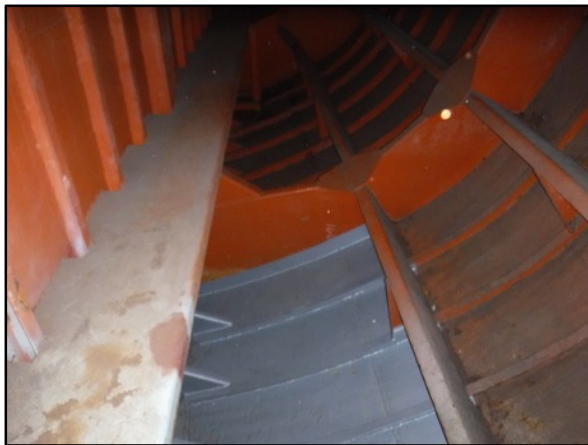
**Existing Coating System:** Unknown red and light blue coating. Touch up has been done with what appears to be Intershield 300 in the lower forward sections of both voids (see Photos 46 and 47).

**Photo 46: No. 11 Port Void**

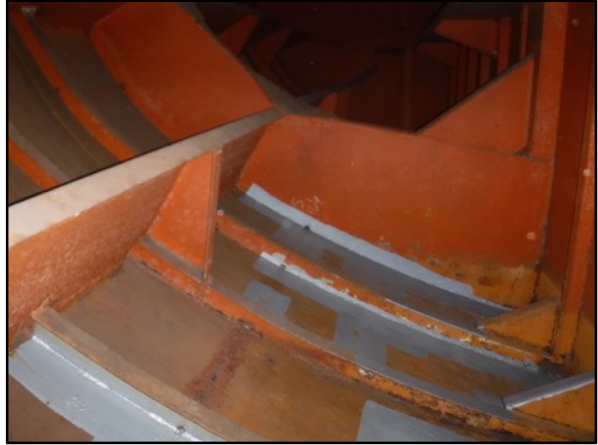
**Photo 47: No. 11 Starboard Void**

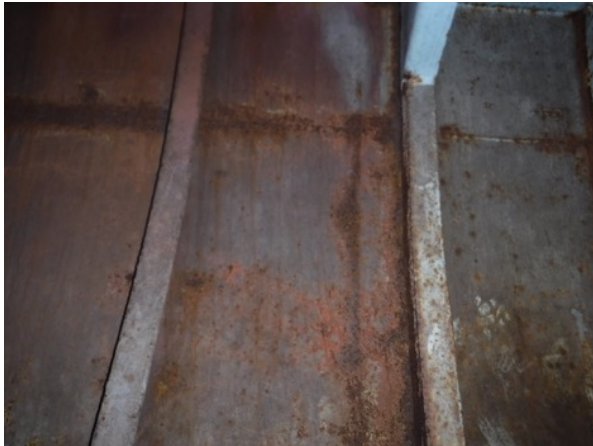
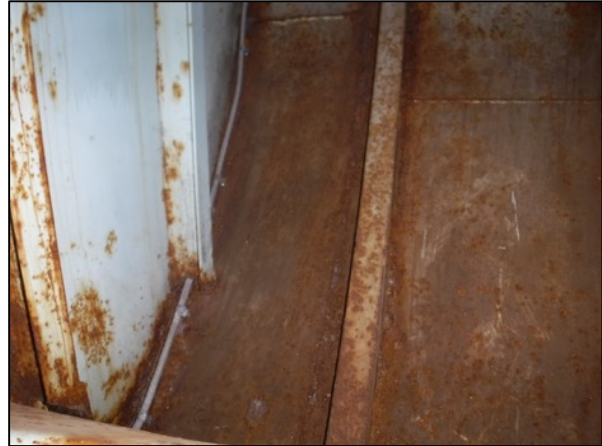
**General Remarks:** There is corrosion on the welds of the skin plate in both voids, above the touch up areas in the forward sections (see Photos 48 and 49). In addition, there is corrosion in the lowest section of both voids, in the middle and aft sections (see Photos 50 and 51). Finally, there is corrosion on the deck of the Cross Flood (see Photo 52).

**Photos 48 & 49: Corrosion on Skin Plate in Forward Section of Both Voids**

**Recommendations for Future:** At next availability, we recommend power tool cleaning (as per SSPC-SP 15) corrosion areas on the skin plate in the forward section of the No. 11 Port & Starboard Voids and coating with two coats and a stripe coat of Intershield 300 epoxy. We also recommend that corrosion areas in the lower aft and middle sections of both voids, near the center line bulkhead, and corrosion areas on the deck of the Cross Flood be power tool cleaned (as per SSPC-SP 15) and touched up with two coats and a stripe coat of Intershield 300 at the next availability. Continue to inspect the No. 11 Port and Starboard Voids on an annual basis.

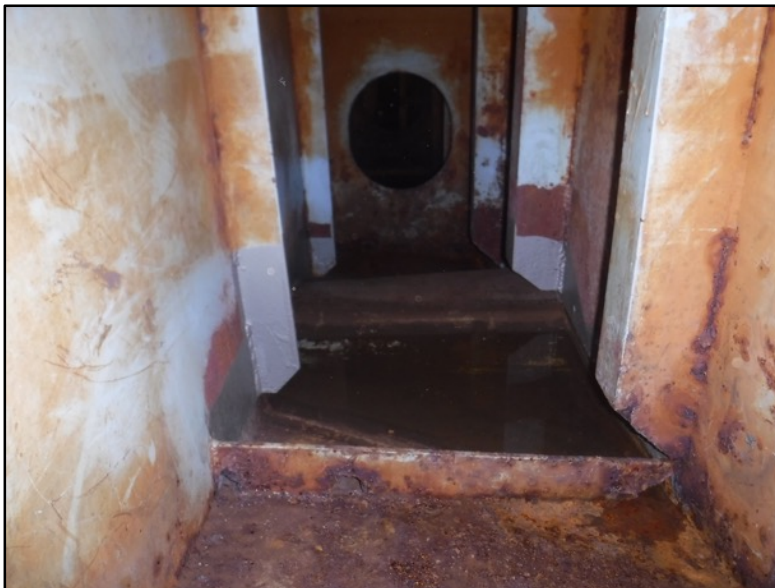
**Photo 52: Corrosion on Deck of Cross Flood**

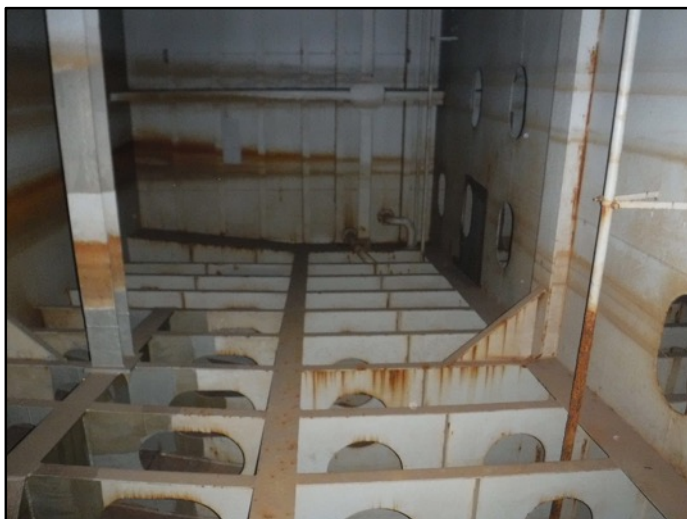
**Existing Coating System:** Unknown off white epoxy. Touch up has been done with what appears to be Intershield 300 epoxy (see Photo 53).

**Photo 53: Existing Coating System in No. 11 Center Line Ballast**

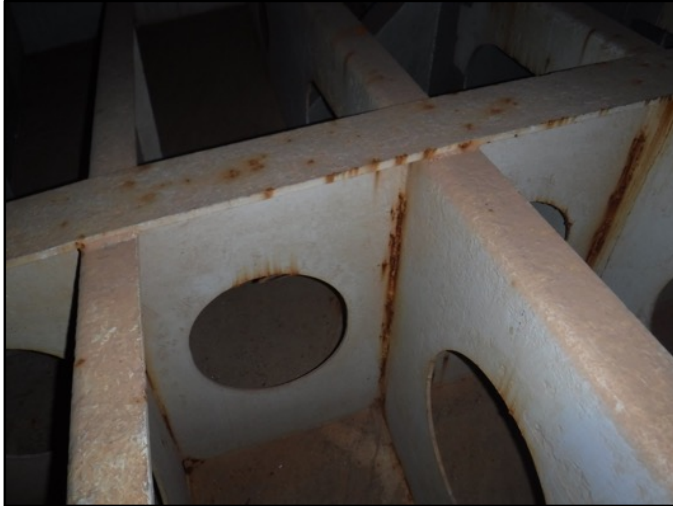
**General Remarks:** Overall, the coatings in the No. 11 Center Line Ballast remain in satisfactory condition. It is dirty on the deck and there is some minor corrosion on skip welds in the lower section (see Photo 54).

**Photo 54: Minor Corrosion on Welds in Lower Section**

**Recommendations for Future:** No touch up currently needed. Continue to inspect the No. 11 Center Line Ballast on an annual basis with special attention on the welds in the lower section.

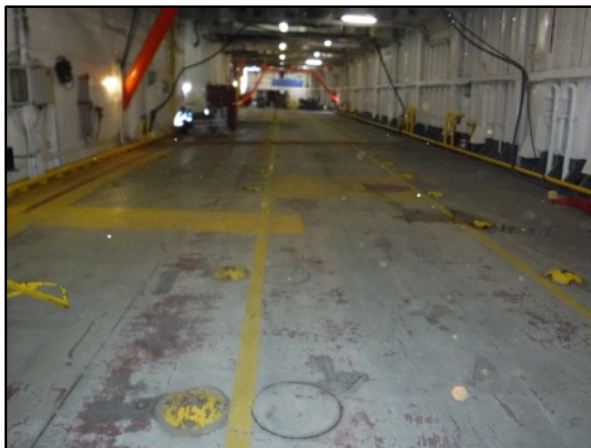
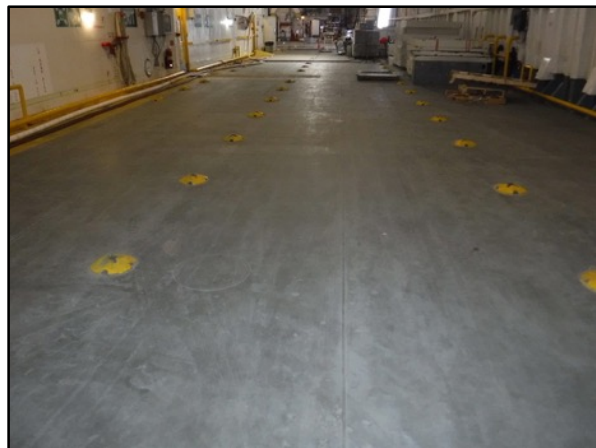
**Photos 55 & 56: Car Deck**

**Existing Coating System:** The Car Deck was most likely originally coated in Interzinc 52 zinc rich epoxy. It appears that touch up has been done over the years with Interlac 665 alkyd enamel (see Photos 55 and 56). The Superstructure and Superstructure Decks were originally topcoated with Interthane 990. They are maintained by the crew using Corroseal and Interlac 665 alkyd enamel.

**General Remarks:** Coatings have worn down on many areas of the Car Deck. The coatings on the superstructure have been well maintained by the crew (see Photos 57-60). As is common,

**Recommendations for Future:** No touch up currently needed. Crew should continue to maintain areas on the Car Deck and Superstructure.

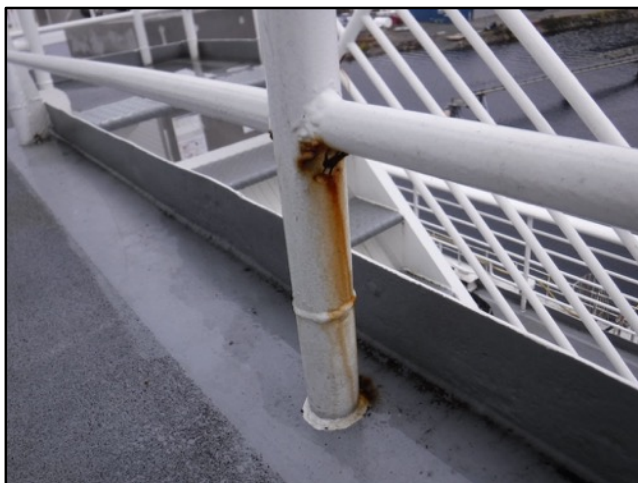
there are some minor corrosion spots on handrails (see Photo 61) and around door/window frames on the Superstructure.

**Photo 61: Corrosion on Handrail**

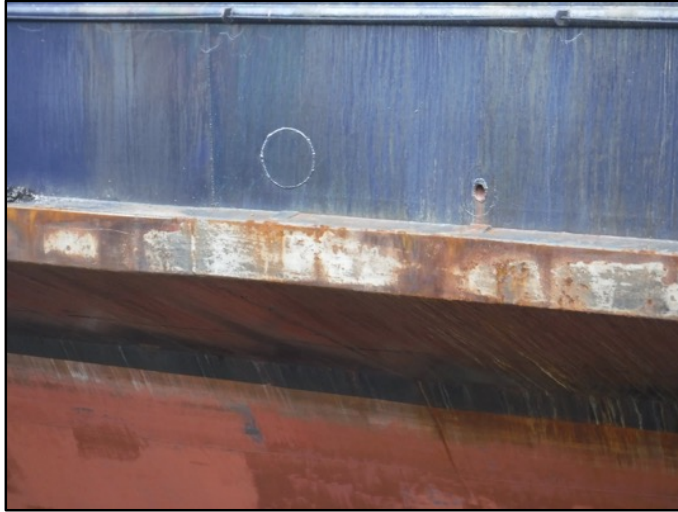
**General Remarks:** The coatings on the rub rails have worn down and there is some minor corrosion (see Photo 64). As is common, there is some rust bleeding under the vents and drains (see Photo 65), and corrosion spots around the anchors. Otherwise, the coatings on the freeboard remain in satisfactory condition.

**Photo 64: Corrosion on Rub Rails**

**Recommendations for Future:** No touch up currently needed. The rub rails will most likely need to be touched up in the next 1-2 years. Continue to inspect the Freeboard on an annual basis.

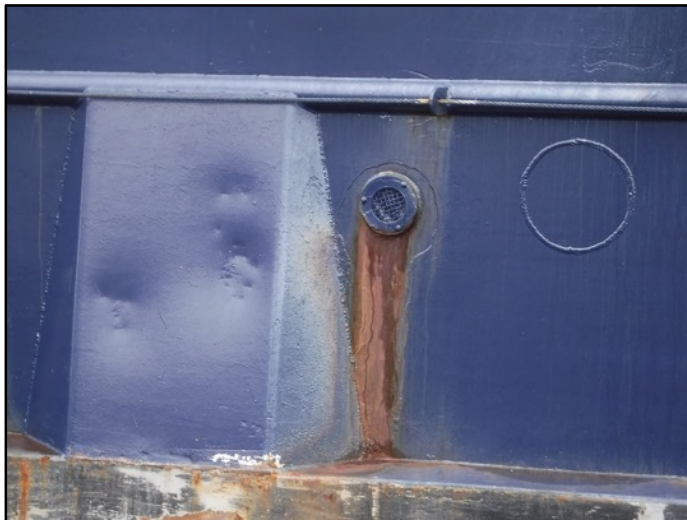
**Photo 65: Rust Bleed Under Vents & Drains**

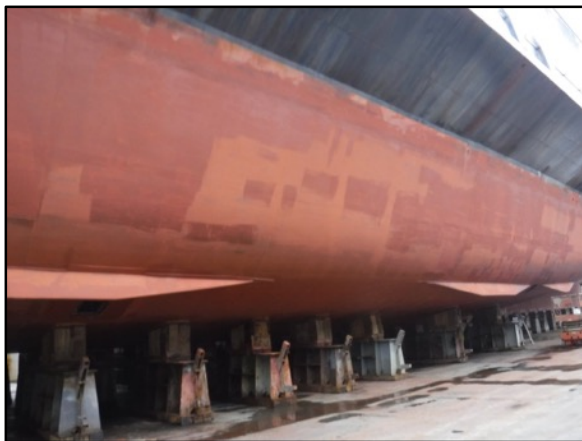
**Existing Coating System:** Appears to be two coats of epoxy and two coats of Antifouling (most likely Intershield 300 epoxy and Interspeed 640 AF). The top coat of AF is red (see Photos 66 and 67).

**Photo 66: Port Side Underwater Hull**

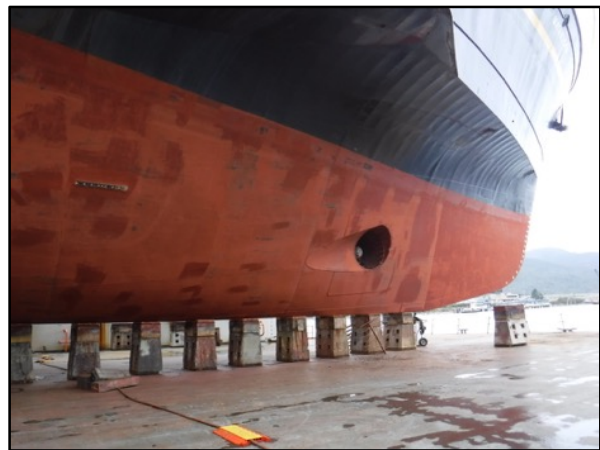
**Photo 67: Starboard Side Underwater Hull**

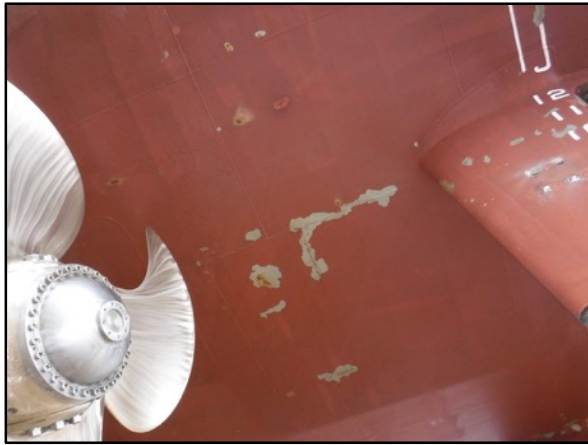
**General Remarks:** Overall, the coatings on the Underwater Hull remain in satisfactory condition. The Black AF is showing through on less than 5 percent of the total area. There are

small AF delamination spots on the flat of the bottom, near the stern (see Photo 68) and on the rudders (see Photo 69).

**Photo 68: AF Delamination Spots Near Stern**

**Recommendations for Future:** At the next availability, we recommend that AF delamination areas are power tool cleaned as per SSPC-SP 3 and coated with one spot coat of Interhield 300 epoxy and two spot coat of Interspeed 640 AF. Continue to inspect the Underwater Hull on an annual basis.

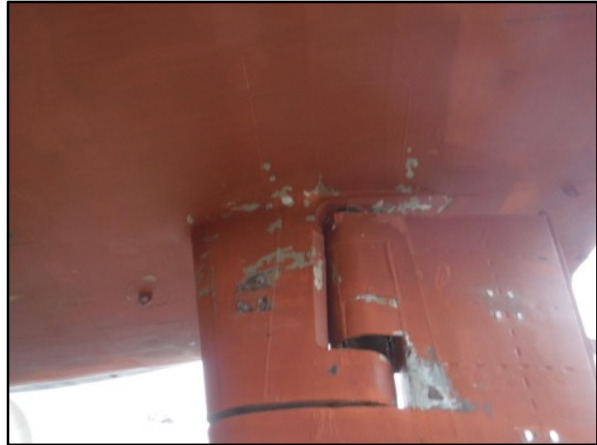
**Photo 69: AF Delamination Spots on Rudders**
