## Geotechnical Findings Report

November 3, 2025

Re: Geotechnical Findings Report – Healy, Center Pit

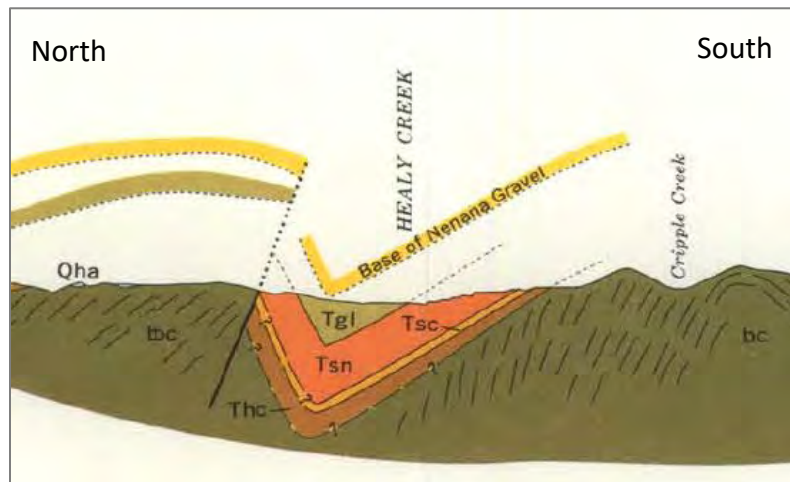
Figure 4: Geologic cross section near Cripple Creek (modified after Wahrhaftig, 1970).

Tertiary rocks in the Healy Creek valley are bounded to the north by a steeply dipping fault which up-thrust Birch Creek Schist north of the fault. The axis of a syncline parallels the fault to the south. Beds south of the fold dip 25 to 40° to the north and beds north of the fold dip 65 to 90° south (Wahrhaftig, 1944, see Figure 4). The coal seam exposed in the northern slope of Center Pit dips approximately 40° towards the northwest.
