MARTIN ENGINEERING, INC.
1985 Gilmore Trail
Fairbanks, AK 99712

24 March 2026

Re: Alaska Army National Guard Readiness Center –
Structural Evaluation of Fire Damaged Concrete Walls
202 Wien Street
Fairbanks, Alaska 99701

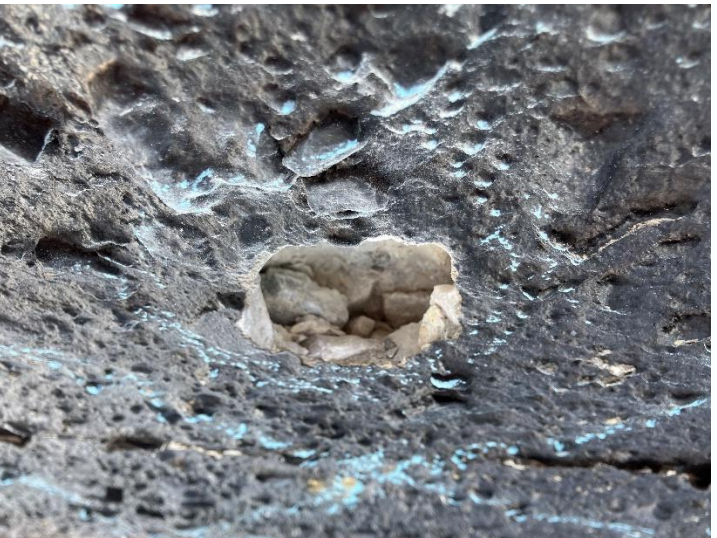
Inside Face Wall 'A'

MEI tested the outside face of the damaged walls 'A' and 'B', the inside and outside faces of the bracketing columns and the inside face of wall 'B'. The inside face of wall 'A' was mostly covered by insulation and was not accessible for testing. MEI also tested wall panels on the West walls that were constructed in the same way as walls 'A' and 'B' but were not subjected to any fire damage.
