# **APPENDIX A**

## **Asbestos Bulk Sample Field Survey Data Sheets and Laboratory Reports**

### **Drawings of Sample Locations**

VETERANS & PIONEERS HOME  
PALMER, ALASKA  
ASBESTOS SAMPLE LOCATIONS

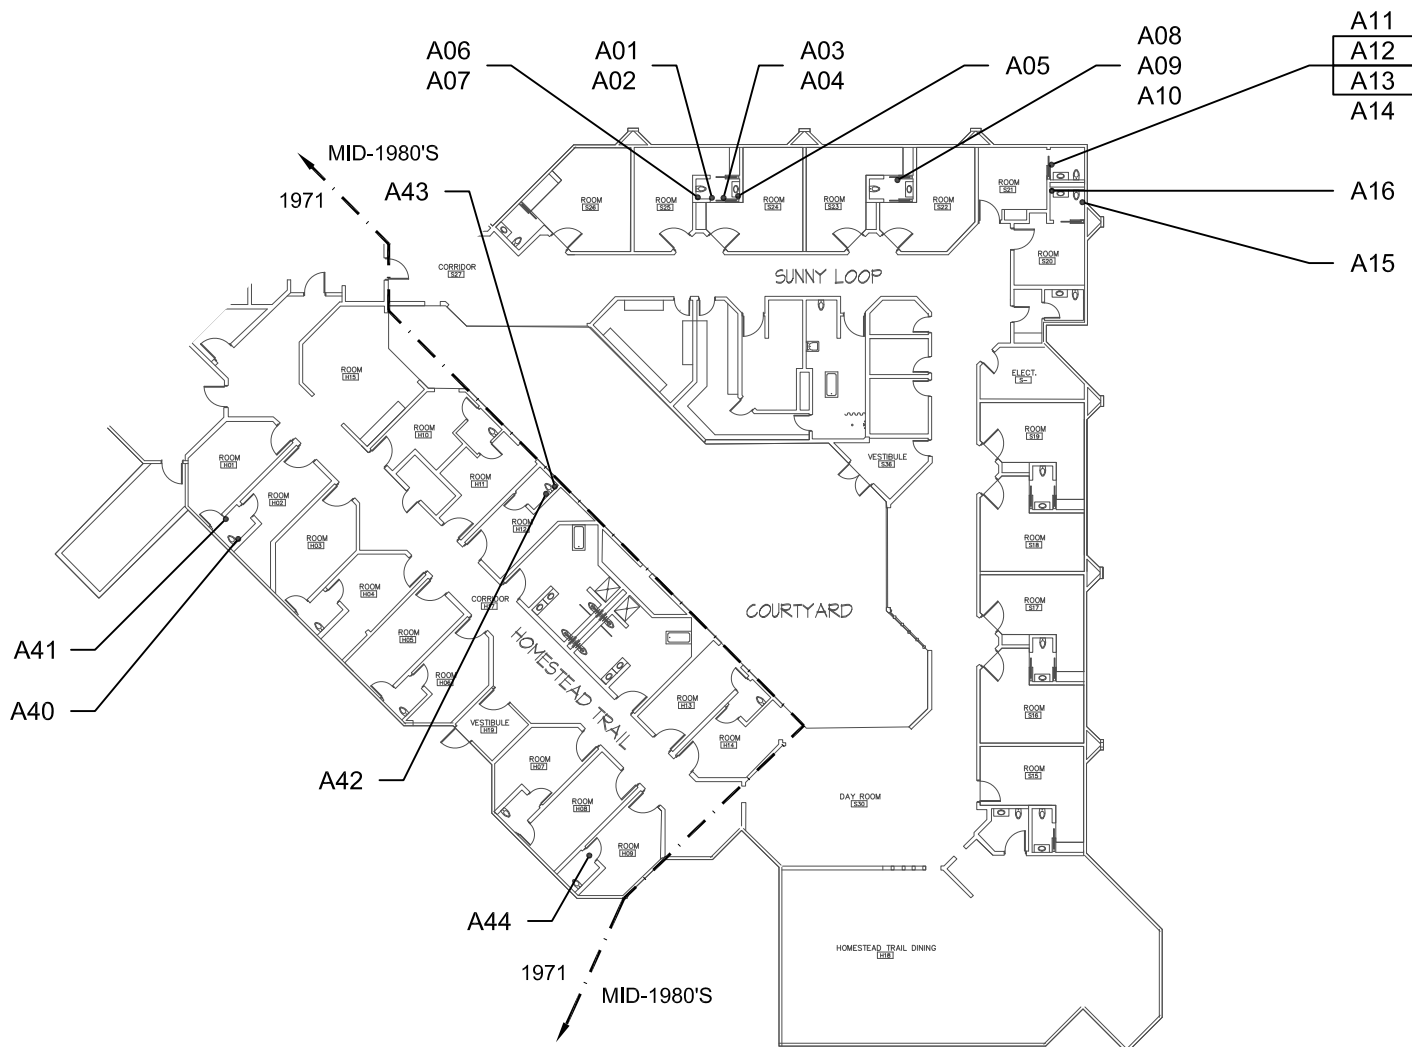
1  
C-1

SUNNY LOOP & HOMESTEAD TRAIL  
NTS

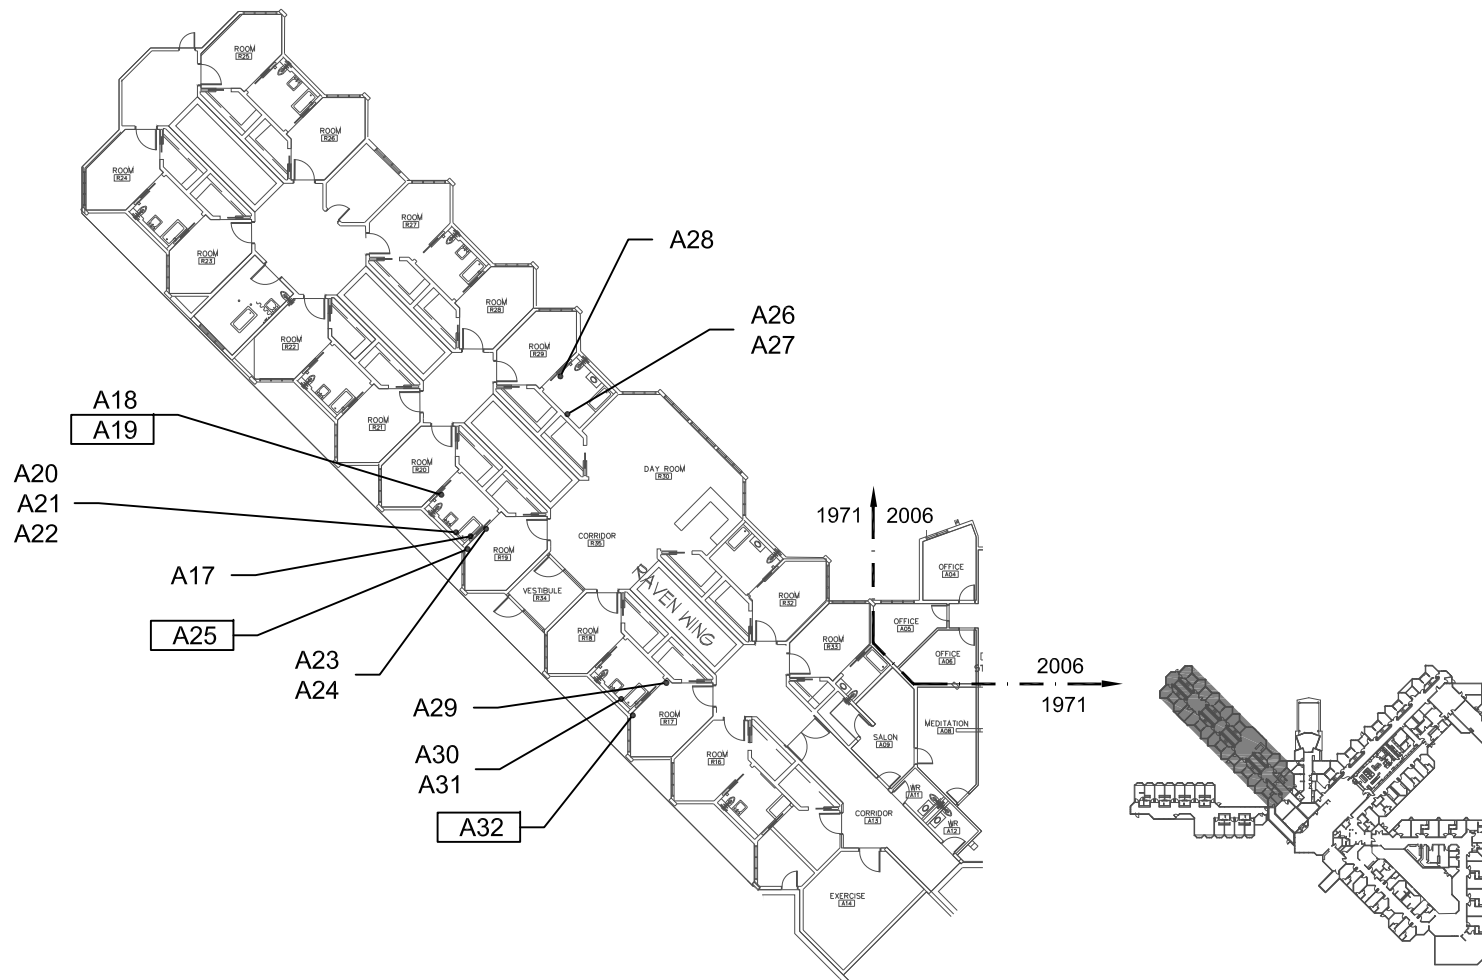
1  
C-2

RAVEN WING  
NTS

VETERANS & PIONEERS HOME  
PALMER, ALASKA  
ASBESTOS SAMPLE LOCATIONS

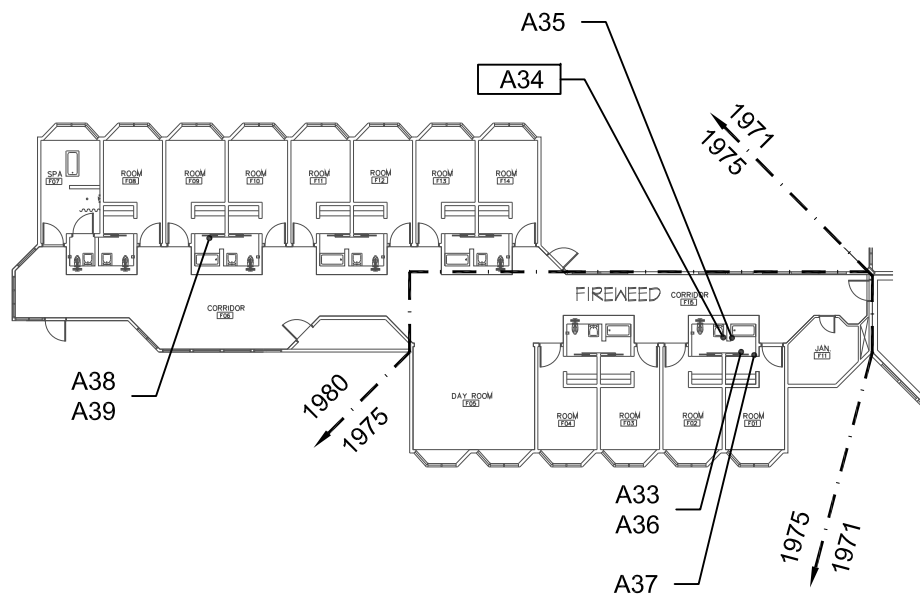
1  
C-3

FIREWEED WING  
NTS

VETERANS & PIONEERS HOME  
PALMER, ALASKA  
ASBESTOS SAMPLE LOCATIONS

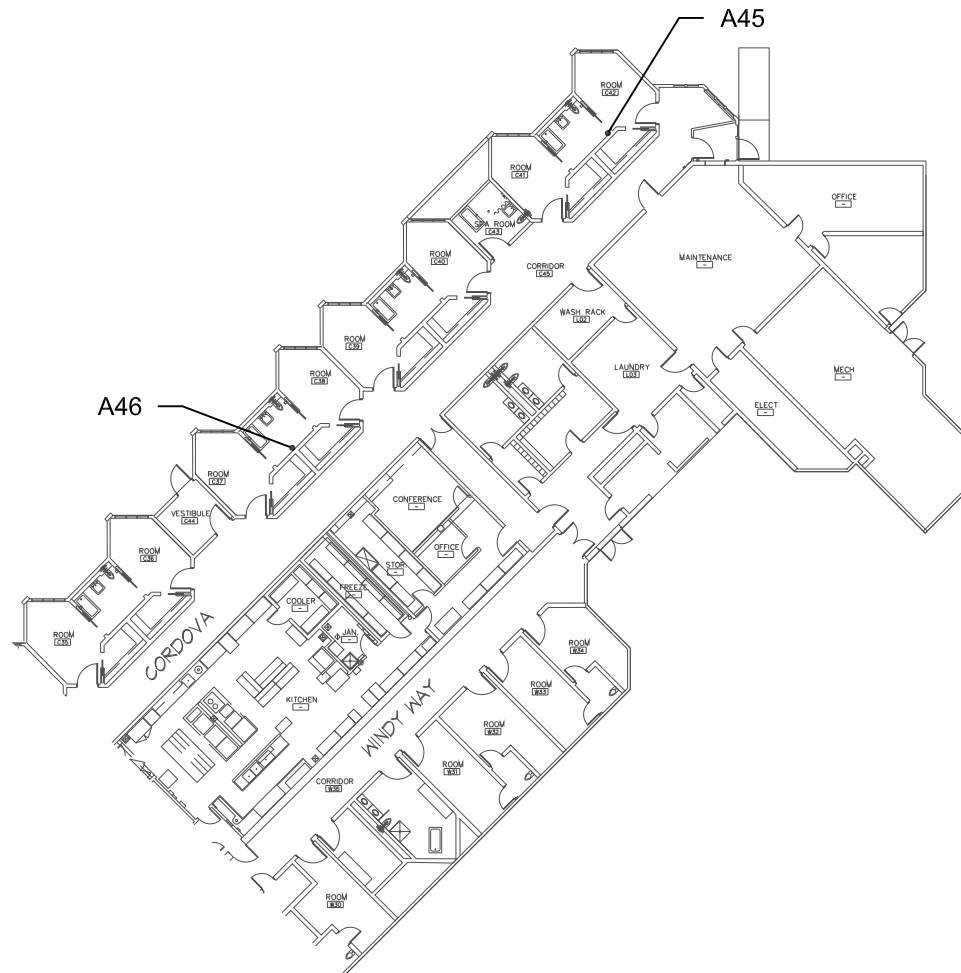
1  
C-4

CORDOVA WING  
NTS

VETERANS & PIONEERS HOME  
PALMER, ALASKA  
ASBESTOS SAMPLE LOCATIONS

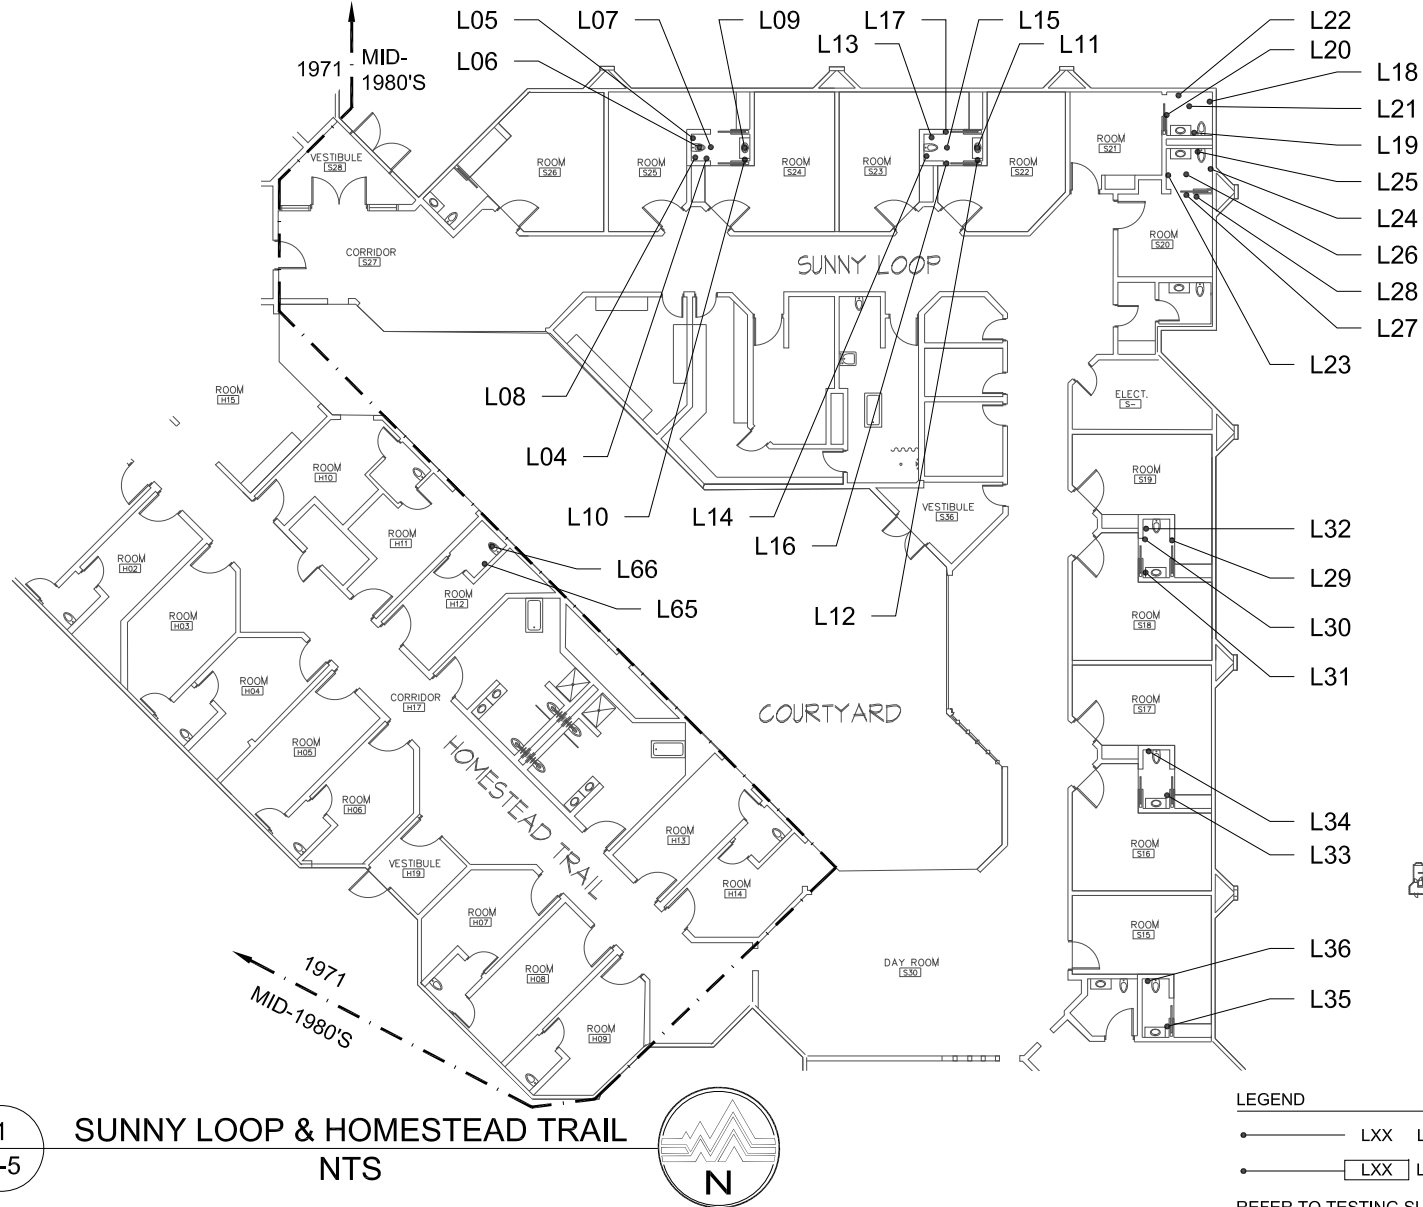
1  
C-5

SUNNY LOOP & HOMESTEAD TRAIL  
NTS

VETERANS & PIONEERS HOME  
PALMER, ALASKA  
LEAD SAMPLE LOCATIONS

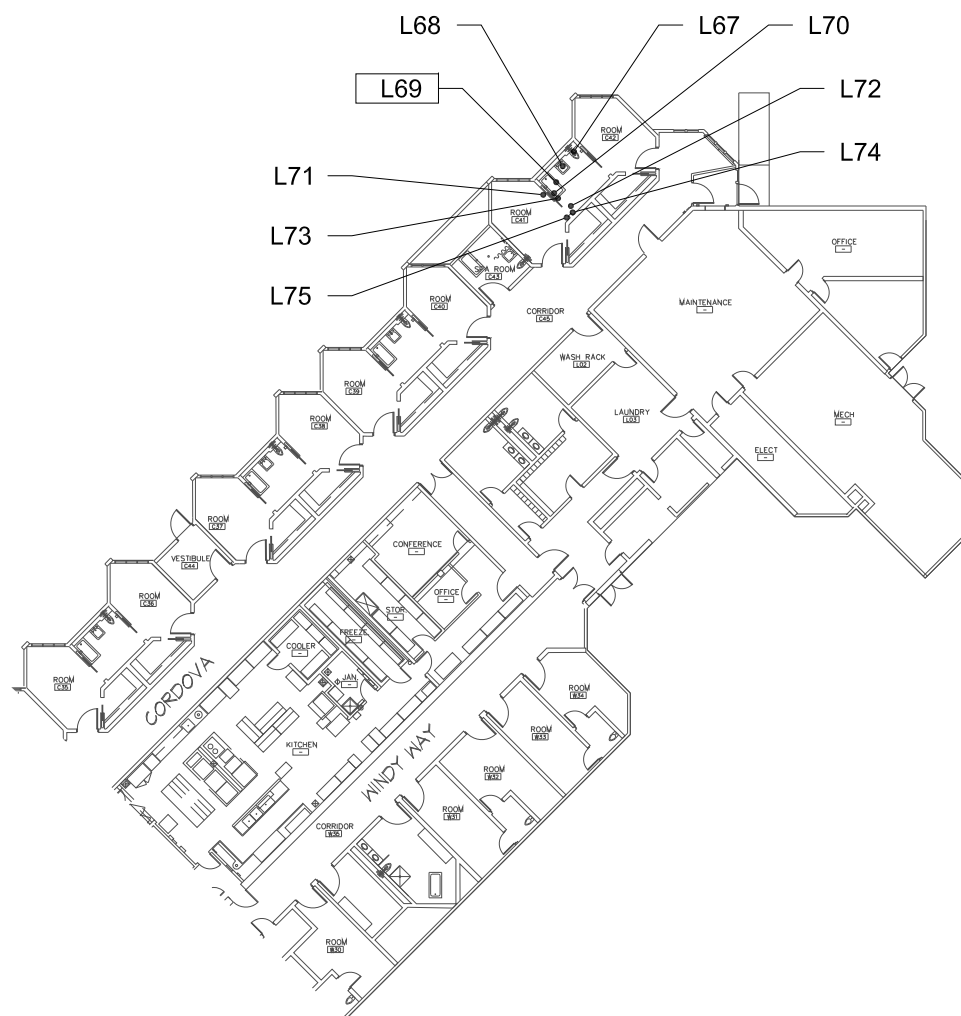
1  
C-8

CORDOVA WING  
NTS
