# Port Lions Airport Master Plan

Project No. 54746

HDR Alaska, Inc.  
2525 C Street, Suite 305  
Anchorage, AK 99503-2569

March 2007

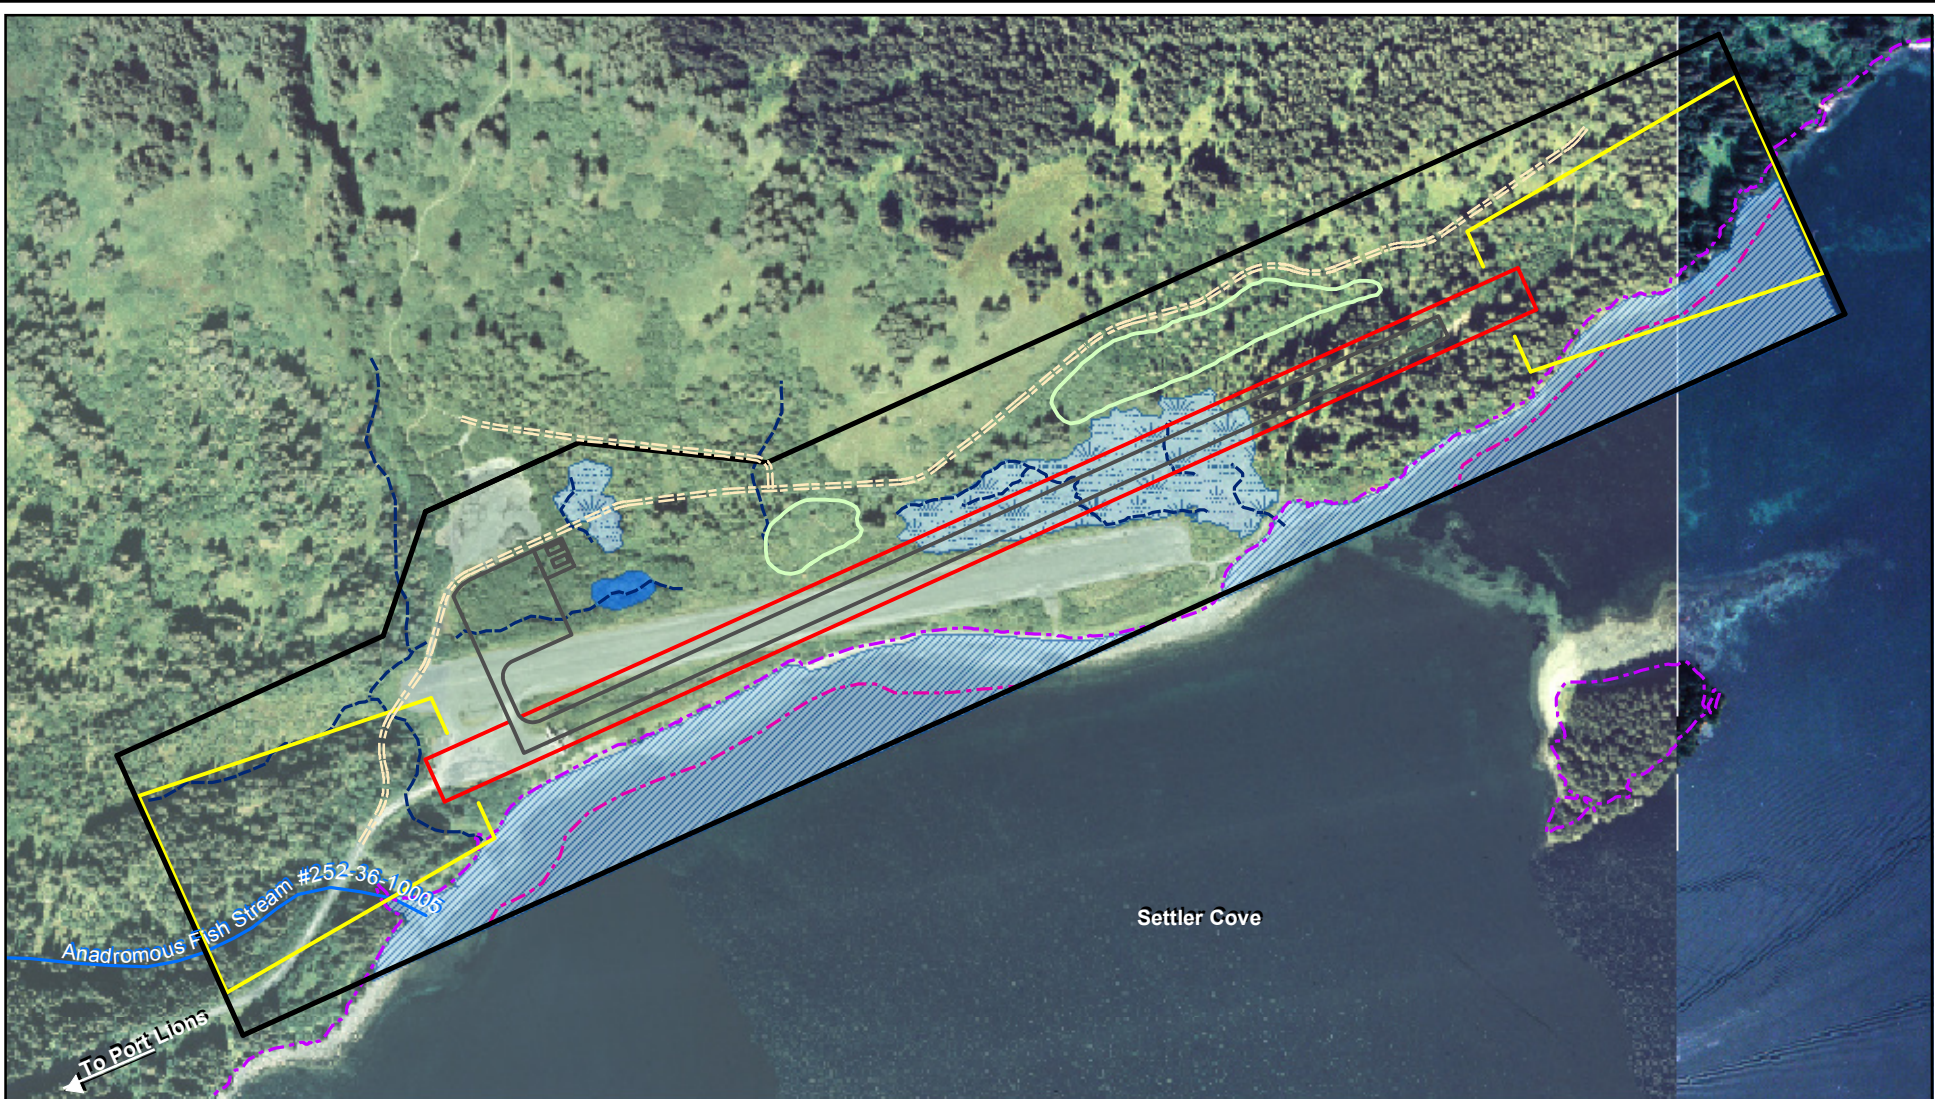
**Port Lions Airport Master Plan  
Environmental Assessment  
Wetlands and Waterbodies**

Numerous small wetlands are found near the shoreline in the upper cove area within Port Lions. Figure 1-3 displays the identified wetlands in the project area. The following wetlands have been identified in the project area from current National Wetlands Inventory (NWI) mapping:

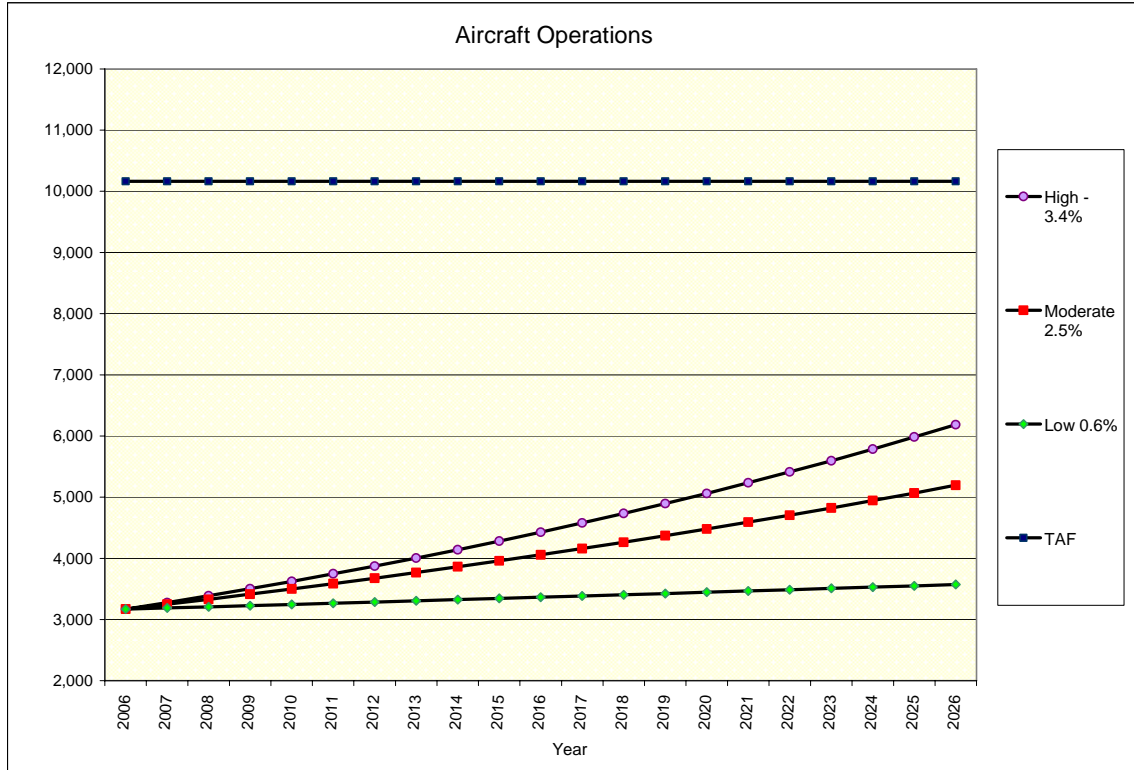
Figure 2-1  
Aircraft Operations Forecast  
Port Lions Airport

Year	Low	Moderate	High	TAF
2006	3,170	3,170	3,170	10,162
2007	3,278	3,249	3,189	10,162
2008	3,389	3,330	3,208	10,162
2009	3,504	3,414	3,227	10,162
2010	3,624	3,499	3,247	10,162
2011	3,747	3,587	3,266	10,162
2012	3,874	3,676	3,286	10,162
2013	4,006	3,768	3,306	10,162
2014	4,142	3,862	3,325	10,162
2015	4,283	3,959	3,345	10,162
2016	4,429	4,058	3,365	10,162
2017	4,579	4,159	3,386	10,162
2018	4,735	4,263	3,406	10,162
2019	4,896	4,370	3,426	10,162
2020	5,062	4,479	3,447	10,162
2021	5,234	4,591	3,468	10,162
2022	5,412	4,706	3,488	10,162
2023	5,596	4,824	3,509	10,162
2024	5,787	4,944	3,530	10,162
2025	5,983	5,068	3,552	10,162
2026	6,187	5,194	3,573	10,162

This section presents three scenarios of air traffic forecasts for aircraft operations, passenger enplanements, and cargo for the Port Lions airport (Figures 2-1 through 2-3). The three forecast scenarios use the base year (2006) estimate for aircraft operations and enplanements, and the 2005 cargo summary from Bureau of Transportation Statistics (BTS).

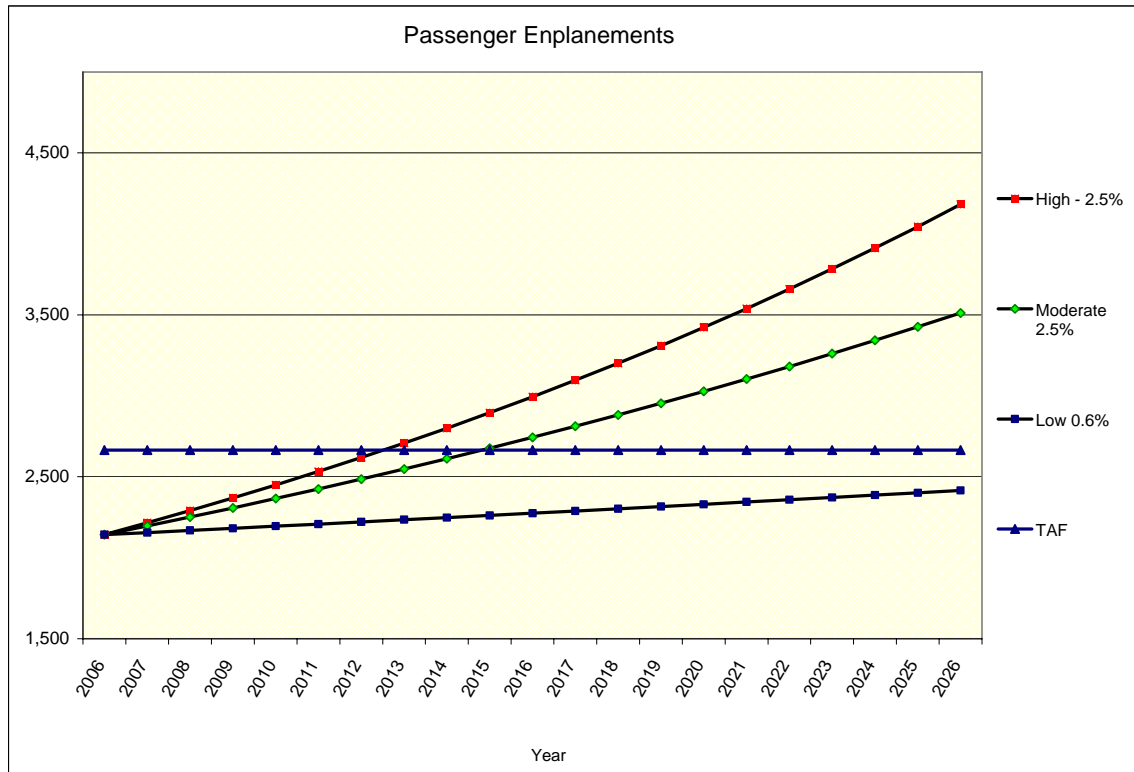
Figure 2-2  
 Passenger Enplanements Forecast  
 Port Lions Airport

Year	Low	Moderate	High	TAF
2006	2,143	2,143	2,143	2,665
2007	2,216	2,197	2,156	2,665
2008	2,291	2,251	2,169	2,665
2009	2,369	2,308	2,182	2,665
2010	2,450	2,365	2,195	2,665
2011	2,533	2,425	2,208	2,665
2012	2,619	2,485	2,221	2,665
2013	2,708	2,547	2,235	2,665
2014	2,800	2,611	2,248	2,665
2015	2,895	2,676	2,262	2,665
2016	2,994	2,743	2,275	2,665
2017	3,096	2,812	2,289	2,665
2018	3,201	2,882	2,302	2,665
2019	3,310	2,954	2,316	2,665
2020	3,422	3,028	2,330	2,665
2021	3,539	3,104	2,344	2,665
2022	3,659	3,181	2,358	2,665
2023	3,783	3,261	2,372	2,665
2024	3,912	3,342	2,387	2,665
2025	4,045	3,426	2,401	2,665
2026	4,182	3,512	2,415	2,665

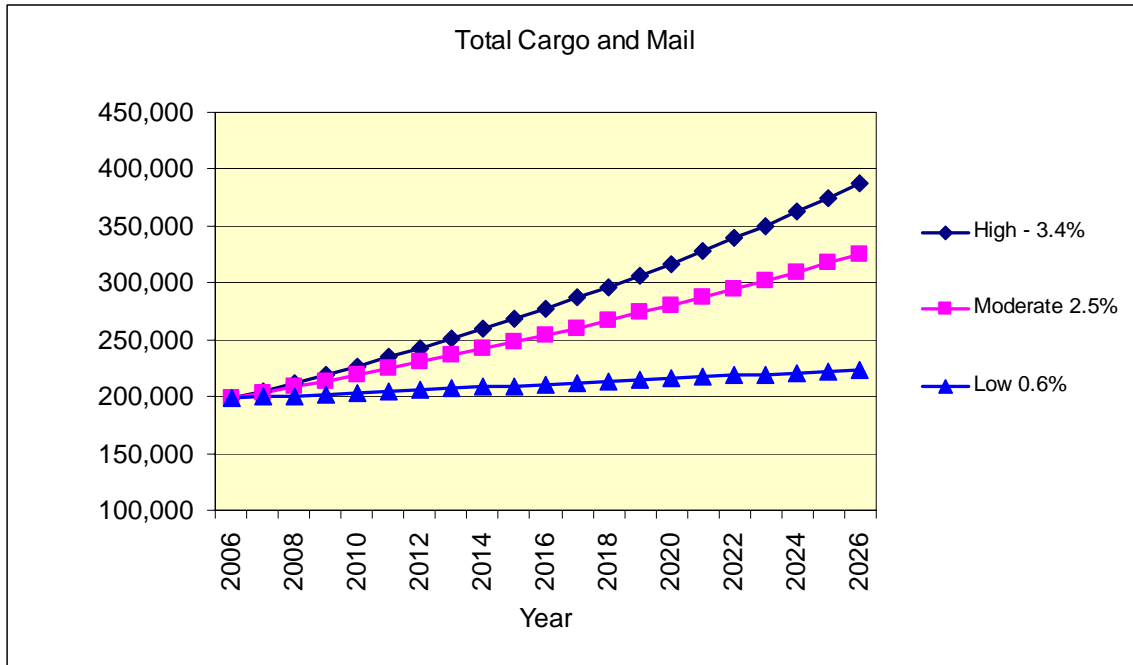
Figure 2-3  
Cargo Operations Forecast  
Port Lions Airport

Year	Low	Moderate	High
2006	198,519	198,519	198,519
2007	199,710	203,482	205,269
2008	200,908	208,569	212,248
2009	202,114	213,783	219,464
2010	203,327	219,128	226,926
2011	204,546	224,606	234,641
2012	205,774	230,221	242,619
2013	207,008	235,977	250,868
2014	208,250	241,876	259,398
2015	209,500	247,923	268,217
2016	210,757	254,121	277,337
2017	212,021	260,474	286,766
2018	213,294	266,986	296,516
2019	214,573	273,661	306,598
2020	215,861	280,502	317,022
2021	217,156	287,515	327,801
2022	218,459	294,703	338,946
2023	219,770	302,070	350,470
2024	221,088	309,622	362,386
2025	222,415	317,362	374,707
2026	223,749	325,296	387,447

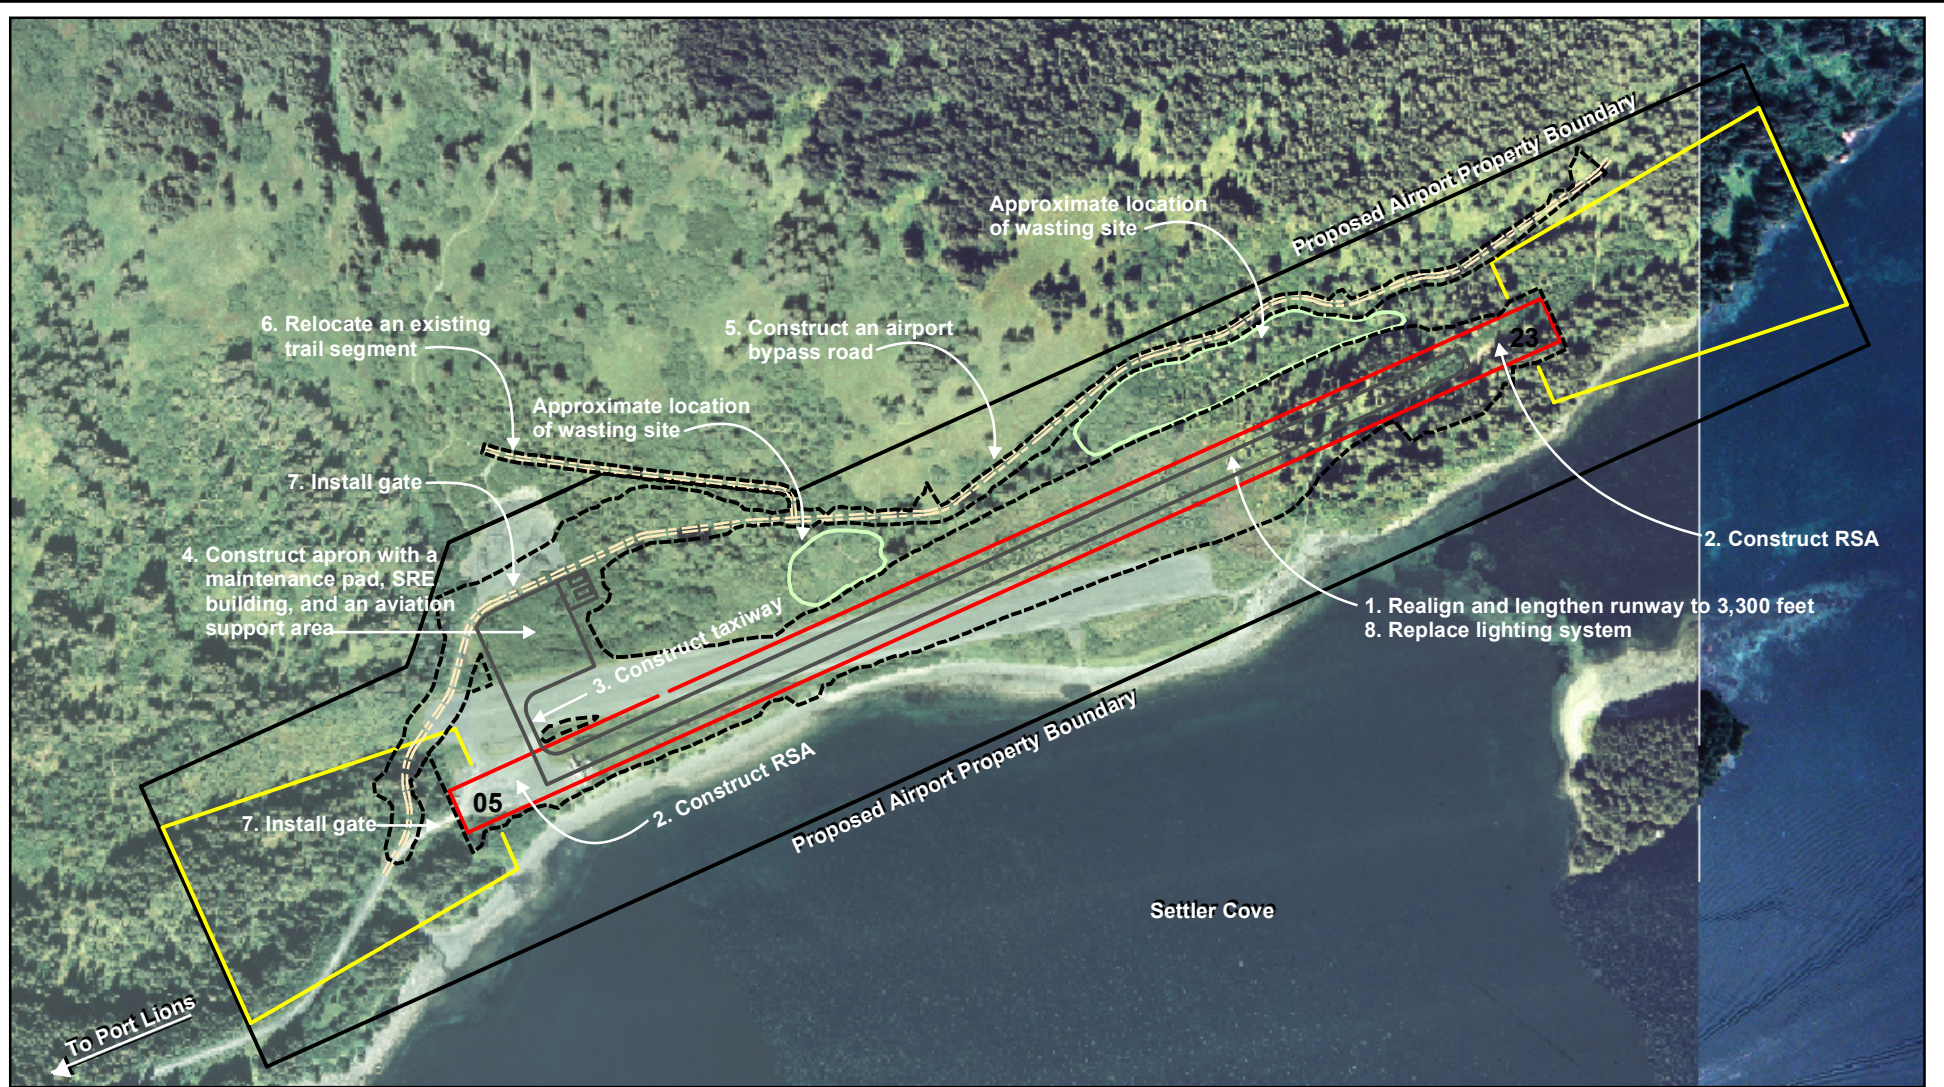
**Figure  
4.2**

# Port Lions Airport Master Plan Environmental Assessment Alternative 2 Runway Realignment

1. Realign runway and lengthen to 3,300 feet, but maintain runway width of 75 feet.
2. Construct a 300-foot by 150-foot runway safety area (RSA) beyond each runway end (Runway 05 and 23).
3. Construct a 212-foot long by 35-foot wide taxiway to provide adequate runway separation distance.
4. Construct an apron with a maintenance pad for a snow removal equipment building (SREB) and an aviation support area for potential lease lot development.
5. Construct a 0.95-mile airport bypass road on the north side of the airport to access areas to the east of Runway 23.
6. Construct a 1,100-foot trail to relocate an existing segment near the northwest end of the runway that will be eliminated through cut/fill activities.
7. Install a gate across airport access roads to limit unauthorized incursions onto airport property.
8. Replace lighting system.

Terrain on the approaches was also problematic. FAA guidance is contained in AC 5300-13, for siting the threshold to avoid terrain. The resulting analysis is shown on Figures 4-2, 4-3, and 4-4 and in the ALP. Terrain penetrations exist for the approaches to both ends of the proposed runway. The analysis found that this terrain penetration could be mitigated by installing Precision Approach Path Indicator (PAPI) lights on both ends of the runway as allowed in the AC. The PAPI will need to be set at a nominal 4° approach slope. The normal approach slope is 3°; however, the steeper 4° is allowed. The steeper approach slope can easily be flown by all of the aircraft anticipated to utilize this runway. A flight check by FAA is required to ensure there are no unanticipated issues.

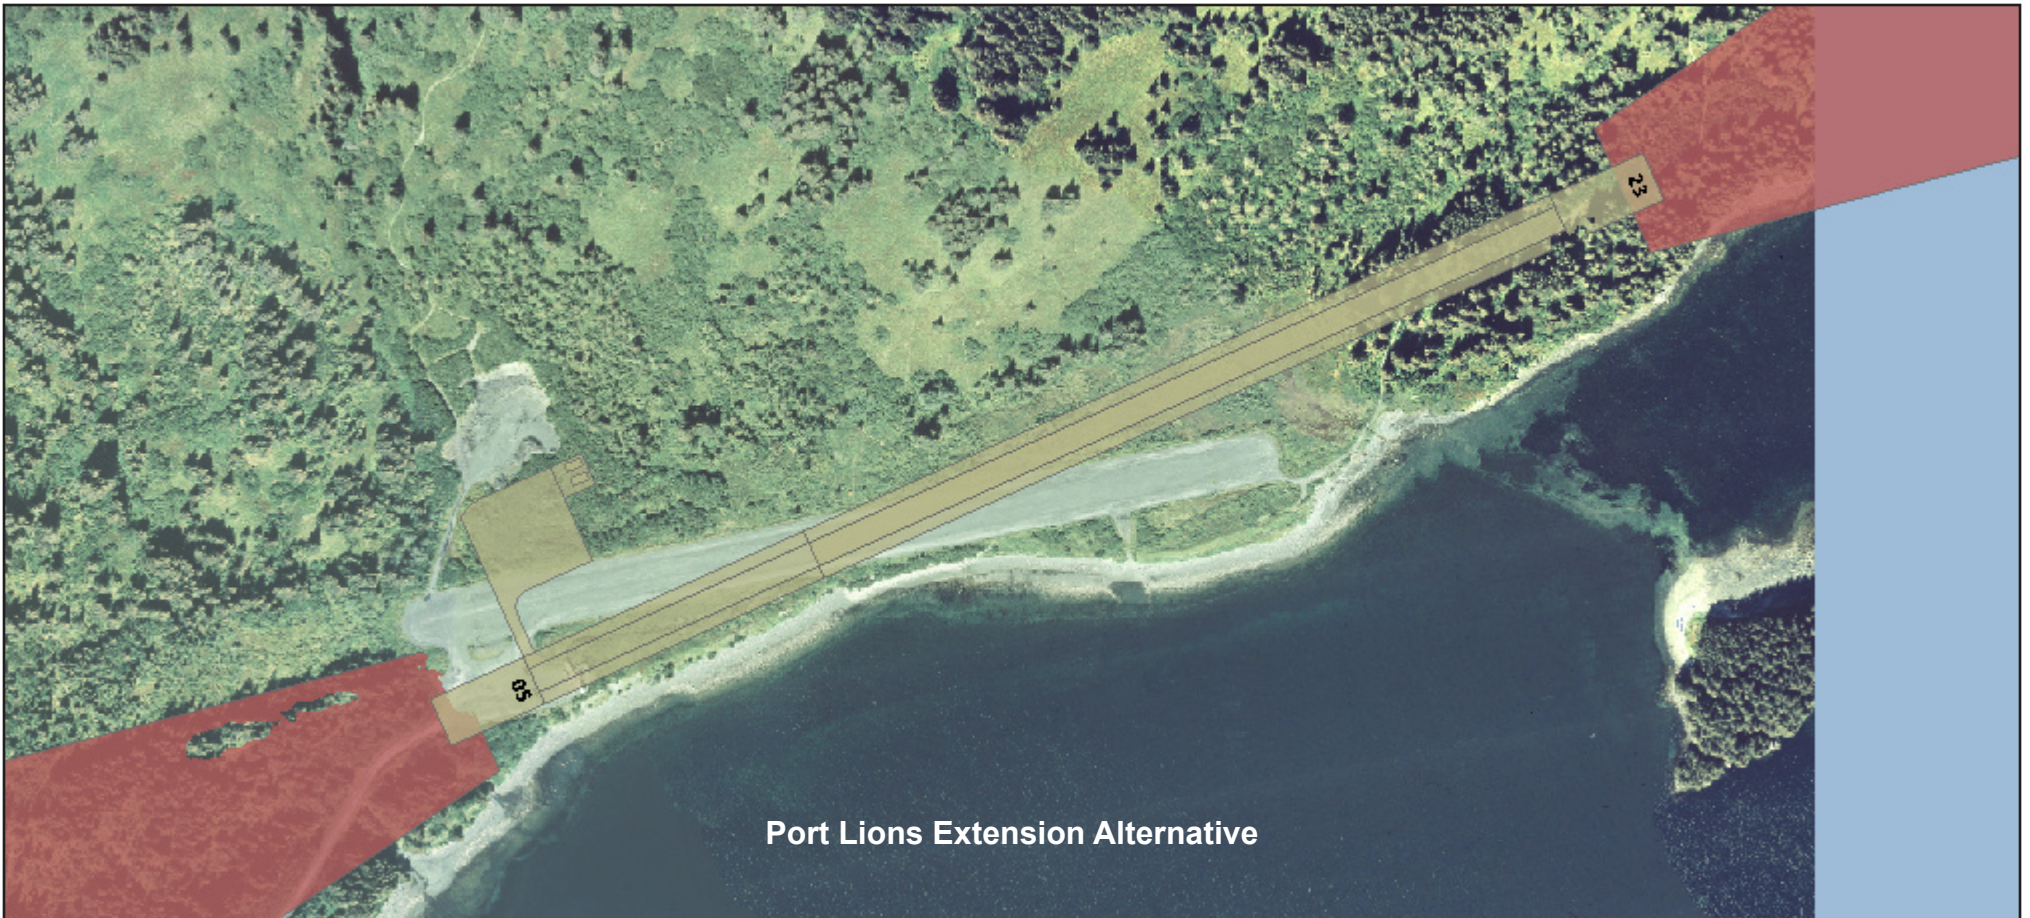
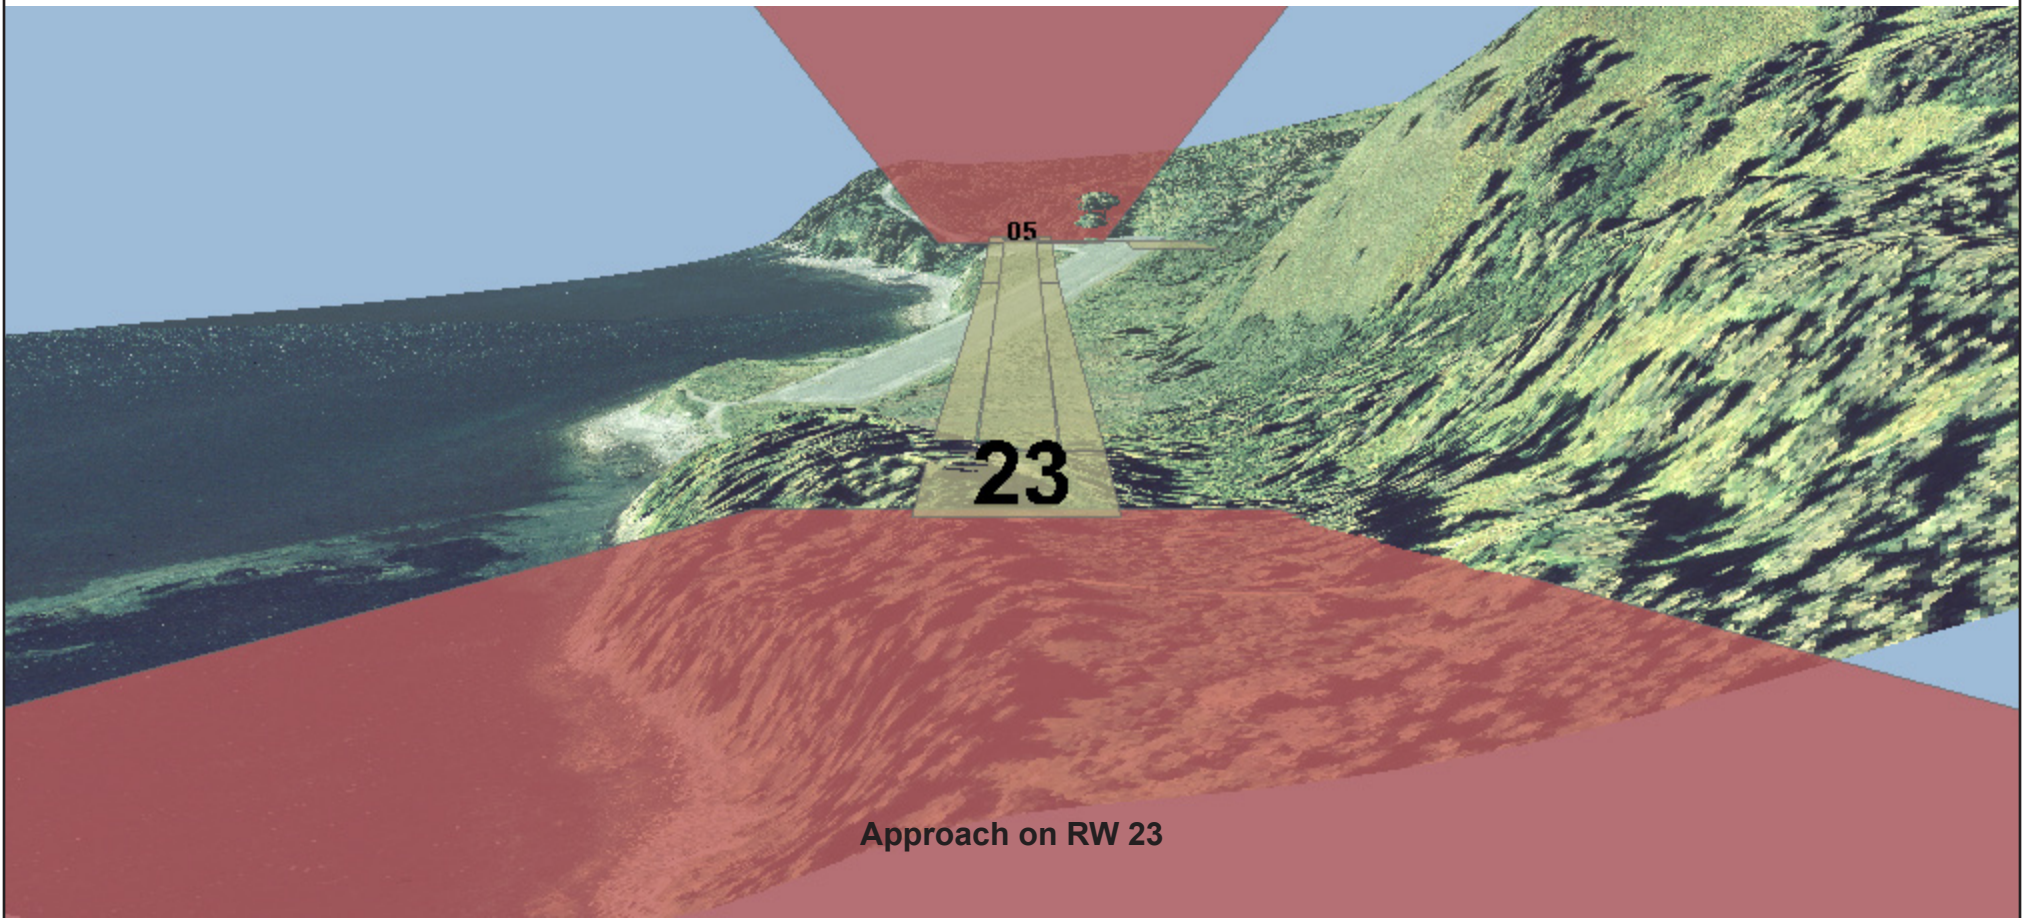
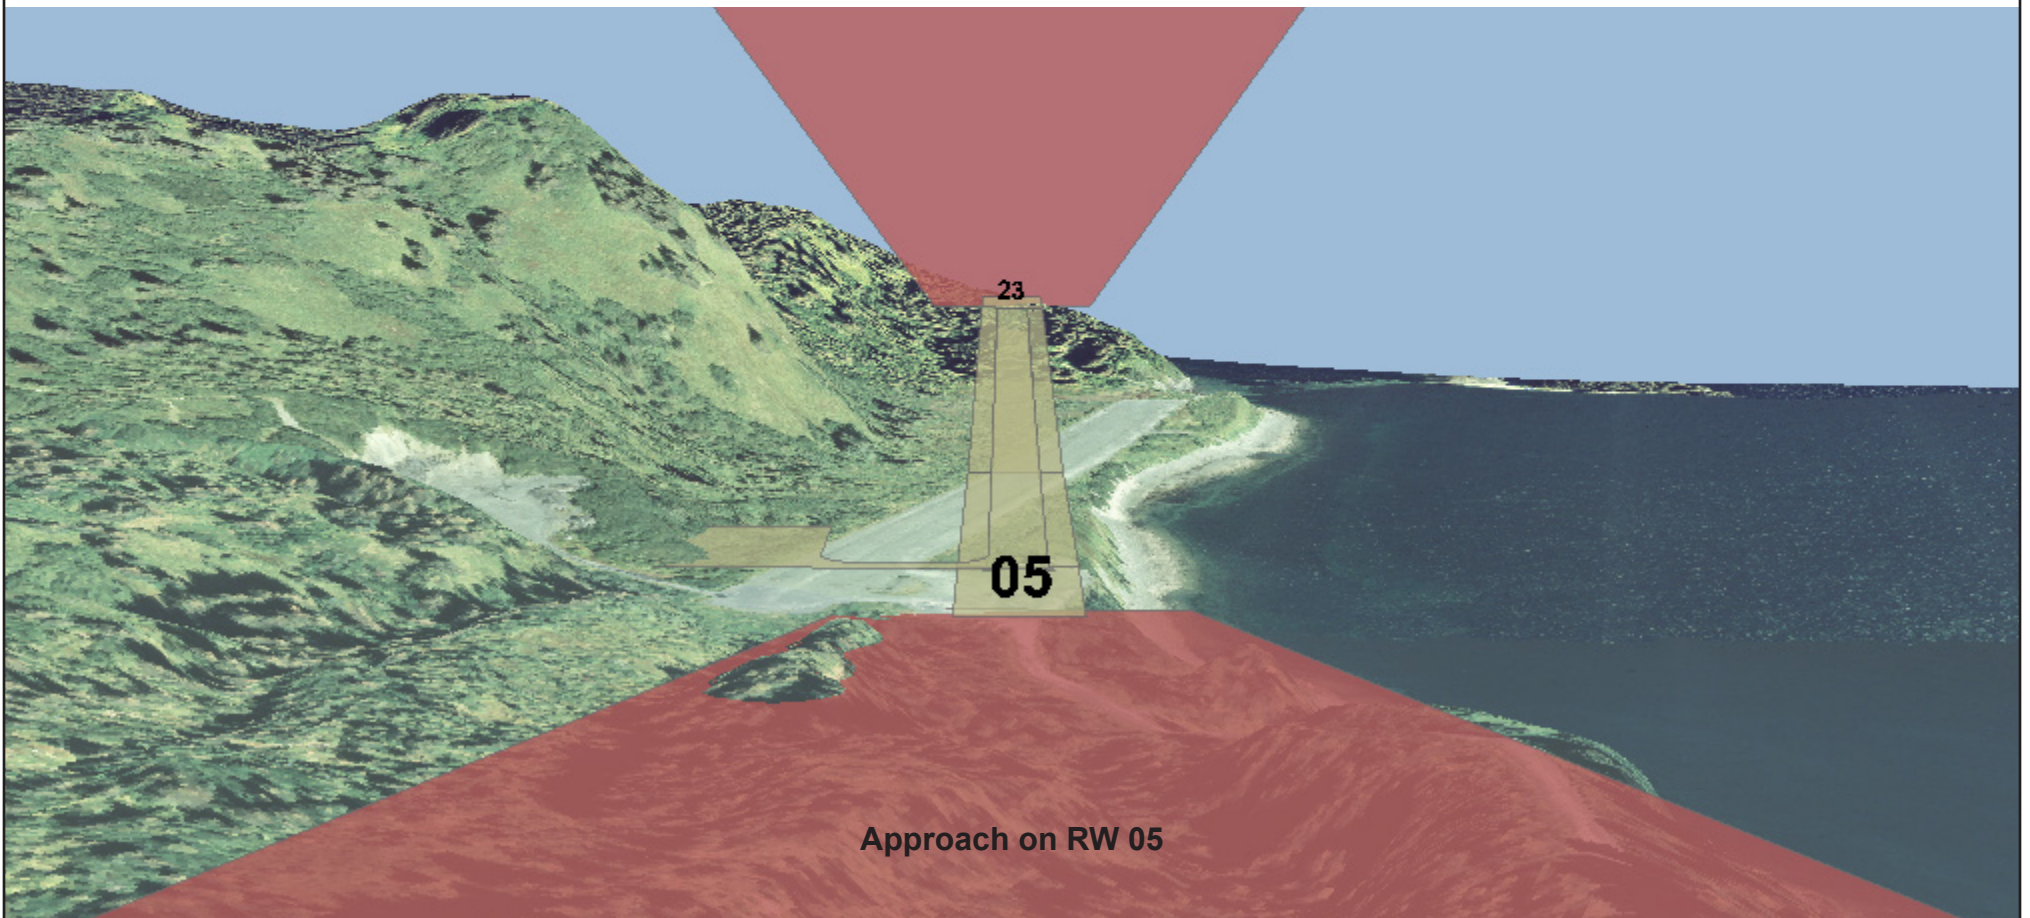
**FIGURE 4-3**

PROPOSED RUNWAY  
75' X 3,300'

**PORT LIONS AIRPORT**  
PORT LIONS, ALASKA  
THRESHOLD SITING SURFACE  
APPENDIX 2, TABLE A2-1 LINE 5

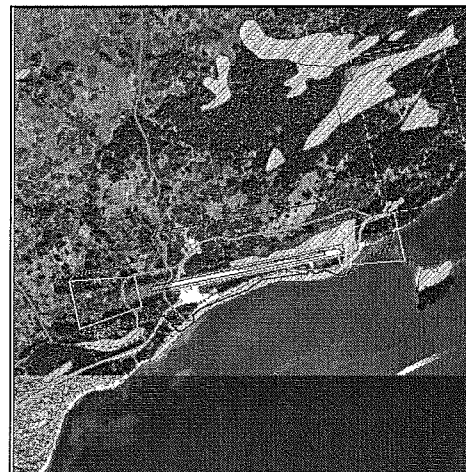
Alternative 1

The runway would be extended from 2,200 ft to 2,700 ft. The apron would be moved to the north side of the runway. A new access road would be developed on the north side of the airport that would connect to the existing trail, and the existing road around the airport would be closed.

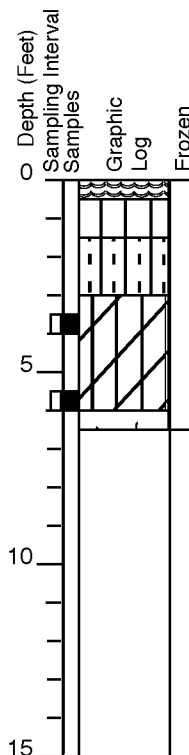
**Log of HOLE: PLA-8**

Date Drilled: August 4, 2004  
 Contractor: City  
 Equipment: CASE 580D w/ 18" toothed bucket  
 GPS Coord.: N 57° 53' 13.1" W 152° 50' 14.9"  
 Elevation: -

Depth (Feet)	Description
0 - 1.5	ORGANIC MAT (Pt) SILT (ML) Tan ash
1.5 - 6.5	ORGANIC SILT (OL) Dark brown
4.5 - 6.5	CLAYEY GRAVELLY SILT (gML) Light gray, hard, clayey silt w/ rock fragments to 8"+, till (?), ppn is 1 to 1.5 T/ft <sup>2</sup>
6.5	WEATHERED BEDROCK (Bx-w) Gray shale Bottom of pit at 6.5 ft.

When laboratory testing was complete, the soils were classified in accordance with the Unified Soil Classification System (Plate 2) and graphic logs of the test pits were prepared (Plates 3 through 7). Laboratory test data, including moisture contents and sieve analysis results are presented graphically on the logs and are tabulated in the summary of samples (Plates 8 through 10).

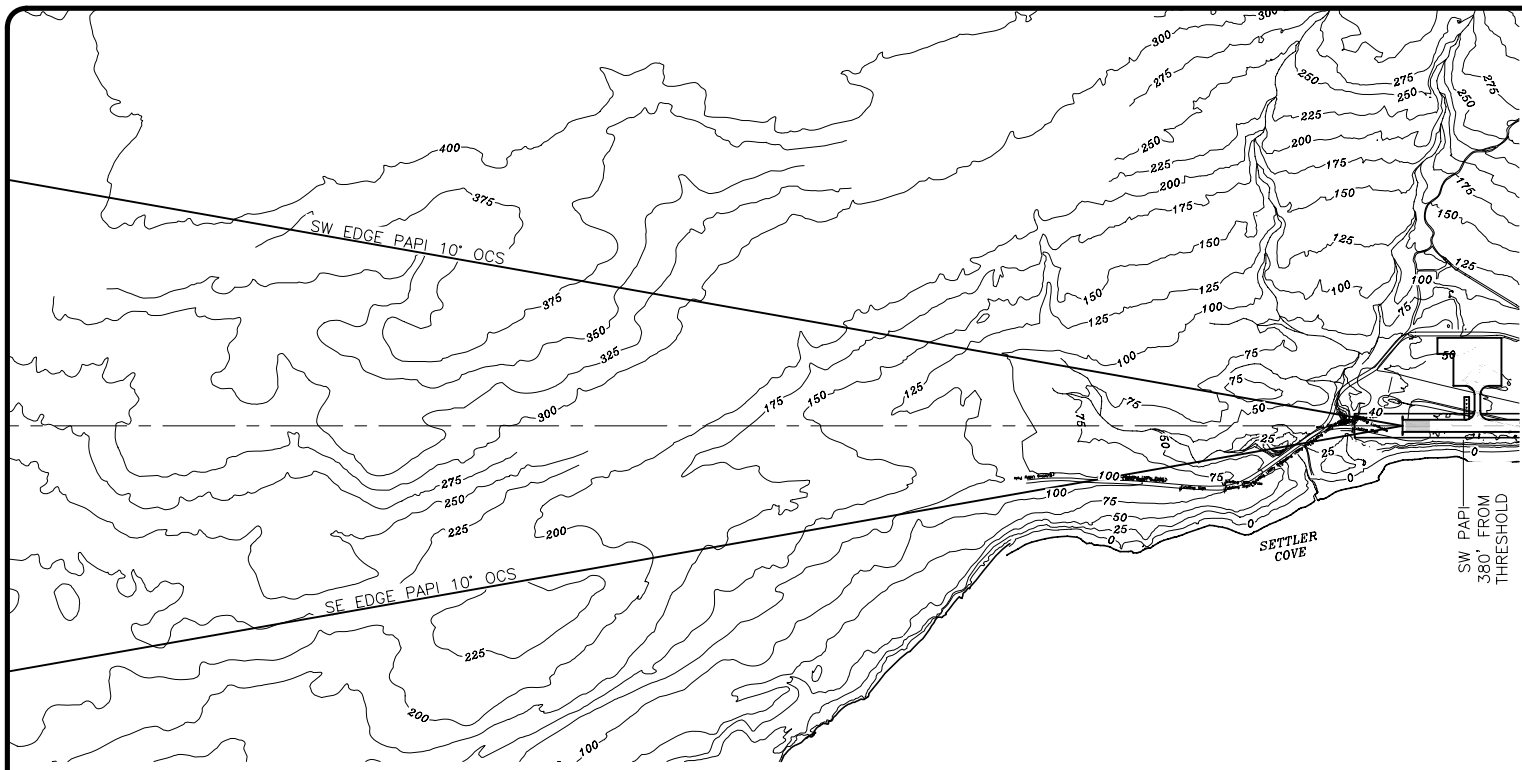
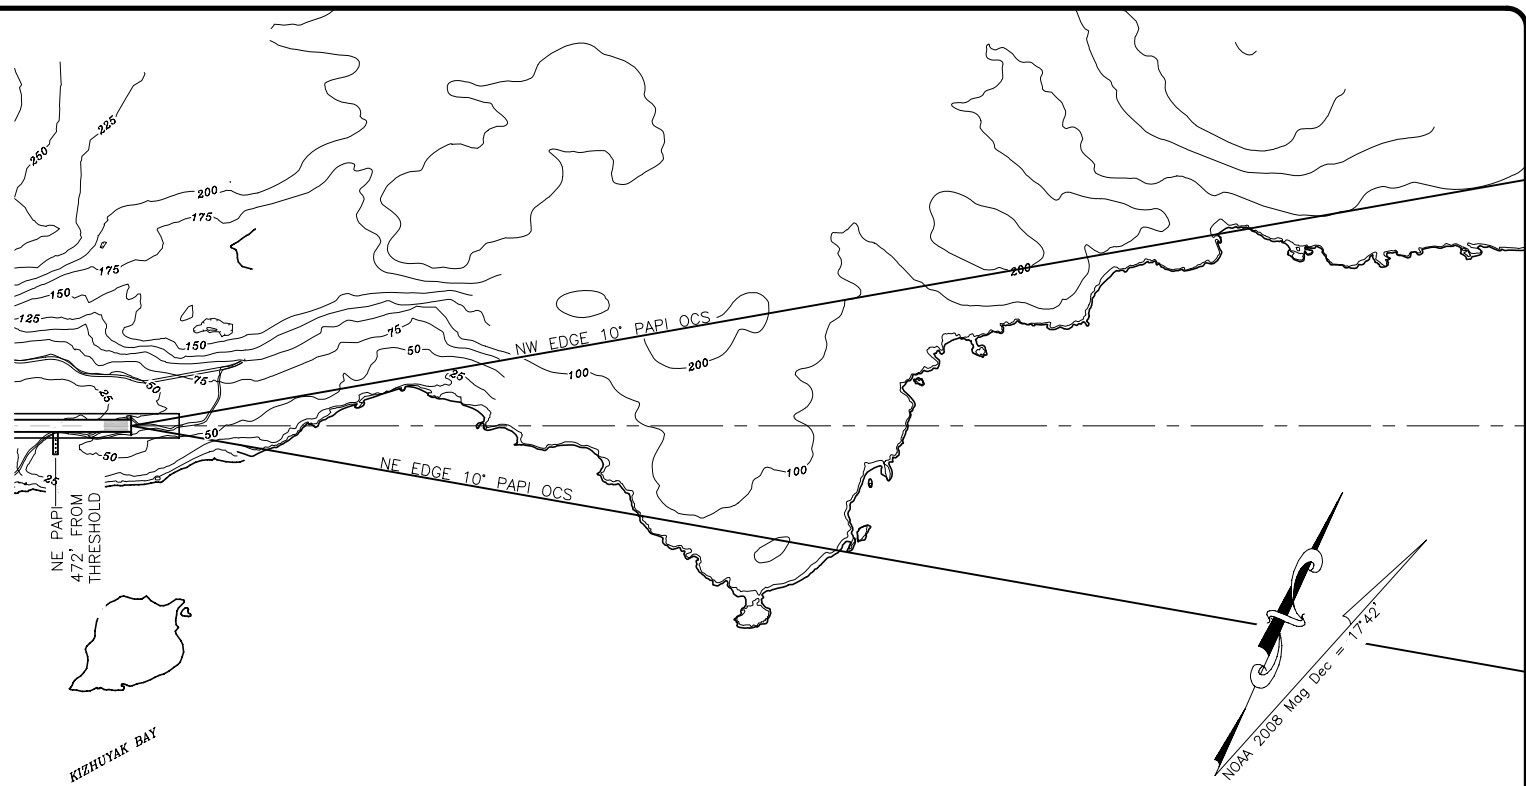
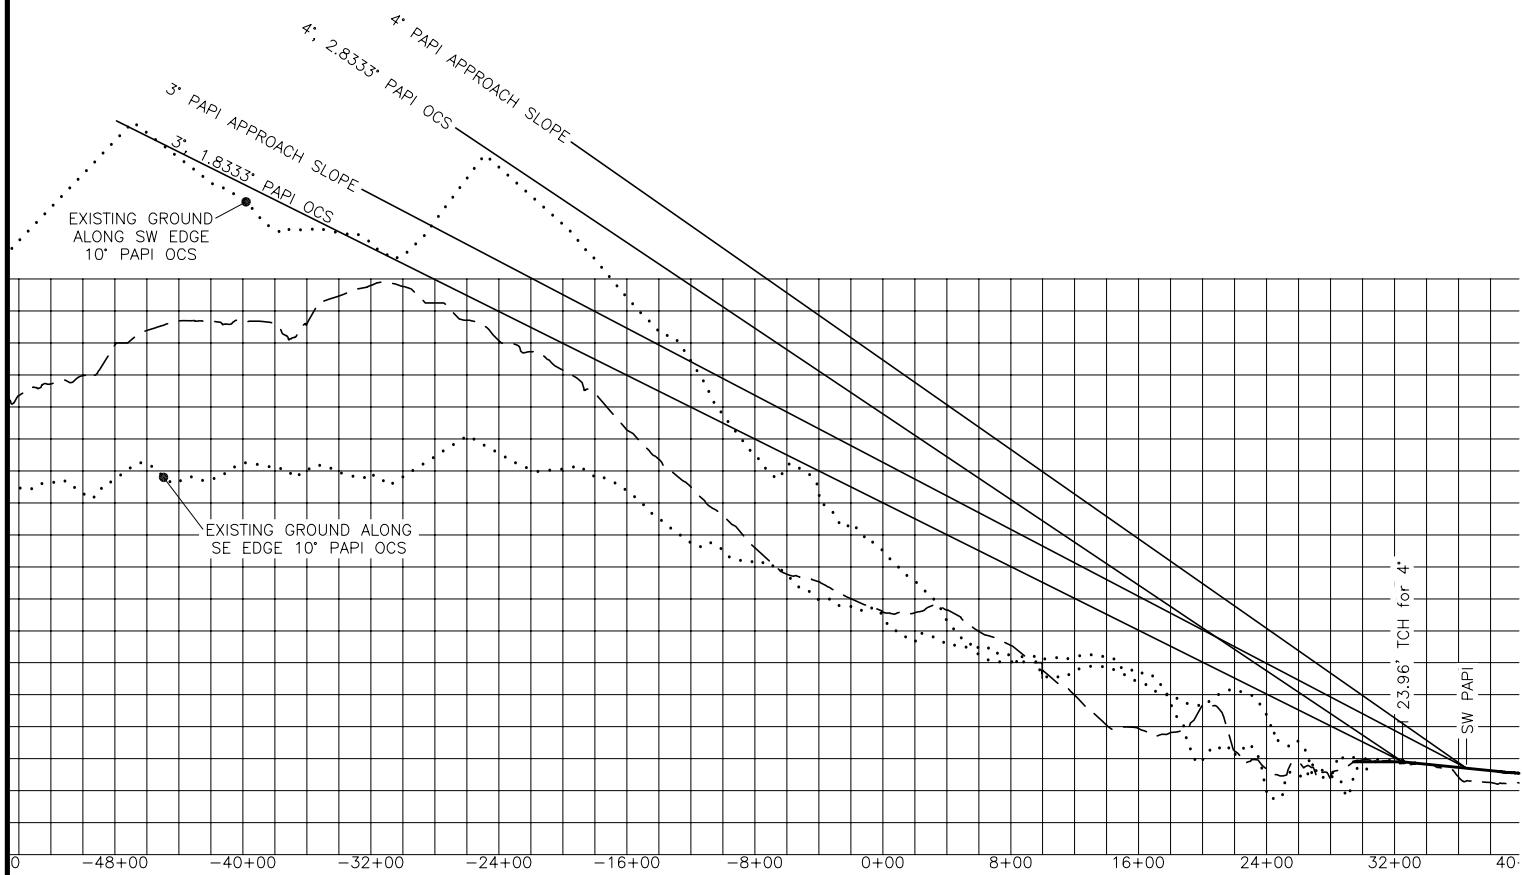
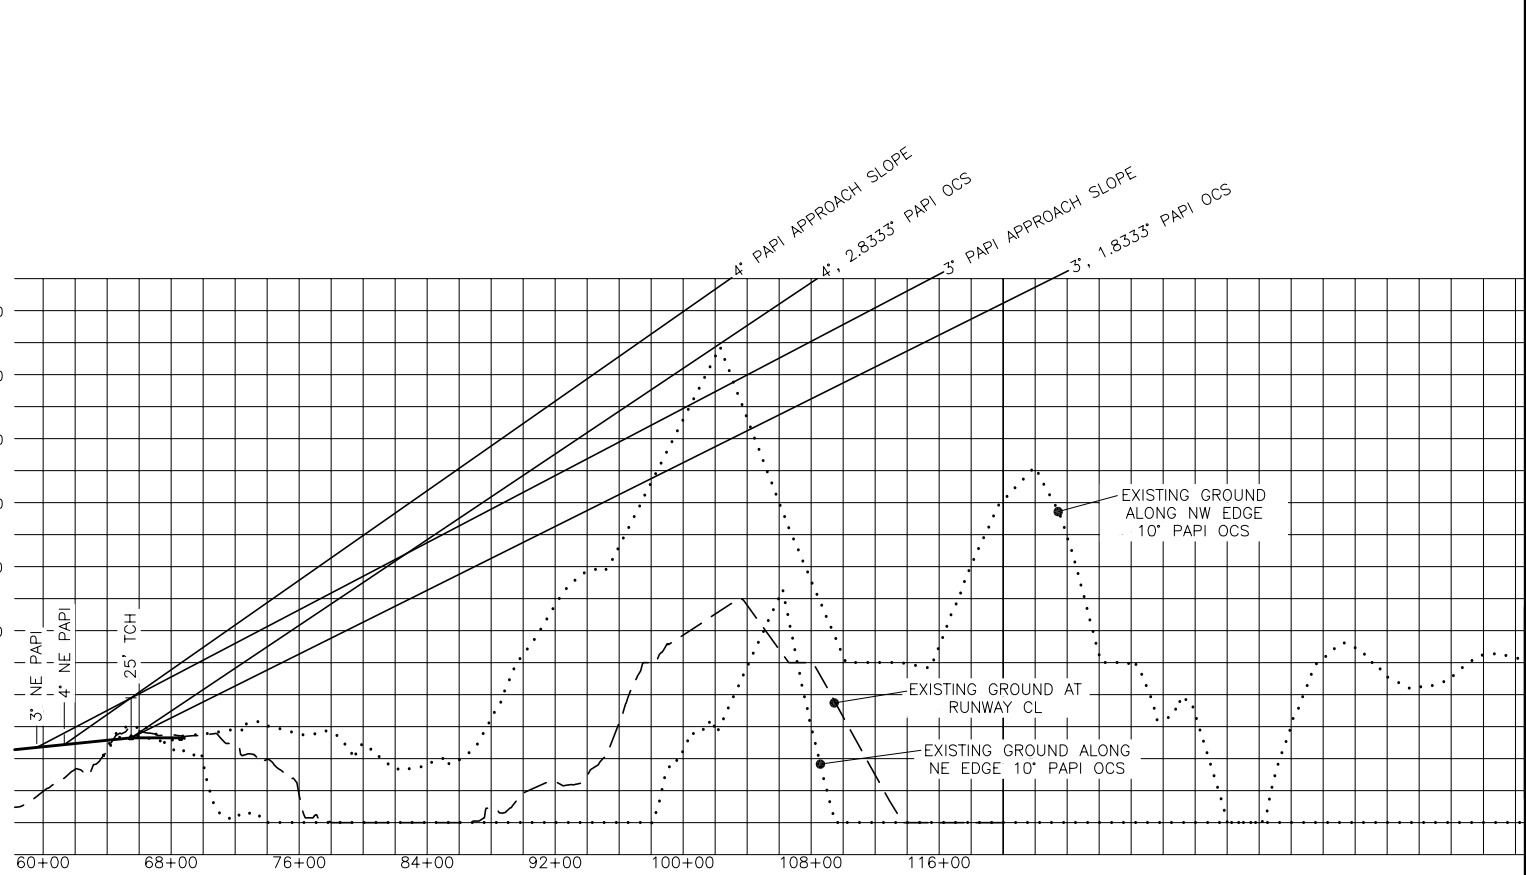
DATE:  
 3-5-07  
 APPENDIX  
 6  
 FIGURE  
 1

PAPI: PRECISION APPROACH PATH INDICATOR  
 OCS: OBSTACLE CLEARANCE SURFACE
