# Port Lions Airport Master Plan

Project No. 54746

HDR Alaska, Inc.  
2525 C Street, Suite 305  
Anchorage, AK 99503-2569

March 2007

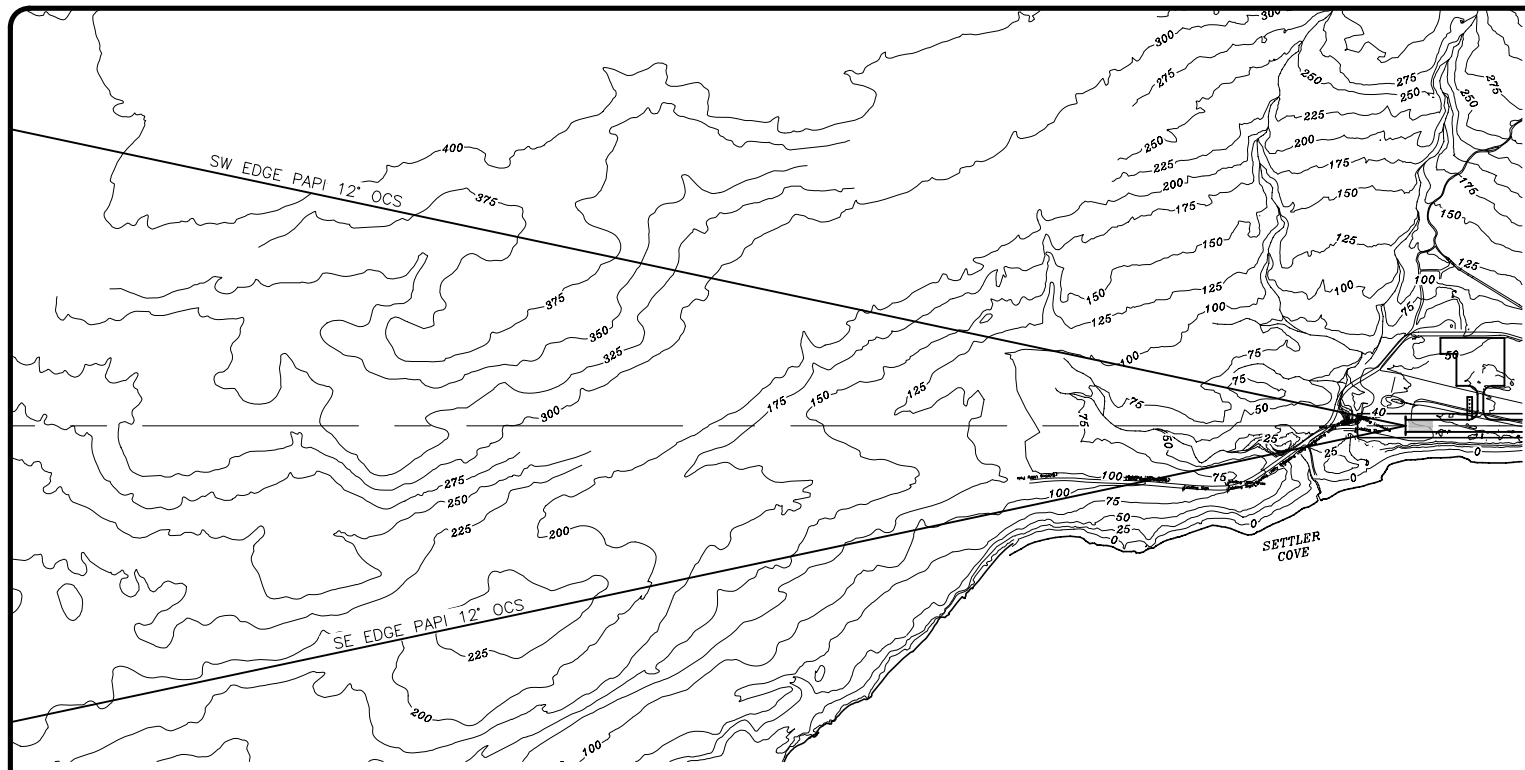
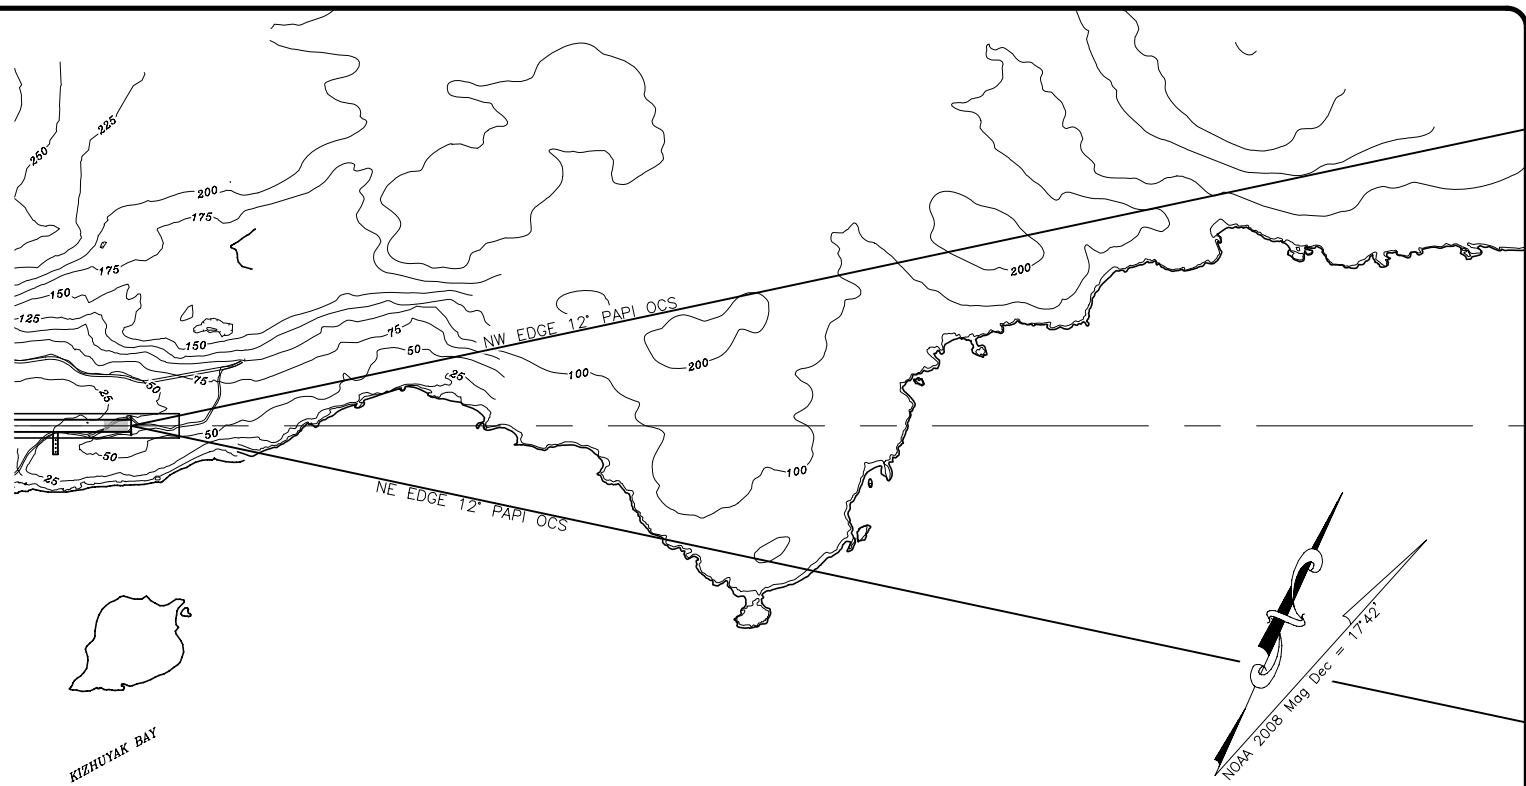
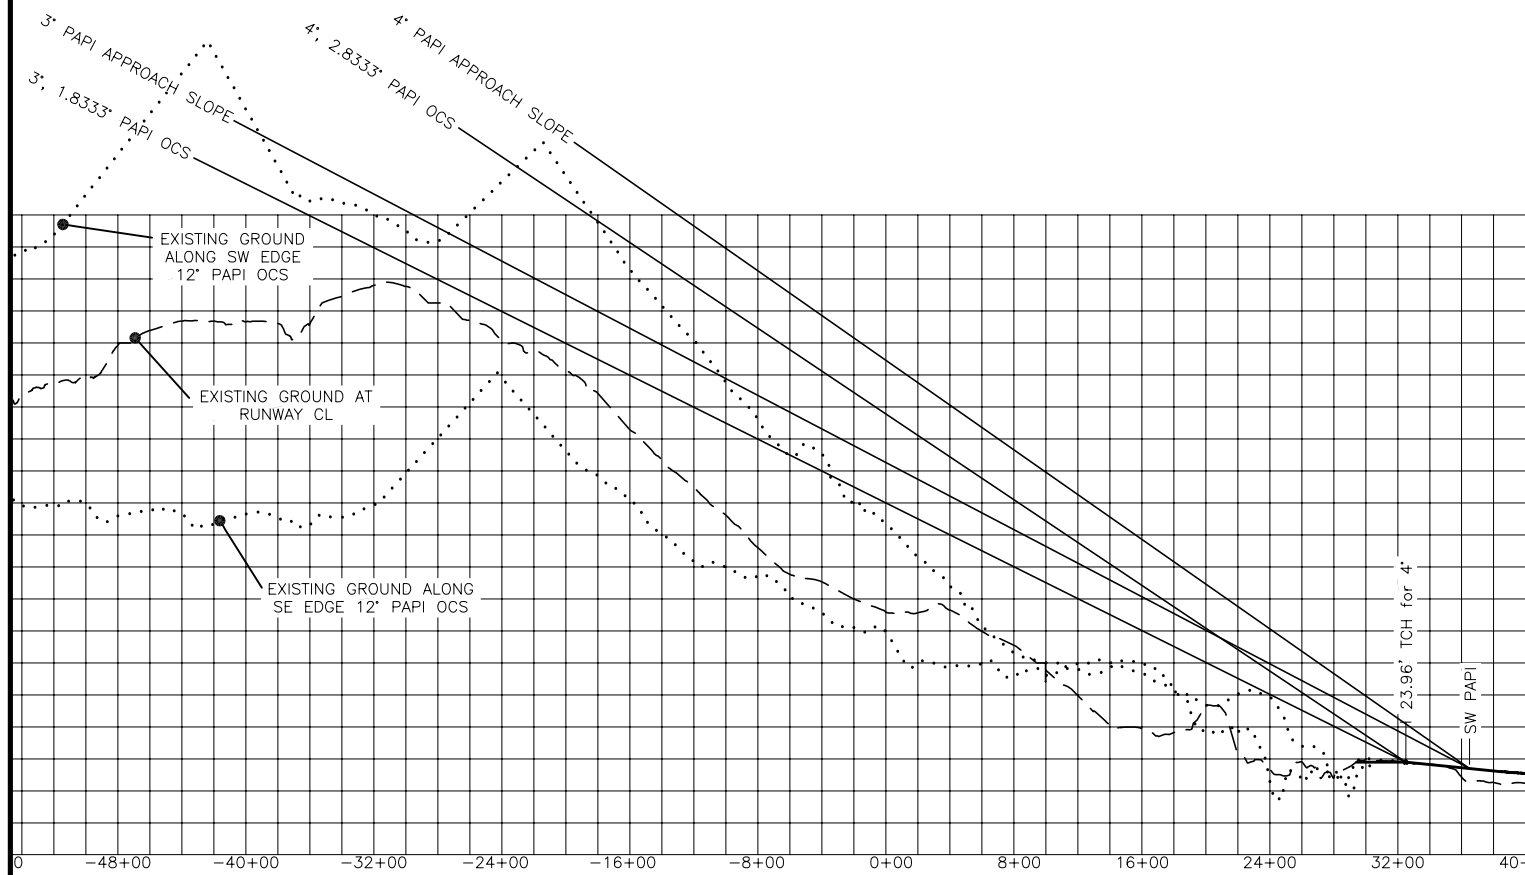
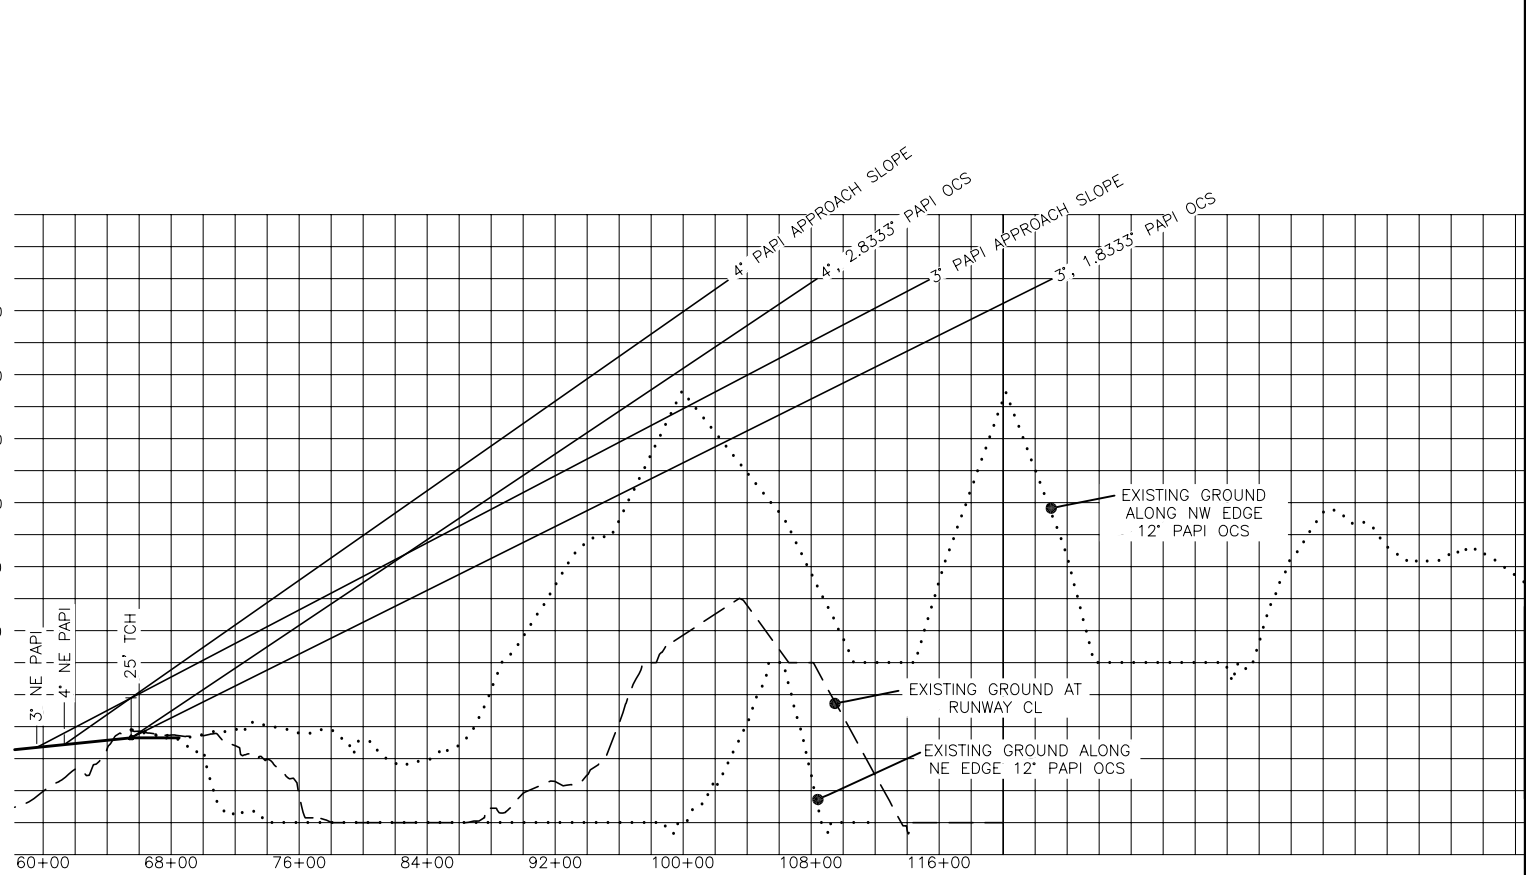
PAPI: PRECISION APPROACH PATH INDICATOR  
 OCS: OBSTACLE CLEARANCE SURFACE
