STATEWIDE MATERIAL SITE INVENTORY

MATERIAL SITE
INSPECTION REPORT

DALTON HIGHWAY

MS 65-9-089-2
Dietrich Quarry

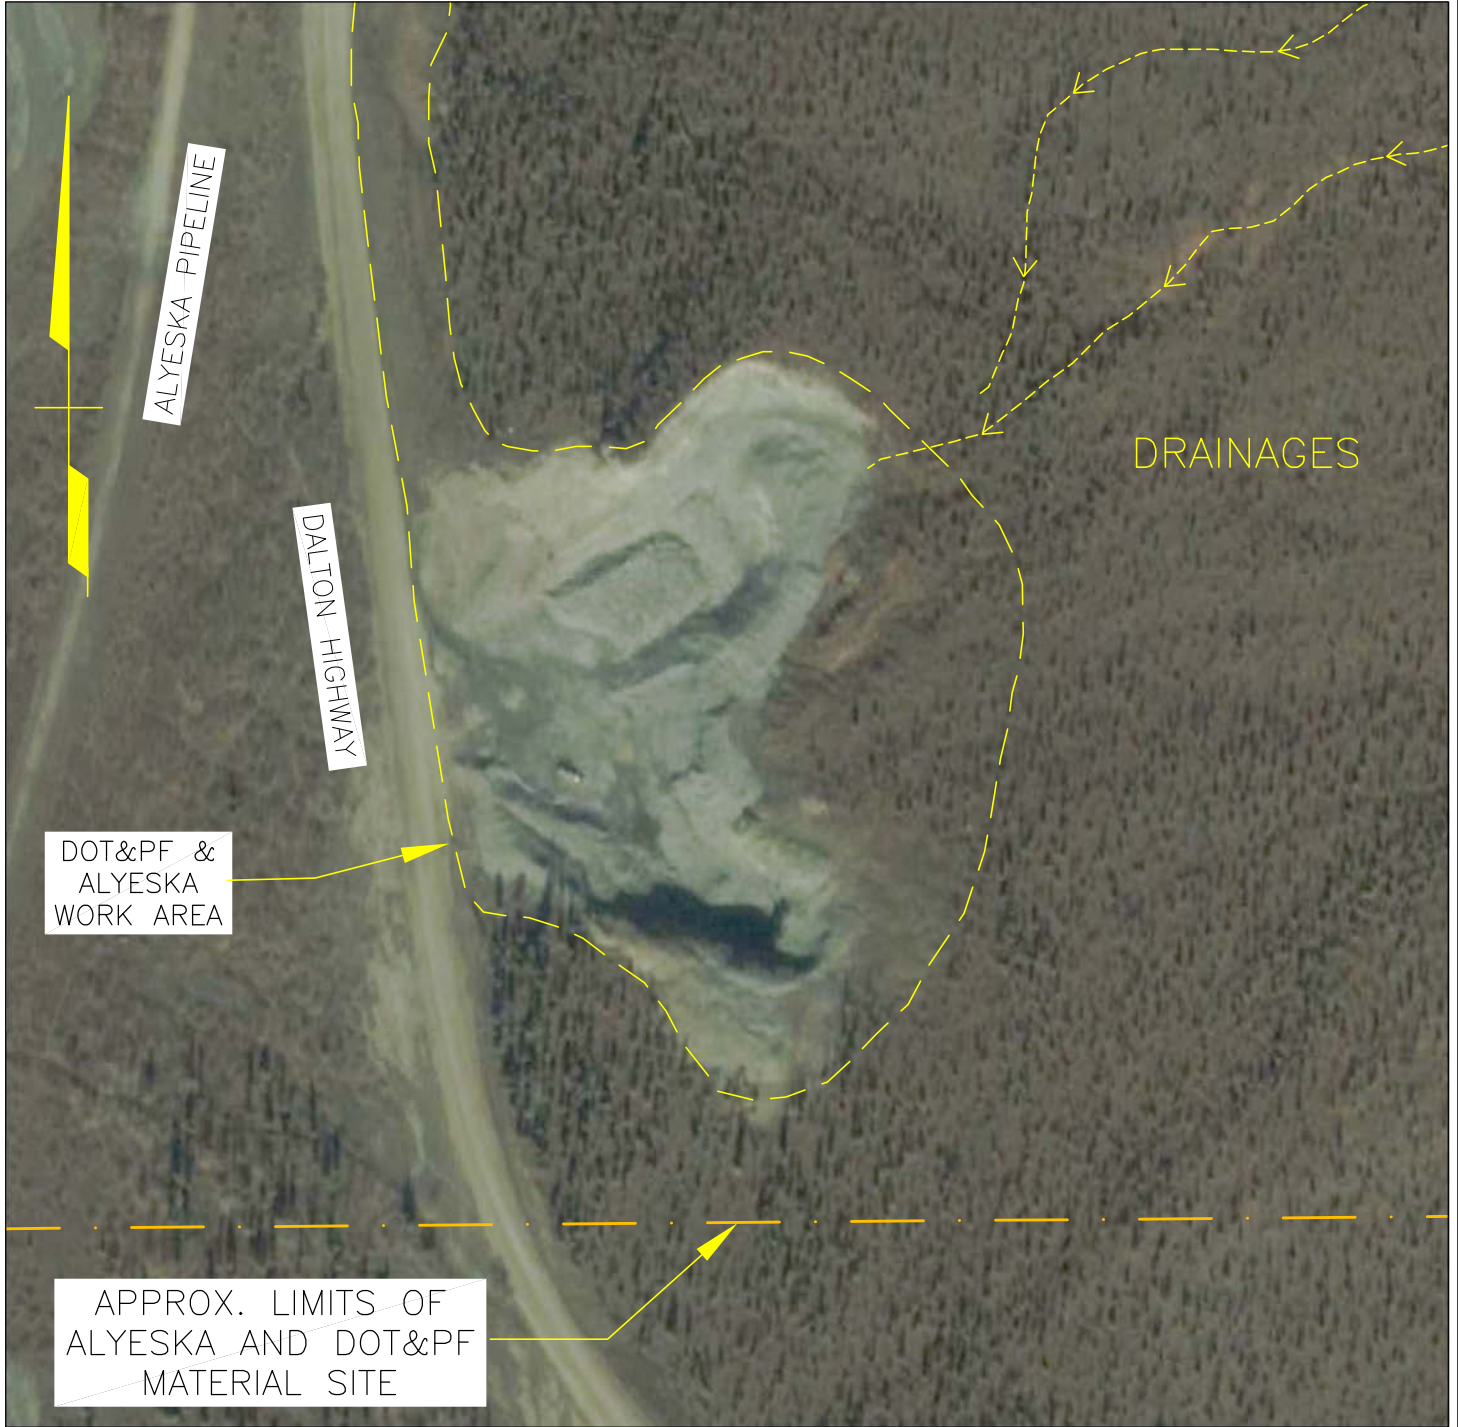
SITE MAP

BASE MAP IS 2005 SATELLITE PHOTOGRAPHY. THIS IS A PLANNING DOCUMENT ONLY. THE MATERIAL SITE BOUNDARIES SHOWN ON THIS DRAWING ARE APPROXIMATE. OWNERSHIP OF THE LANDS ADJACENT TO THIS SITE ARE UNKNOWN. THE ACCESS ROW SHOULD BE VERIFIED.

28. Numerous spoil piles were noted within the existing pit during the 2009 site inspections. Some portions of the spoil piles appear greater than 70 feet thick and were apparently utilized as ramps to reach working faces within the quarry.
