TIER 1 EVALUATION / SITE HISTORY REPORT FOR DREDGING

Seward Freight Dock Expansion Project

August 25, 2015

Project No. 1523305

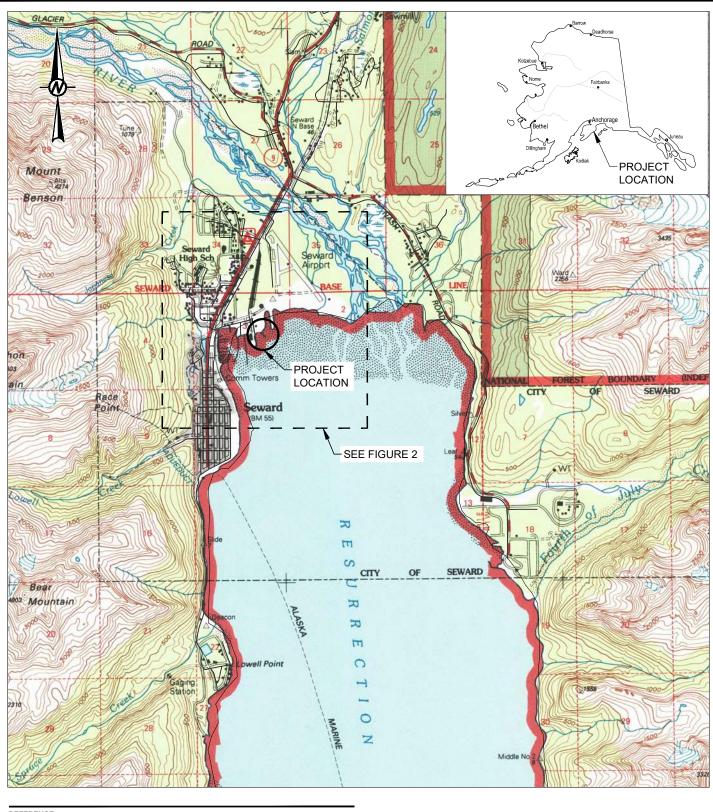
1

1:63,360 SCALE TOPOGRAPHIC MAP CREATED AND DISTRIBUTED BY USGS. QUADRANGLE USED IS SEWARD A-7, AK (1997).

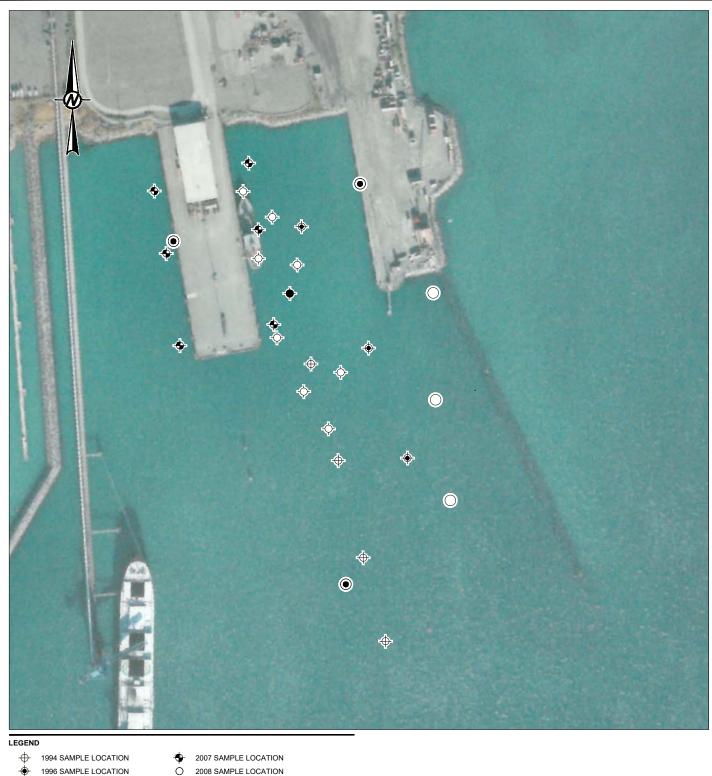
- 2008 SAMPLE LOCATION Ο
- 2009 SAMPLE LOCATION ۲

The Seward Freight Dock Expansion Project includes removing approximately 22,000 cubic yards (CY) of bottom substrate (i.e., dredge material) from the east side of the Freight Dock area shown in Figure 3. ARRC plans to discharge this dredged material to a nearby deep-water disposal area in Resurrection Bay (Figure 3).
