4.0 FACILITY REQUIREMENTS

4.1 Critical Aircraft

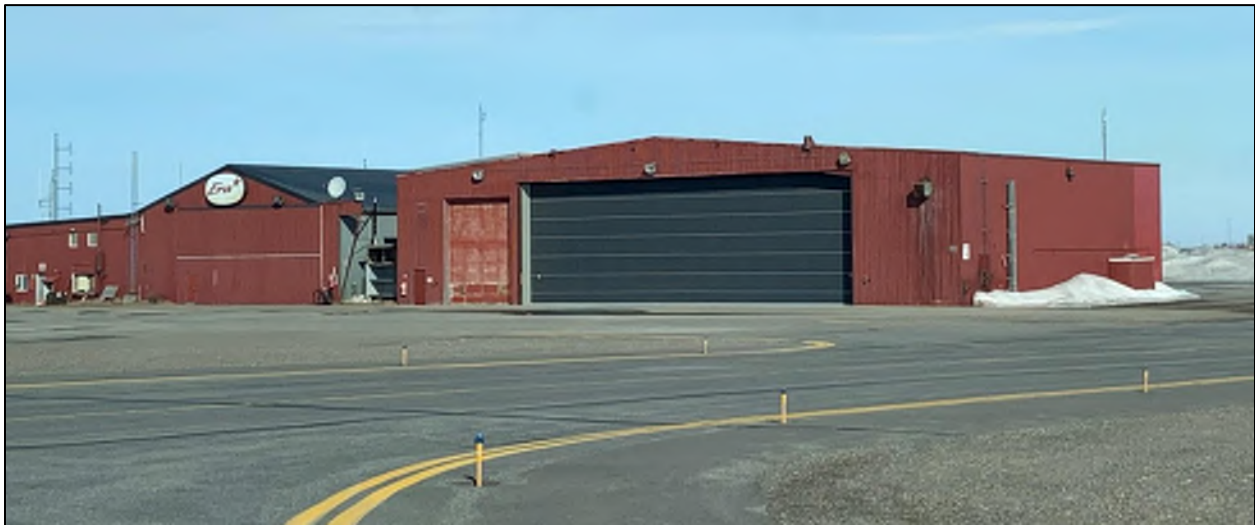
Figure 4-1: Vacant Era Buildings are in Taxiway A ROFA when Taxiway A is used as Temporary Runway

During prior runway reconstruction projects, Taxiway A was used for nearly two years as a temporary runway. This required a special waiver from FAA regarding runway width and RSA width. The taxiway was marked and lighted as a runway, and some navigation aides were relocated to the temporary runway. The minimum ROFA standard for Deadhorse is 400 feet horizontally from the runway centerline. This dimension should also be applied to the taxiway centerline to preserve the option of safely using the taxiway as a temporary runway in the future. Buildings on the Era lease lot are approximately 350 feet from the Taxiway A centerline and are the only existing structures that penetrate the ROFA when applied to Taxiway A. These buildings (Figure 4-1) were present during prior runway resurfacing projects when the taxiway was used as the temporary runway. Other runway repaving options are to repave half the width at a time while keeping half of the runway in operation or to construct a temporary runway on the widened RSA.

Recommendation: *Recommend tenant lease be terminated and buildings be removed to provide a 400-foot ROFA along Taxiway A (also see later discussion about the buildings' effect on snow removal and terminal apron expansion).*

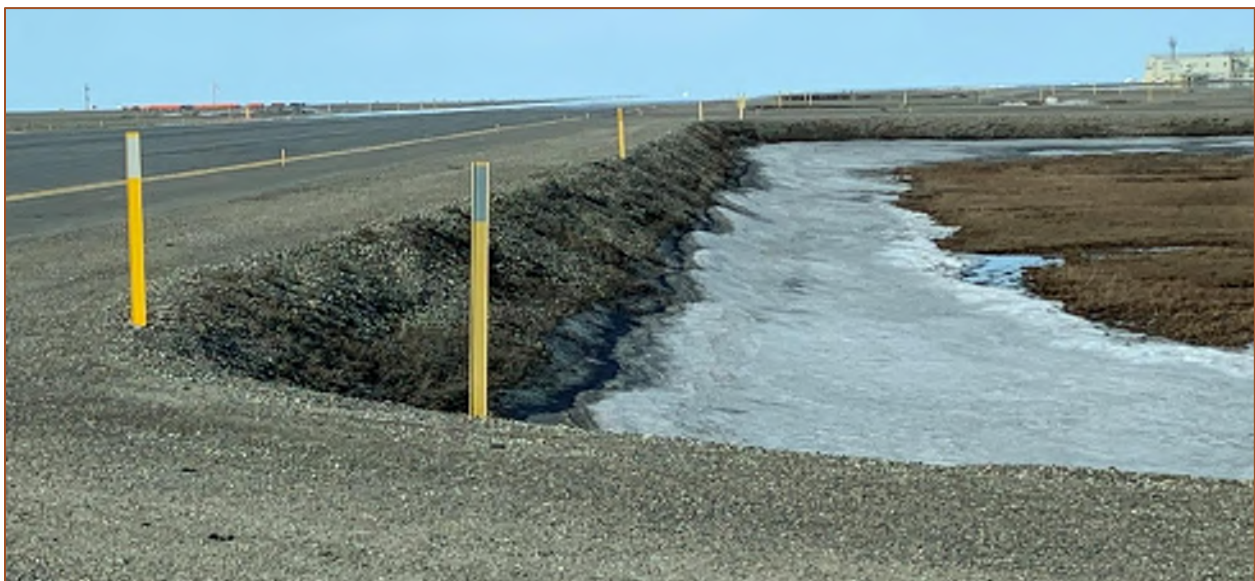
Figure 4-2: Steep Taxiway Shoulder Slopes and Erodible Materials

The taxiways generally have steep shoulder slopes, are constructed of erodible materials, and are unable to support vegetation that would reduce erosion (Figure 4-2). Class 1 rock has been placed at some locations where the connector taxiways connect to the apron.

Recommendation: *The taxiway shoulder slope should be constructed with more gradual slopes or other methods should be investigated to reduce erosion, such as better compaction and alternative materials (such as recycled asphalt) used in the construction. Some taxiway shoulder slopes may be flattened as part of the upcoming fencing and drainage project.*

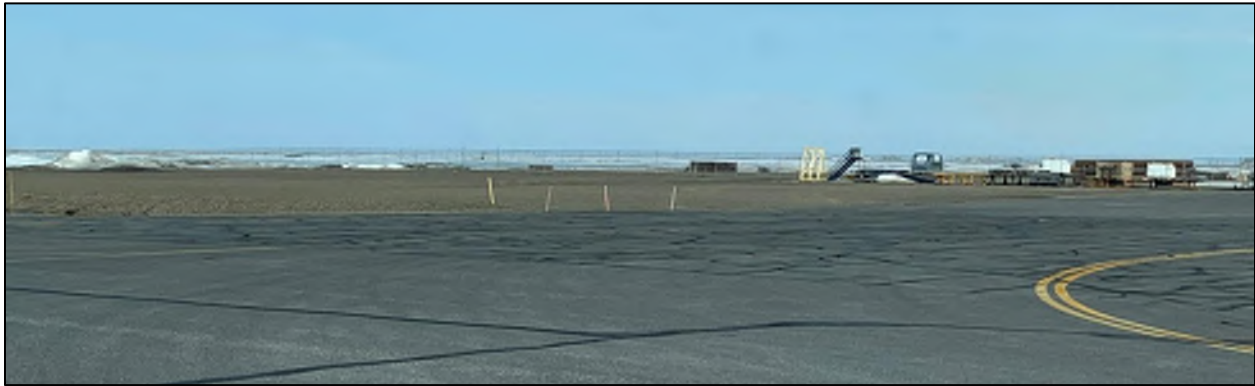
Figure 4-3: This DAC Apron Could Support a New Terminal/Hangar Development on the Vacant Lease Lot Behind It

- are partially developed and could be expanded (Deadhorse Aviation Center, Colville) (Figure 4-3)
- are mostly unused with old facilities that should be replaced/upgraded (Alaska Airlines)
- are used by DOT&PF for drainage ponds or snow storage.

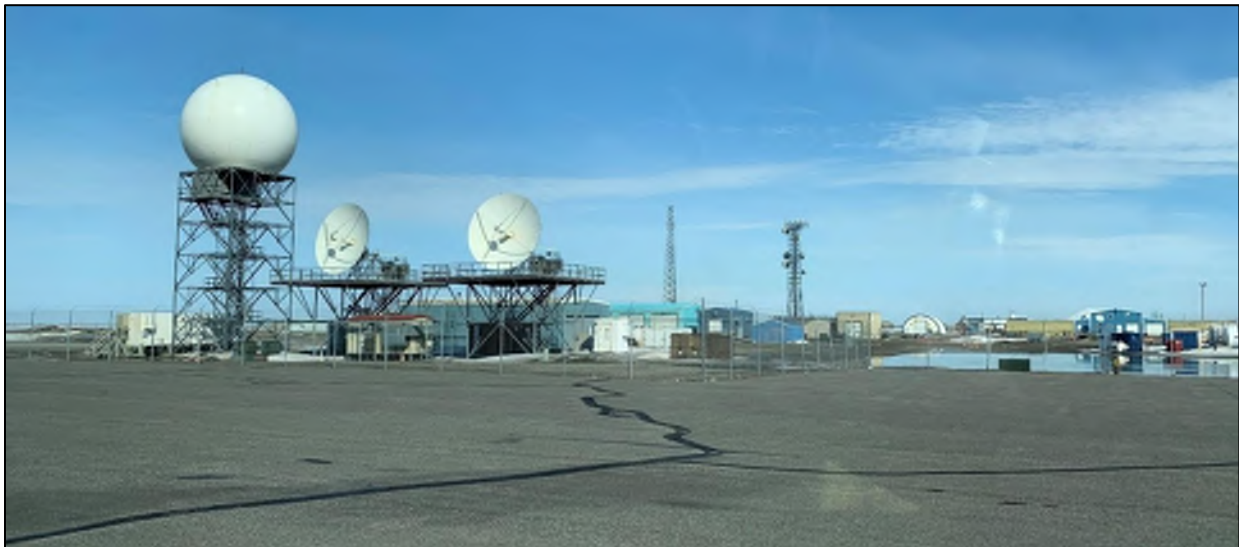
Figure 4-4: GA Apron Used for Tie Downs and Helicopter Operations

During military helicopter operations the GA apron is crowded and helicopter rotor wash and flying debris can damage other helicopters and fixed-wing aircraft tied down on the apron. Helicopter sling loads leaving this apron can create operational conflicts with other aircraft and may drop FOD onto the aprons, taxiways, and runway. During busy summer months there may be 12 helicopters operating from the GA apron, around the clock (Figure 4-4). Oil exploration and development also have the potential to increase GA apron use.

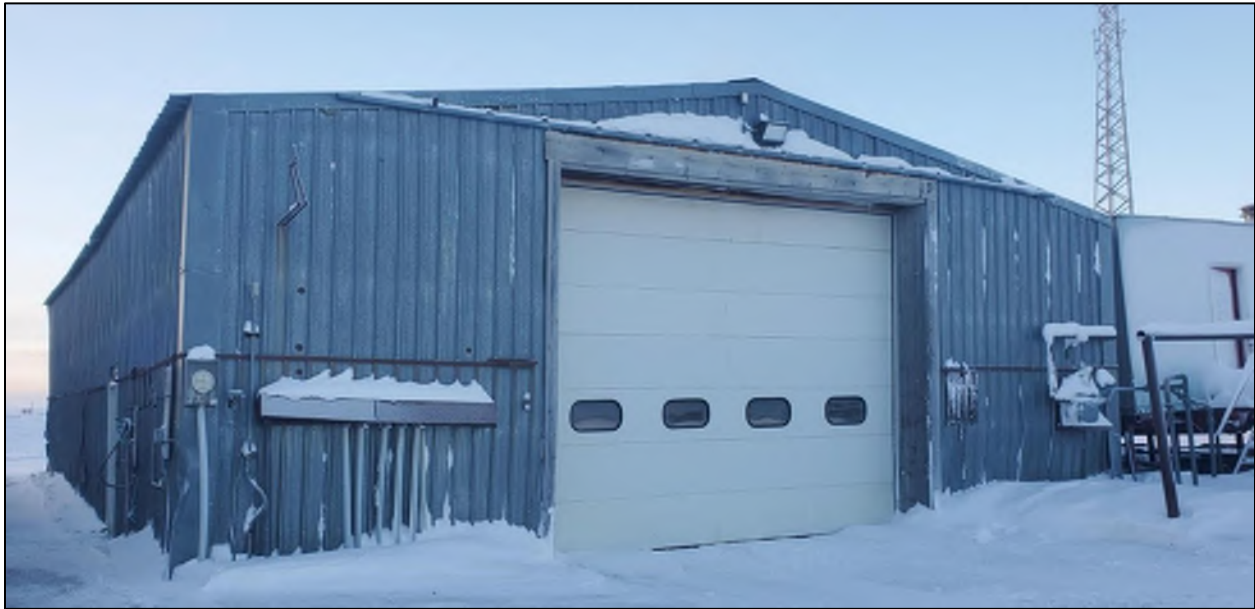
Figure 4-5: Aged M&O Cold Storage Building

The combined ARFF/SREB building was expanded in 2016. It currently meets the airport's needs and is expected to continue to be adequate until expected replacement in 15 or 20 years. Support buildings on various lots on the north side of Deadhorse Drive are old and nearing the end of adequate use (Figure 4-5 and Figure 4-6). The buildings provide warm- and cold storage for sand and various maintenance and operations supplies and equipment that would be more efficiently located at the ARFF/SREB facility.

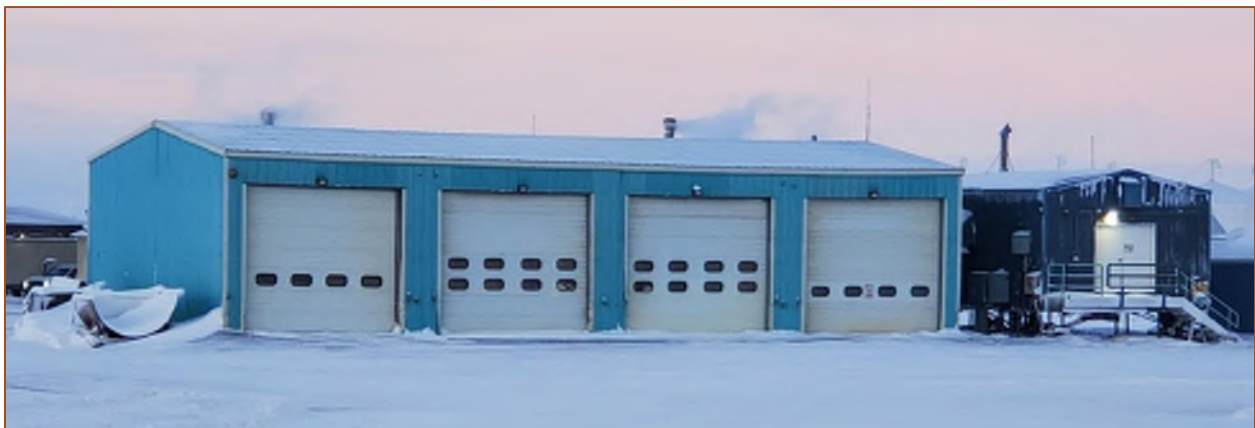
Figure 4-6: Aged M&O Warm Storage Building

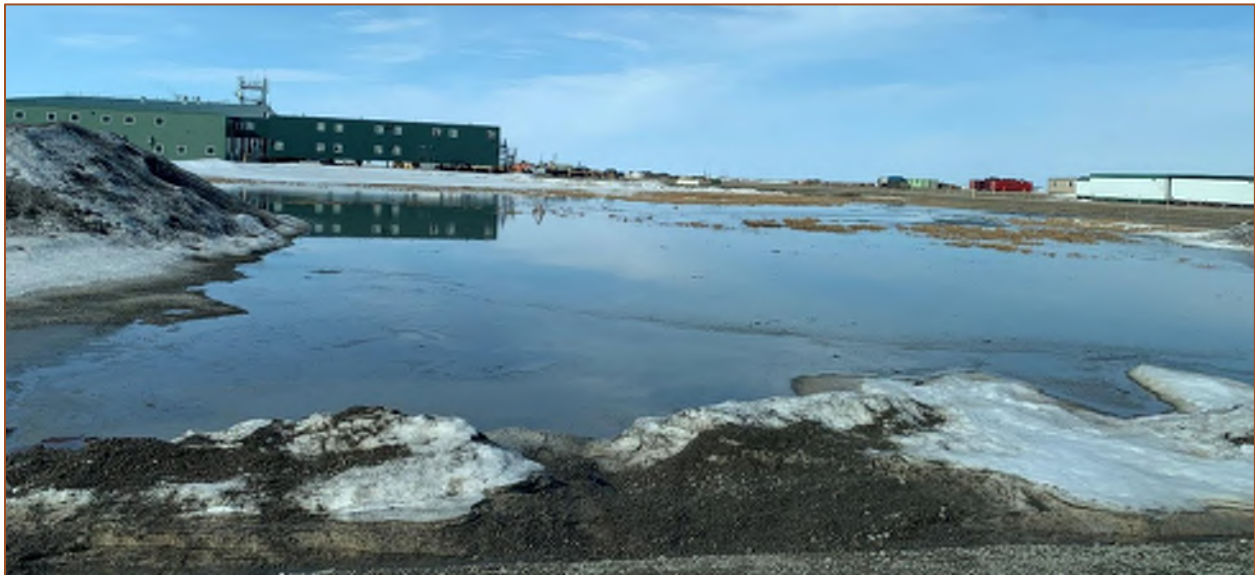
Figure 4-7: Ponding in Front of ARFF/SREB Parking Lot

Drainage on and around the airfield and developed lease areas is poor because the area is flat, and tenants sometimes block or do not maintain drainage (Figure 4-7). Much of the airfield and lease areas south of Deadhorse Drive are being addressed in the upcoming fencing project by replacing and adding culverts, filling in low areas, and redirecting drainage. Airport staff also try to address spring/summer drainage issues by pumping water away from lease areas.

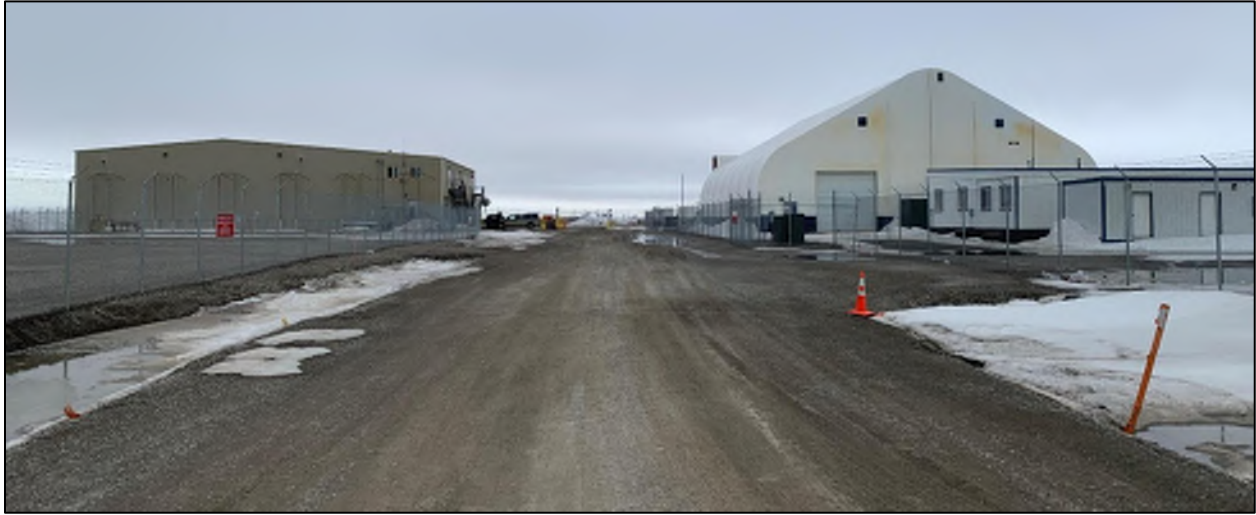
Figure 4-8: Road to Wright Air Terminal/Hangar where Snow Removal is Problematic

Airport staff spend considerable time moving snow off airfield and landside surfaces and at security gates. Because of drifting issues, some snow must be hauled away by loader, which is much less efficient than blowing and plowing snow. Several potential lease lots are used for snow storage. The lease lot layout at the Era/Colville area causes drifting and plowing becomes ineffective, causing a drain on M&O resources.

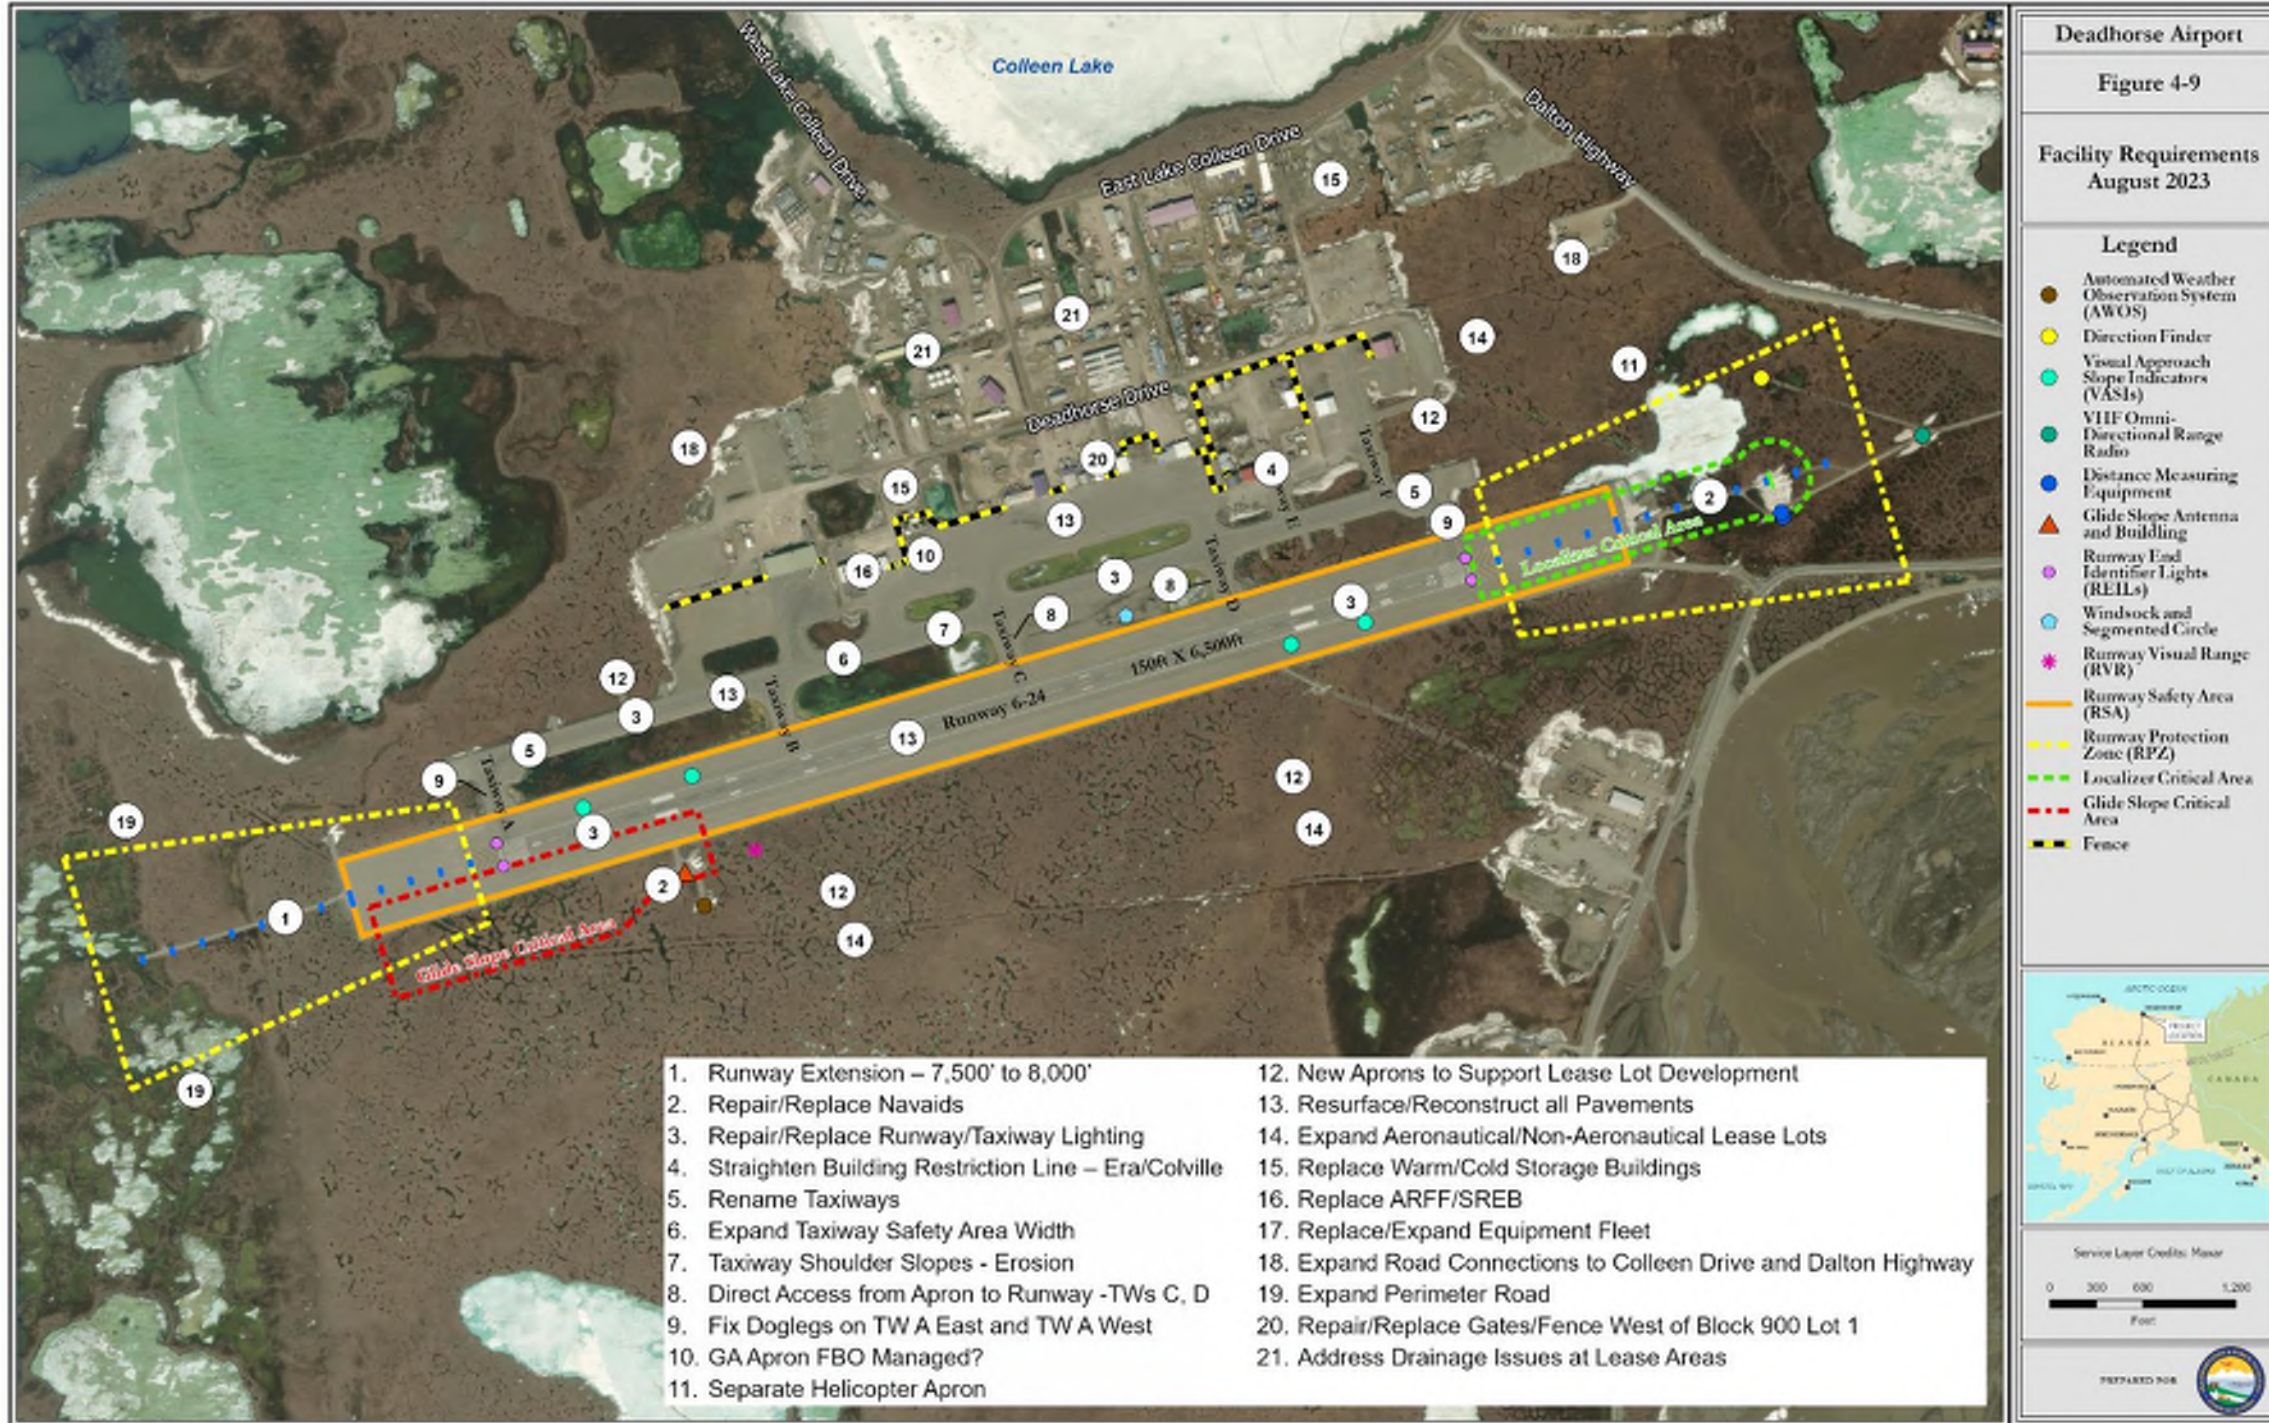
Figure 4-9: Facility Requirements

Table 4-5 and Figure 4-9 provide the facility requirements for the Deadhorse Airport
