Attachment F: General Mining and Reclamation Guidelines for Material Site 65-9-116-2 Bonanza Creek: Milepost 124.4 Dalton Highway

State of Alaska
Department of Transportation and Public Facilities
General Mining and Reclamation Guidelines for
Material Site 65-9-116-2
Bonanza Creek: Milepost 124.4 Dalton Highway

The general Mining and Reclamation (M&R) Guidelines, detailed below, is for material site (MS) 65-9-116-2, also known as the Bonanza Creek or Bonanza Creek West. This referenced MS will be authorized under a Highway Easement Deed (HED), issued to the Alaska Department of Transportation and Public Facilities (DOT&PF) by the Federal Highway Administration.

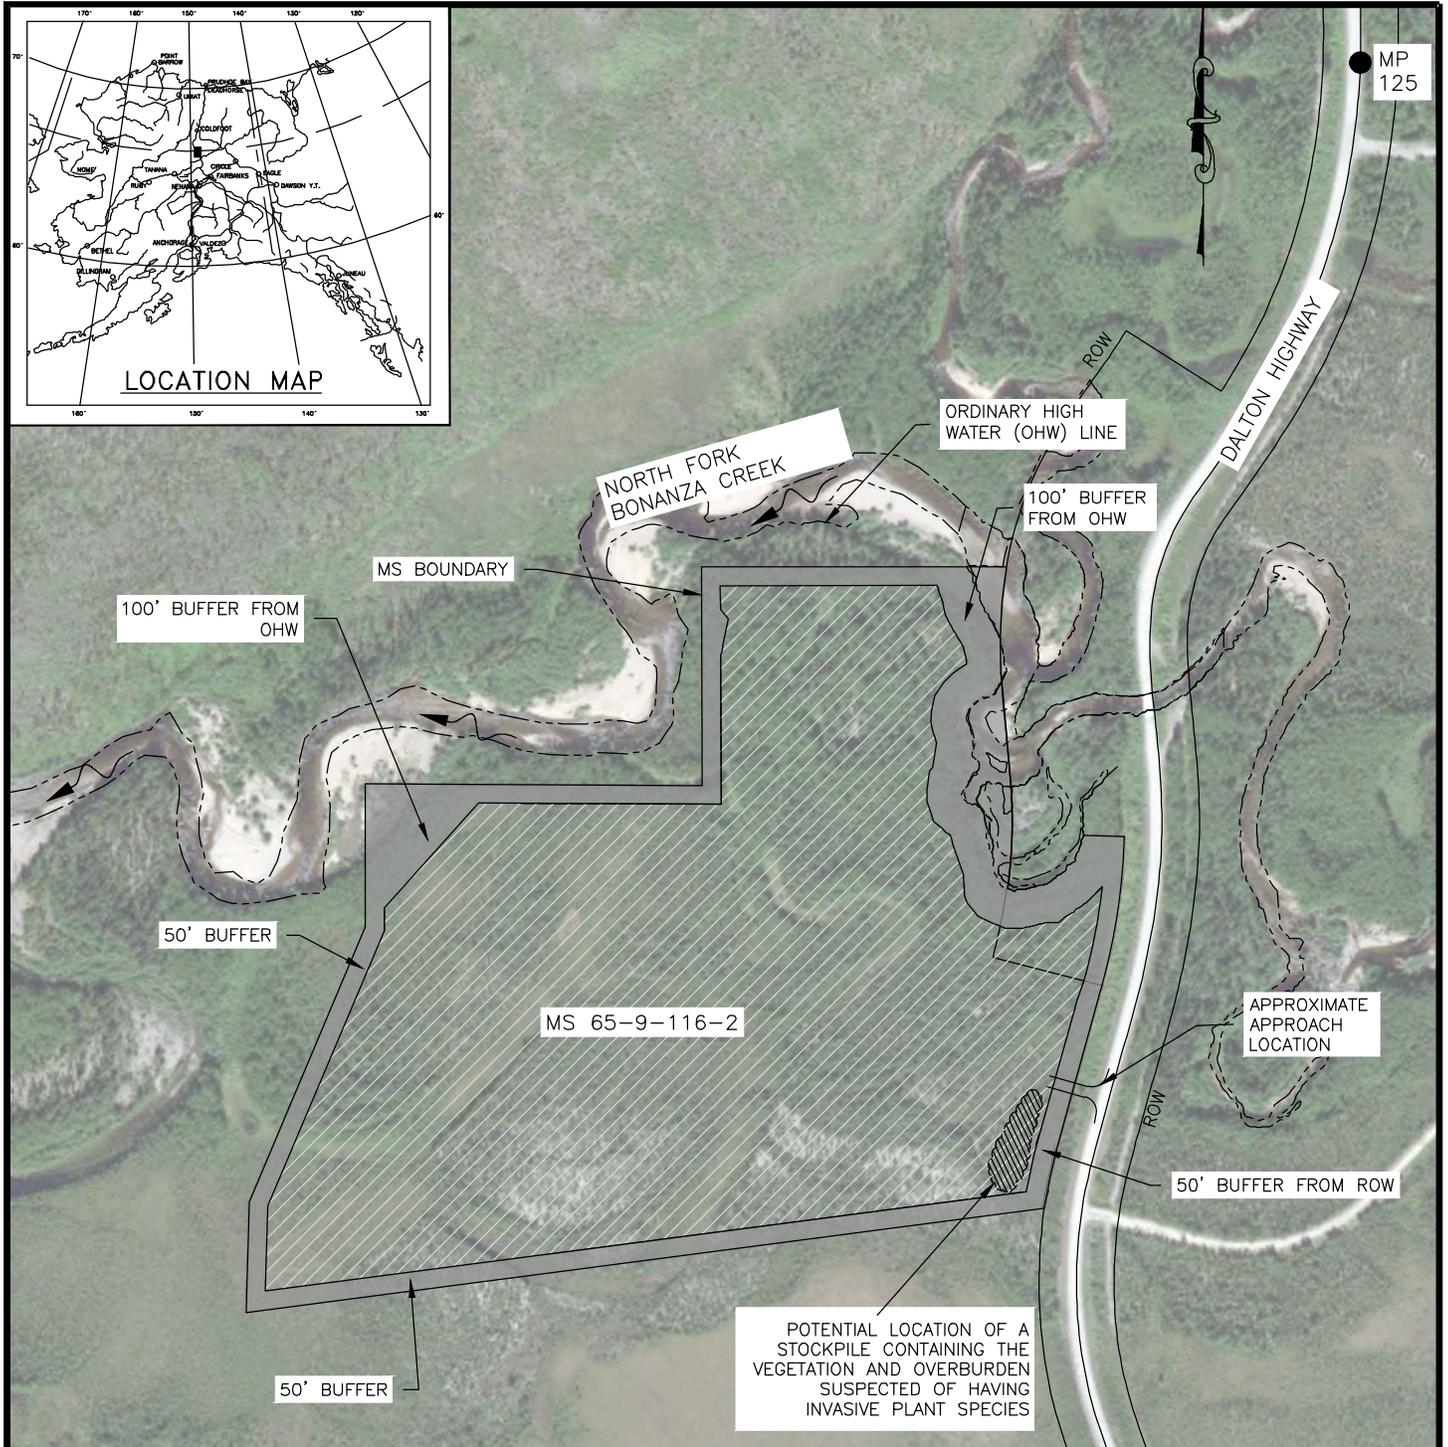
NORTHERN REGION	DATE: 12/12/23
SCALE NTS DRAWN BY: BAM	FIGURE 1

Figure 1: Plan View of MS 65-9-116-2.

M.S. 65-9-116-2

WITHIN
USGS QUAD. BETTLES C2
T21N, R14W, FM
Section 7

Material site contains ~51 acres.

STATE OF ALASKA
DEPARTMENT OF TRANSPORTATION
AND PUBLIC FACILITIES
MATERIAL SITE PLAN
M.S. 65-9-116-2

MS 65-9-116-2 is located within the Bonanza Creek floodplain on the west side of the Dalton Highway near milepost (MP) 124.4, and; within the southwest $\frac{1}{4}$ of the northeast $\frac{1}{4}$ of Section 07, Township 21 North, Range 14 West, Fairbanks Meridian, USGS Quadrangle Bettles C-2 (Figure 1).

Maintaining distance (buffer) between pit limits and adjacent lands or water bodies is intended to screen the site from adjacent land and to protect water quality and riparian habitats. Except where necessary to create access to the mining area from the highway, manage activities to eliminate disturbance within buffers. In this regard, development of MS 65-9-116-2 will require that a 100-foot-wide minimum buffer be established, clearly marked, and maintained from the active channel of Bonanza Creek, measured from the ordinary high water (OHW) level. This buffer is to be surveyed and clearly marked to the satisfaction of the engineer. No ground disturbance is allowed within this area. A 50-foot-wide buffer is also to be established as shown on Figure 1.

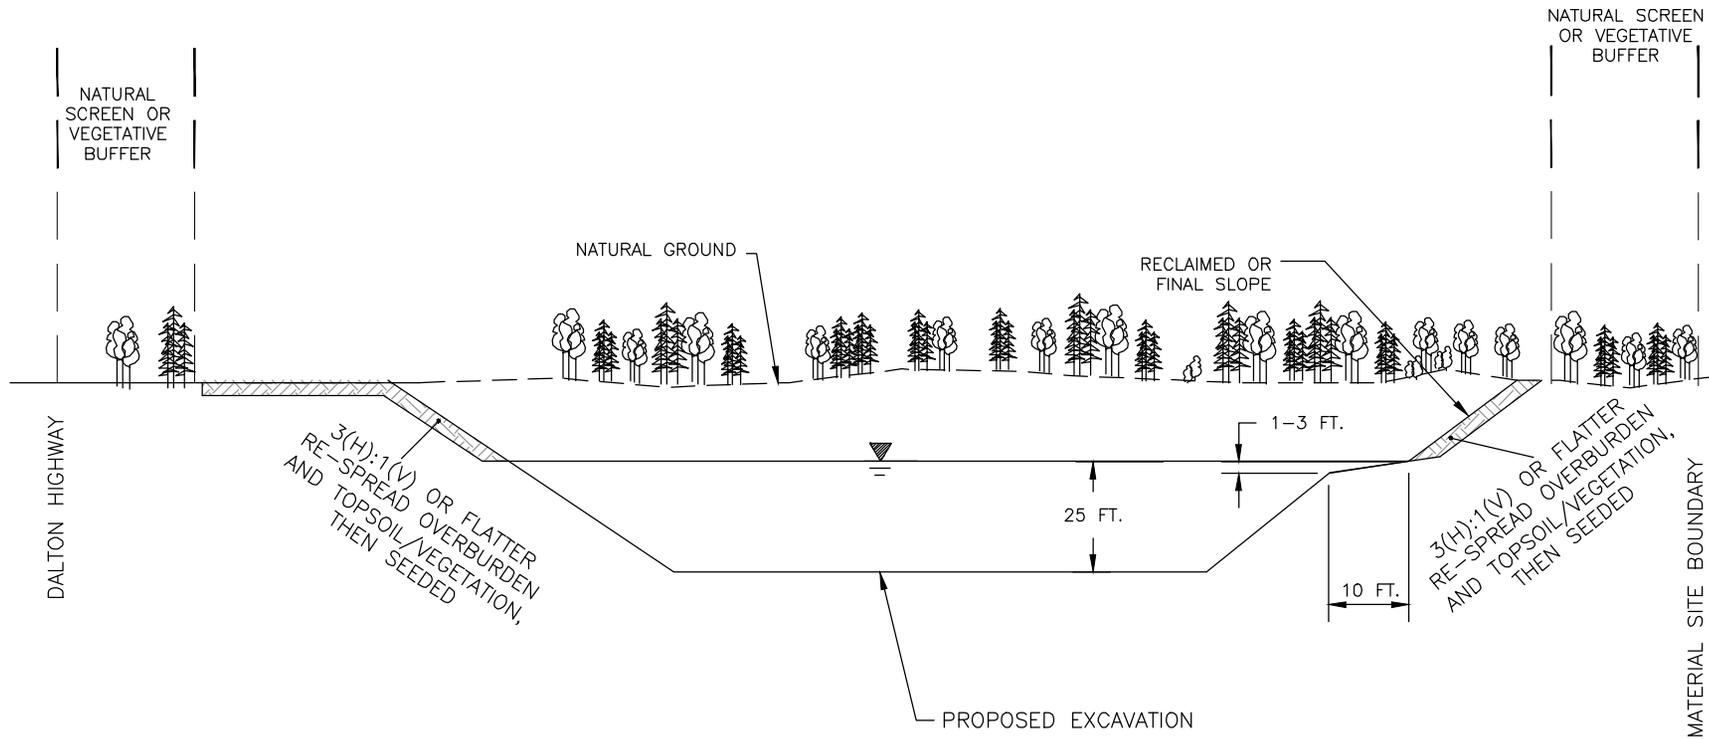
STATE OF ALASKA DEPARTMENT OF TRANSPORTATION AND PUBLIC FACILITIES	
DATA: WK	MINING RECLAMATION TYPICAL SECTION
DRAWN: BAM	
APPROVED: IH	PROJECT NO. N/A
DATE: 12-12-23	FIGURE 2

Figure 2: Typical Cross Section in Unconsolidated Material Below Water Table.

BONANZA CREEK
MS 65-9-116-2
TYPICAL CROSS SECTION OF MINING

NOT TO SCALE

Furthermore, once the 3:1 slope meets the groundwater level of the newly formed pond the grade is to change to a flatter slope for a horizontal distance of 10 feet below the waterline, see Figure 2. A rounded shaped shoreline (such as kidney-bean shape) is also required to the extent practicable, meaning a symmetrical pit such as a nice rectangular shaped pit with straight shorelines is not to occur.

8. Once the 3:1 slope meets the groundwater level of the newly formed pond the grade of the slope below the waterline is to change to flatten for a horizontal distance of 10 feet, see Figure 2.
9. A kidney-bean-like shape shoreline is required to the extent practicable.

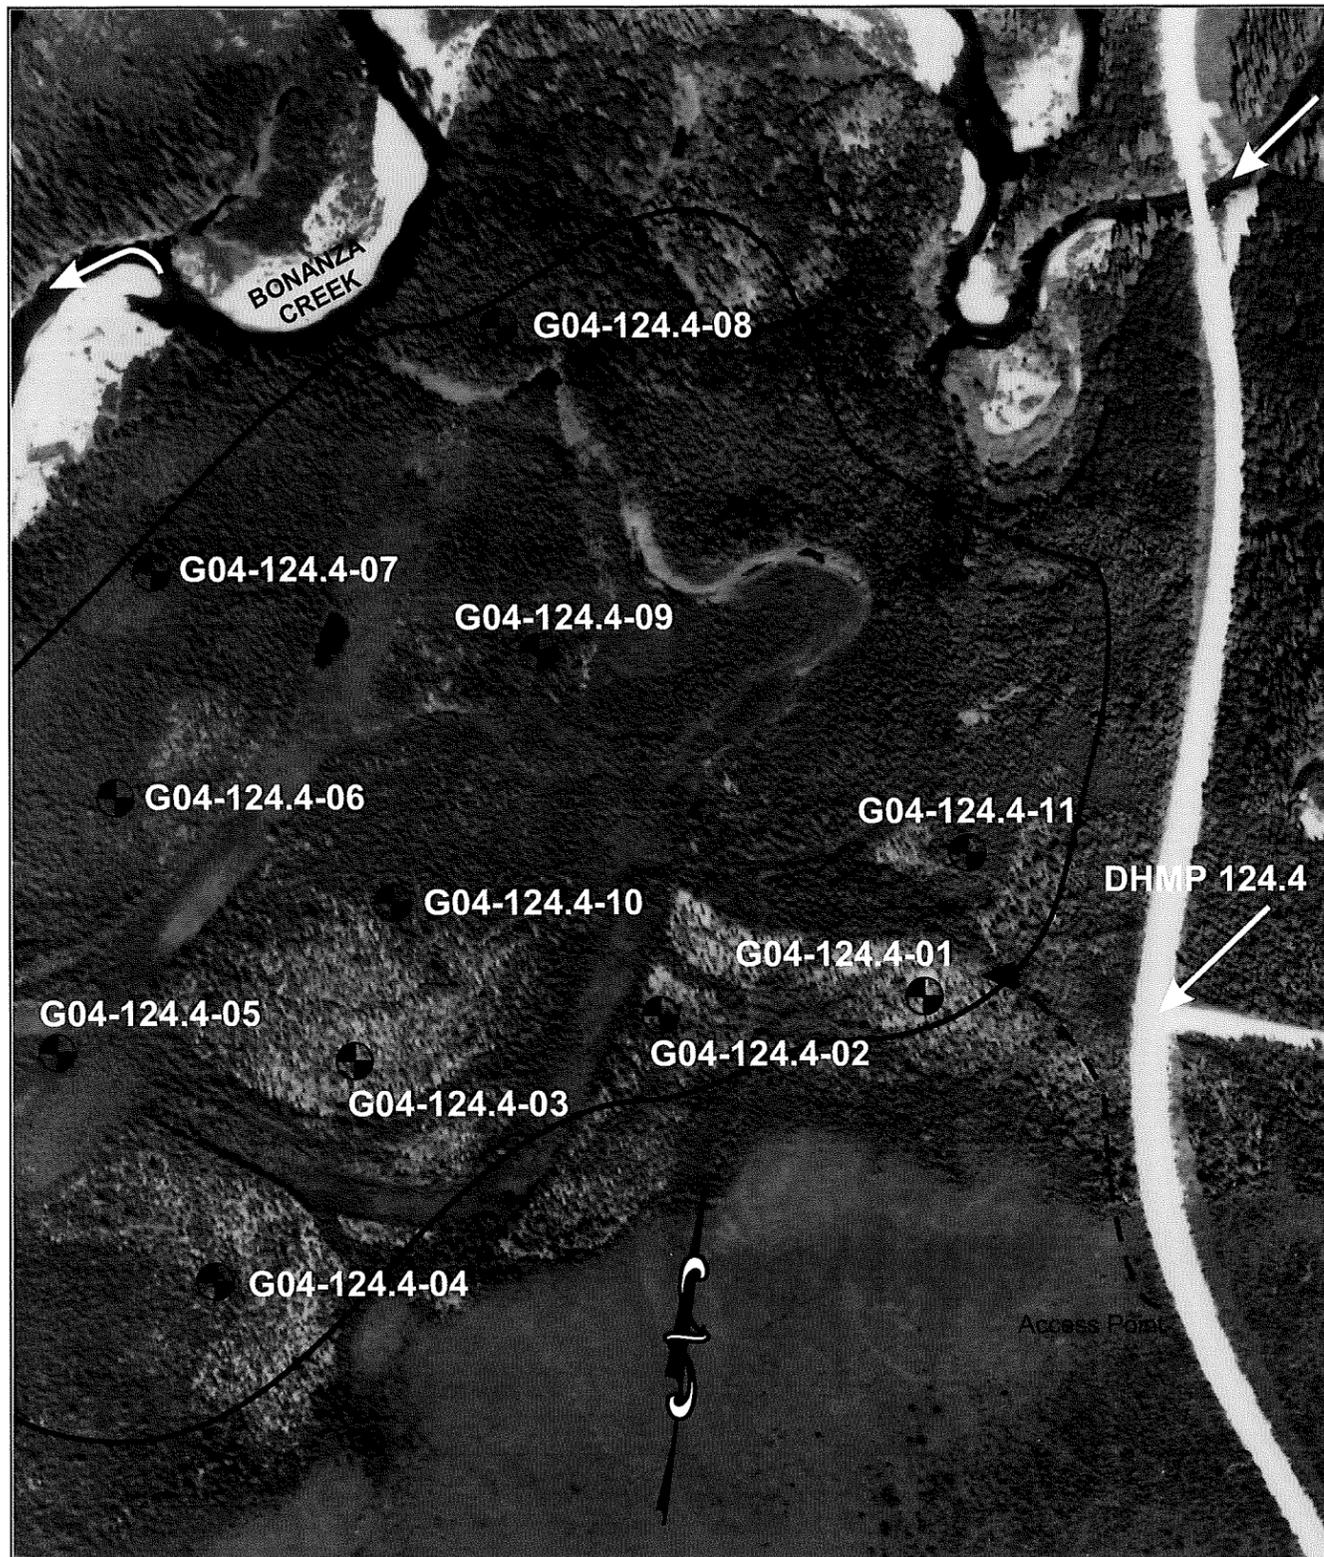
Figure 8.7.1
**DALTON HIGHWAY MP 124.4
 BONANZA WEST**
 ADOT & PF / DALTON HIGHWAY / AK

LEGEND:
 ⊕ GAI BOREHOLE LOCATION
 (APPROX.), TAKEN 5/04

Photo Date: 6-29-99

This site is located on a very broad floodplain immediately to the west of the Dalton Highway at MP 124.4. It has not been previously developed for any purpose and has no existing access road. Access by tracked vehicle is possible by departing the highway embankment a few hundred feet south of the site and following the highway right-of-way to the north.

This site is a relatively level abandoned floodplain deposit of sandy gravel. A few old channels cut through the site, some of which have seasonally ponded water. The overall site relief appears to be less than 10 ft. The floodplain on the south side of the river is bound by moderately steep silt-mantled slopes underlain by Paleozoic schists and phyllite of the Ruby-Arctic Alaska terrain. Granitic rocks of Cretaceous age outcrop on the north side of the river. Surface drainage shows historic channels of Bonanza Creek have at one time passed through the area, but no recent flows are indicated. Bonanza Creek appears fairly stable in its current channel.

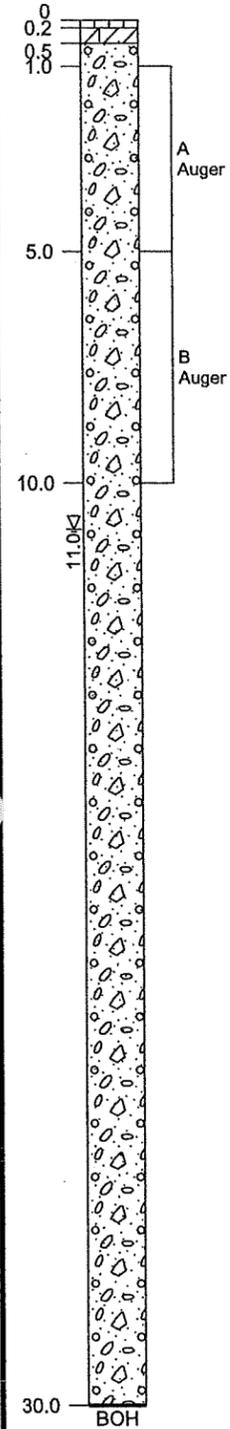
G04-124.4-04

Location: DALTON HWY MP 124.4/BONANZA WEST
5/19/04

0.0 - 0.2; Dark brown, Organic Or Peat, (PT)
0.2 - 0.5; Brown, Organic Silt, (OL)
0.5 - 30.0; Brown, loose, moist to wet, Sandy Gravel, (GP), Occasional cobbles encountered, 3" max size
04-7530/A, A-1-a, M.C.=2.8%, Organic=0.6%, p200=3.0, LL=NV, PI=NP, Gravel=50%, Sand=47%, Silt=3.0%
04-7531/B, A-1-a, p200=2.8, LL=NV, PI=NP, Gravel=63%, Sand=34.2%, Silt=2.8%

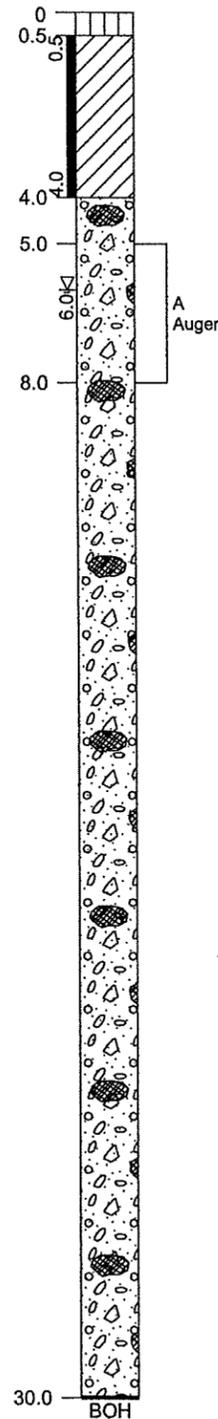
G04-124.4-05

Location: DALTON HWY MP 124.4/BONANZA WEST
5/19/04

0.0 - 0.5; Dark brown, wet, Organic Or Peat, (PT)
0.5 - 4.0; Gray, frozen (ice rich, Vr-Vs), wet when thawed, Silt Vr - Vs
4.0 - 30.0; Brown, loose, wet, Sandy Gravel w/ Cobbles, (GP-GW), Cobbles mostly 3" minus, 5" max size
04-7532/A, A-1-a, p200=4.8, LL=NV, PI=NP, Gravel=67%, Sand=28.2%, Silt=4.8%

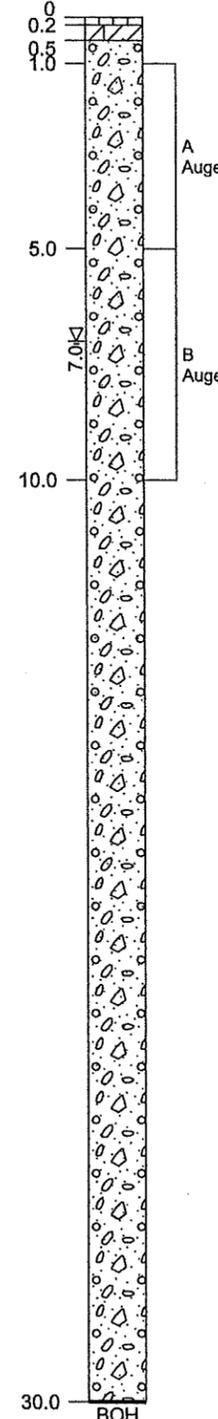
G04-124.4-06

Location: DALTON HWY MP 124.4/BONANZA WEST
5/19/04

0.0 - 0.2; Dark brown, Organic Or Peat, (PT)
0.2 - 0.5; Brown, Organic Silt, (OL)
0.5 - 30.0; Brown, loose, moist to wet, Sandy Gravel, (GP), Occasional cobbles, 4" max size
04-7533/A, A-1-a, M.C.=5.2%, Organic=1.1%, p200=3.9, LL=NV, PI=NP, Gravel=57%, Sand=39.1%, Silt=3.9%
04-7534/B, A-1-a, p200=1.2, LL=NV, PI=NP, Gravel=74%, Sand=24.8%, Silt=1.2%

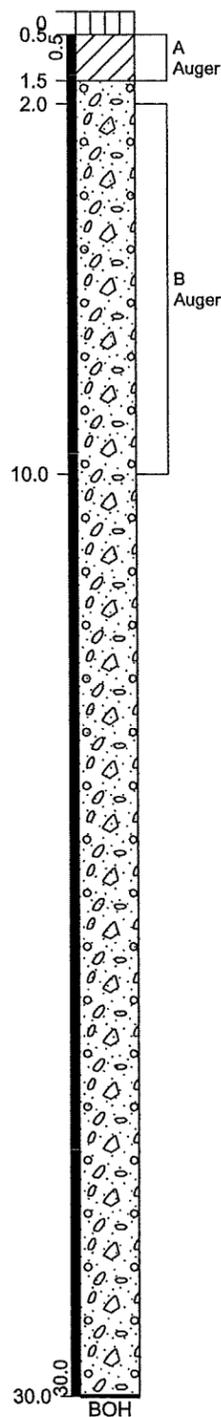
0.0 - 0.5; Dark brown, Organic or Peat, (PT)
 0.5 - 1.5; Gray, frozen (ice rich, Vr-Vs), wet when thawed, Silt, (ML)
 04-7535/A, A-4 (0), M.C.=110.7%, Organic=12.2%, p200=67.6, LL=NV, PI=NP, Gravel=0%, Sand=32.4%, Silt=67.6%
 1.5 - 30.0; Light brown, frozen (Nf), moist to wet when thawed, Sandy Gravel (GP), Mostly 1" minus, 2" max size
 04-7536/B, A-1-a, p200=6.9, LL=NV, PI=NP, Gravel=50%, Sand=43.1%, Silt=6.9%

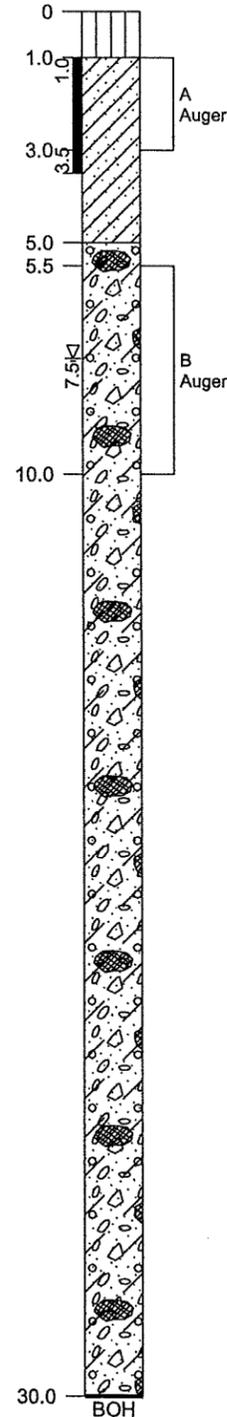
0.0 - 1.0; Dark brown, wet, Organic Or Peat, (PT)
 1.0 - 5.0; Gray, frozen (ice rich, Vr-Vs), wet when thawed, Sandy silt (ML)
 04-7537/A, A-4 (0), M.C.=77.9%, Organic=8.9%, p200=74.5, LL=NV, PI=NP, Gravel=0%, Sand=25.5%, Silt=74.5%
 5.0 - 30.0; Gray, wet, Silty Sandy Gravel w/ Cobbles, (GP-GM), 4" max size
 04-7538/B, A-1-b, p200=17.7, LL=NV, PI=NP, Gravel=54%, Sand=28.3%, Silt=17.7%

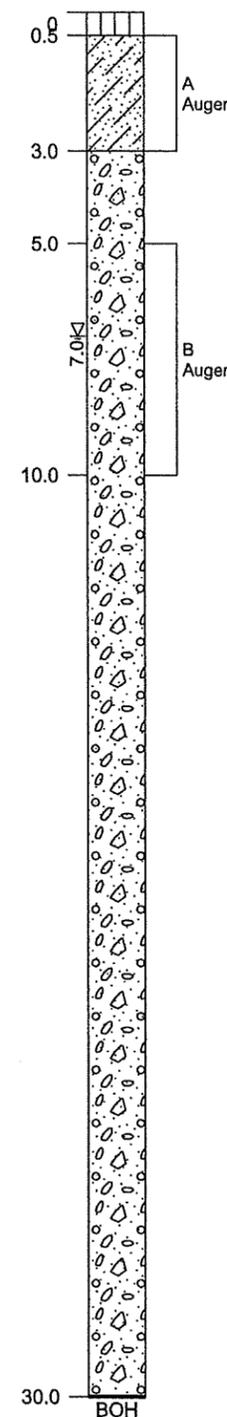
0.0 - 0.5; Dark brown, Organic Or Peat, (PT)
 0.5 - 3.0; Brown, loose, moist, Silty Sand, (SW-SM)
 04-7539/A, A-2-4, M.C.=8.7%, Organic=1.2%, p200=10.2, LL=NV, PI=NP, Gravel=8%, Sand=81.8%, Silt=10.2%
 3.0 - 30.0; Brown, loose, moist to wet, Sandy Gravel, (GP), Occasional cobbles, 4" max size
 04-7540/B, A-4-a, p200=3.9, LL=NV, PI=NP, Gravel=55%, Sand=41.1%, Silt=3.9%

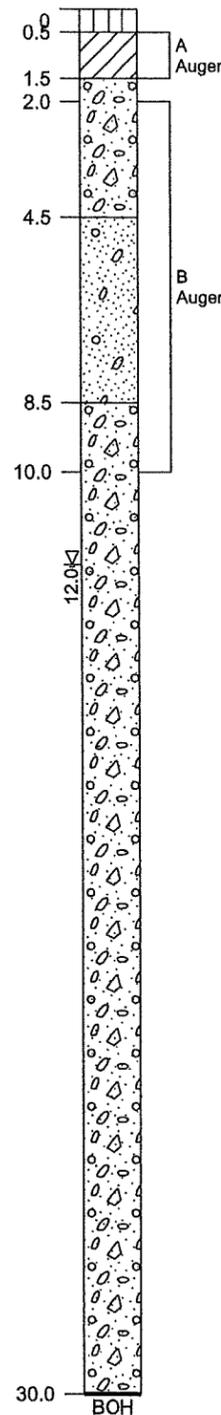
G04-124.4-10
 Location: DALTON HWY MP 124.4/BONANZA WEST
 5/20/04

0.0 - 0.5; Dark brown, wet, Organic Or Peat, (PT)
 0.5 - 1.5; Gray, moist to wet, Silt, (ML)
 04-7541/A, A-4 (0), M.C.=35.5%,
 Organic=6.4%, p200=87.4, LL=Nv,
 PI=NP, Gravel=0%, Sand=12.6%,
 Silt=87.4%
 1.5 - 4.5; Brown, loose, moist, Sandy Gravel,
 (GP), Occasional cobbles, 4" max size
 04-7542/B, A-1-a, p200=3.1, LL=Nv,
 PI=NP, Gravel=56%, Sand=40.9%,
 Silt=3.1%, LA=35, Degrad=77
 4.5 - 8.5; moist, Gravelly Sand, (GP), Course
 sand
 8.5 - 30.0; Brown, loose, moist, Sandy Gravel,
 (GP), Occasional cobbles, 4" max size

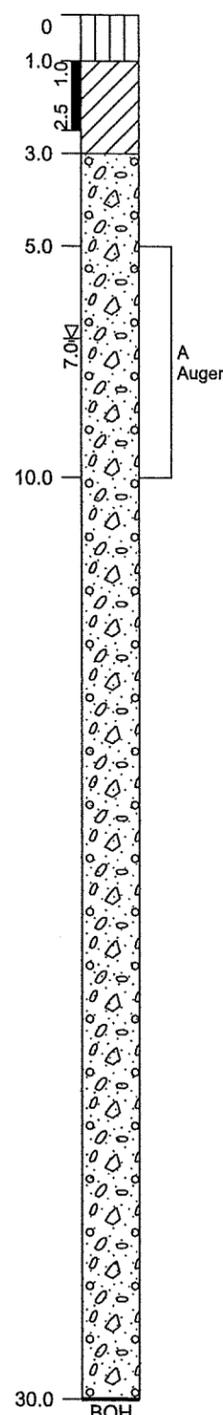
G04-124.4-11
 Location: DALTON HWY MP 124.4/BONANZA WEST
 5/20/04

0.0 - 1.0; Dark brown, wet, Organic Or Peat,
 (PT)
 1.0 - 3.0; Gray, frozen (Visible ice), wet when
 thawed, Silt, (ML)
 3.0 - 30.0; Brown, loose, wet, Sandy Gravel,
 (GP), Occasional cobbles, mostly 2" minus, 4"
 max size
 04-7543/A, A-1-a, p200=7.1, LL=Nv,
 PI=NP, Gravel=54%, Sand=38.9%,
 Silt=7.1%, LA=35, Degrad=77

1) Sample A was combined
 with G04-124.4-10 B for LA
 and deg tests.

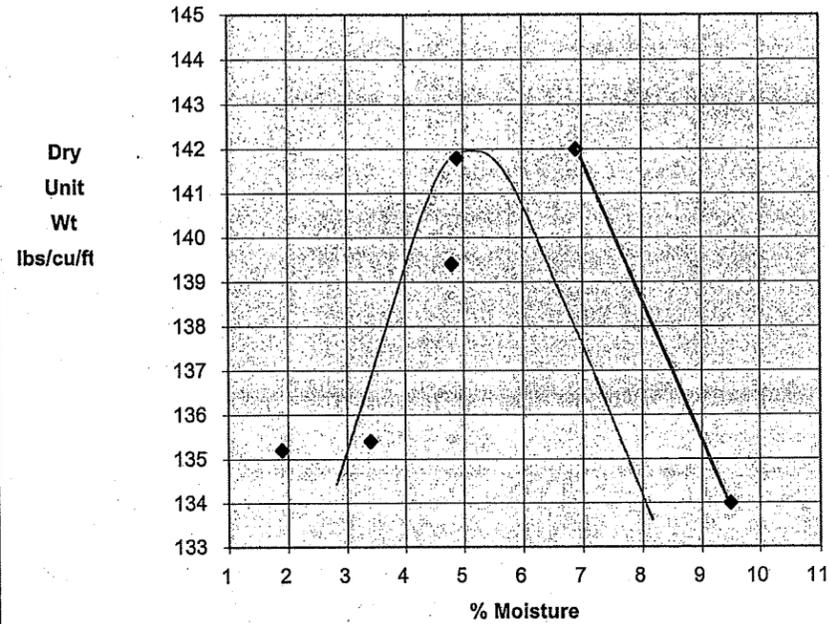
MOISTURE / DENSITY RELATIONS

Dry Unit Wt	1	2	3	4	5	ZAV	ZAV
lbs/cu/ft	135.2	135.4	139.4	141.8		134	142
kg/cu/m	2166	2169	2233	2271		2147	2275
% Moisture	1.9	3.4	4.8	4.9		9.5	6.9
Free Moist:		sweat	bleed	bleed			
ASTM D-1557	Reg Lab						
AASHTO T-180D	lbs/cu/ft	kg/cu/m	Field				
**Max. Density	142						
Opt. Moist	5.2

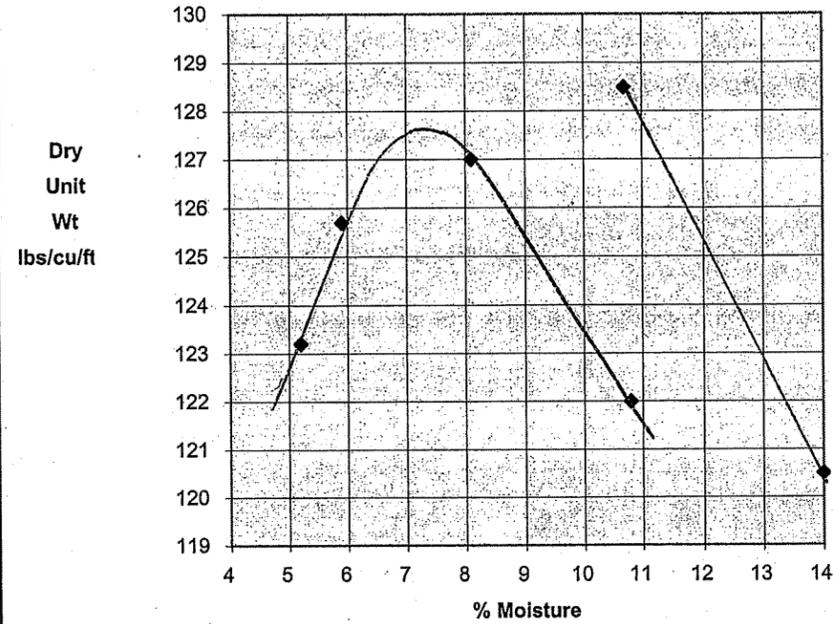
MOISTURE / DENSITY RELATIONS

Dry Unit Wt	1	2	3	4	5	ZAV	ZAV
lbs/cu/ft	123.2	125.7	127	122		120.5	128.5
kg/cu/m	1974	2014	2034	1954		1930	2058
% Moisture	5.2	5.9	8.1	10.8		14	10.7
Free Moist:

ASTM D-1557	Reg. Lab	
AASHTO T-180D*	lbs/cu/ft	kg/cu/m
**Max. Density	127.7	
Opt. Moist	7.3
