**STATE OF ALASKA IFSB NUMBER 2521S019  
ADVISORY NUMBER THREE (4)**

**INVITATION FOR SEALED BID TITLE  
Sealed Bid Sale Ro-Ro Car / Passenger  
Catamaran Type Ferry  
FVF Chenega & FVF Fairweather**

**This Advisory is issued to provide information regarding some damage that recently occurred to the vessels while moored in Ketchikan during a violent winter storm that occurred the week of November 30, 2020.**

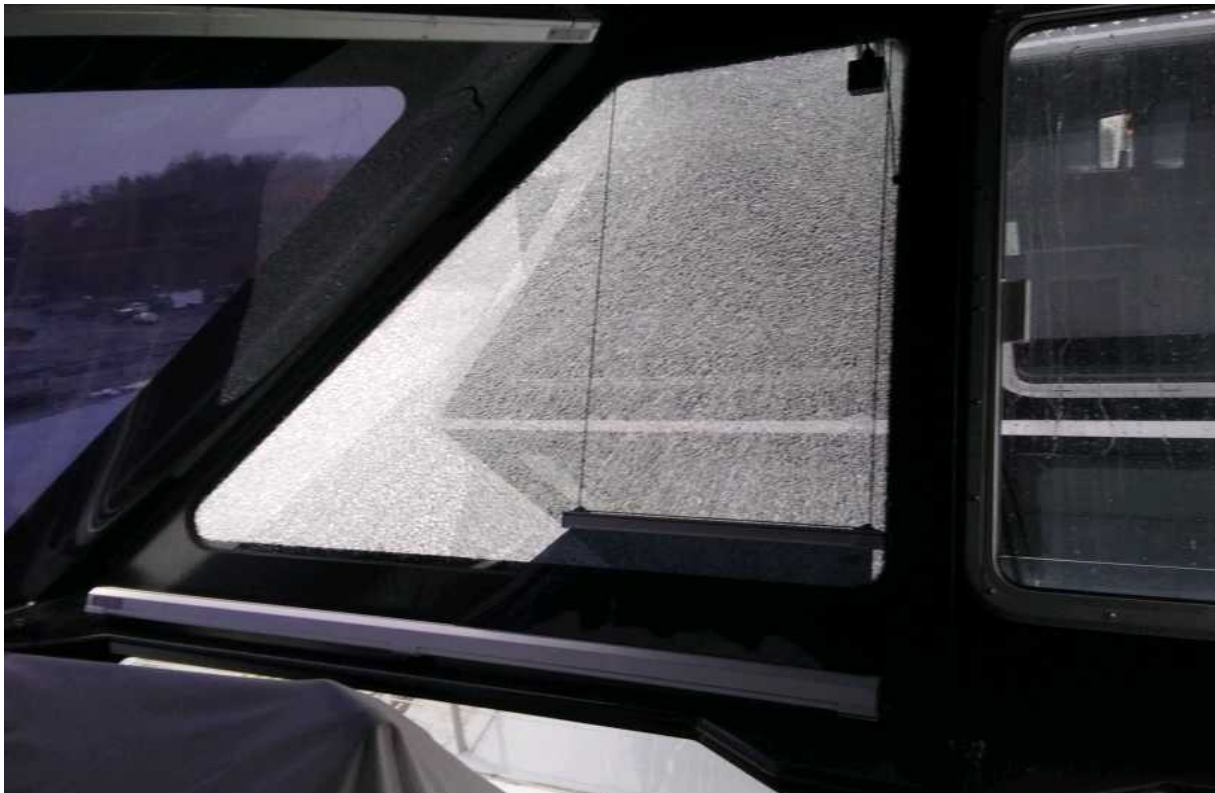
1. This picture is the FVF Chenega is the Starboard Bridge Window that has been shattered but is still intact. There is some water intrusion into the bridge area of the FVF Chenega due to this damage. However, while the window will not be replaced before the sale, the window has been sealed and the water intrusion has been halted.

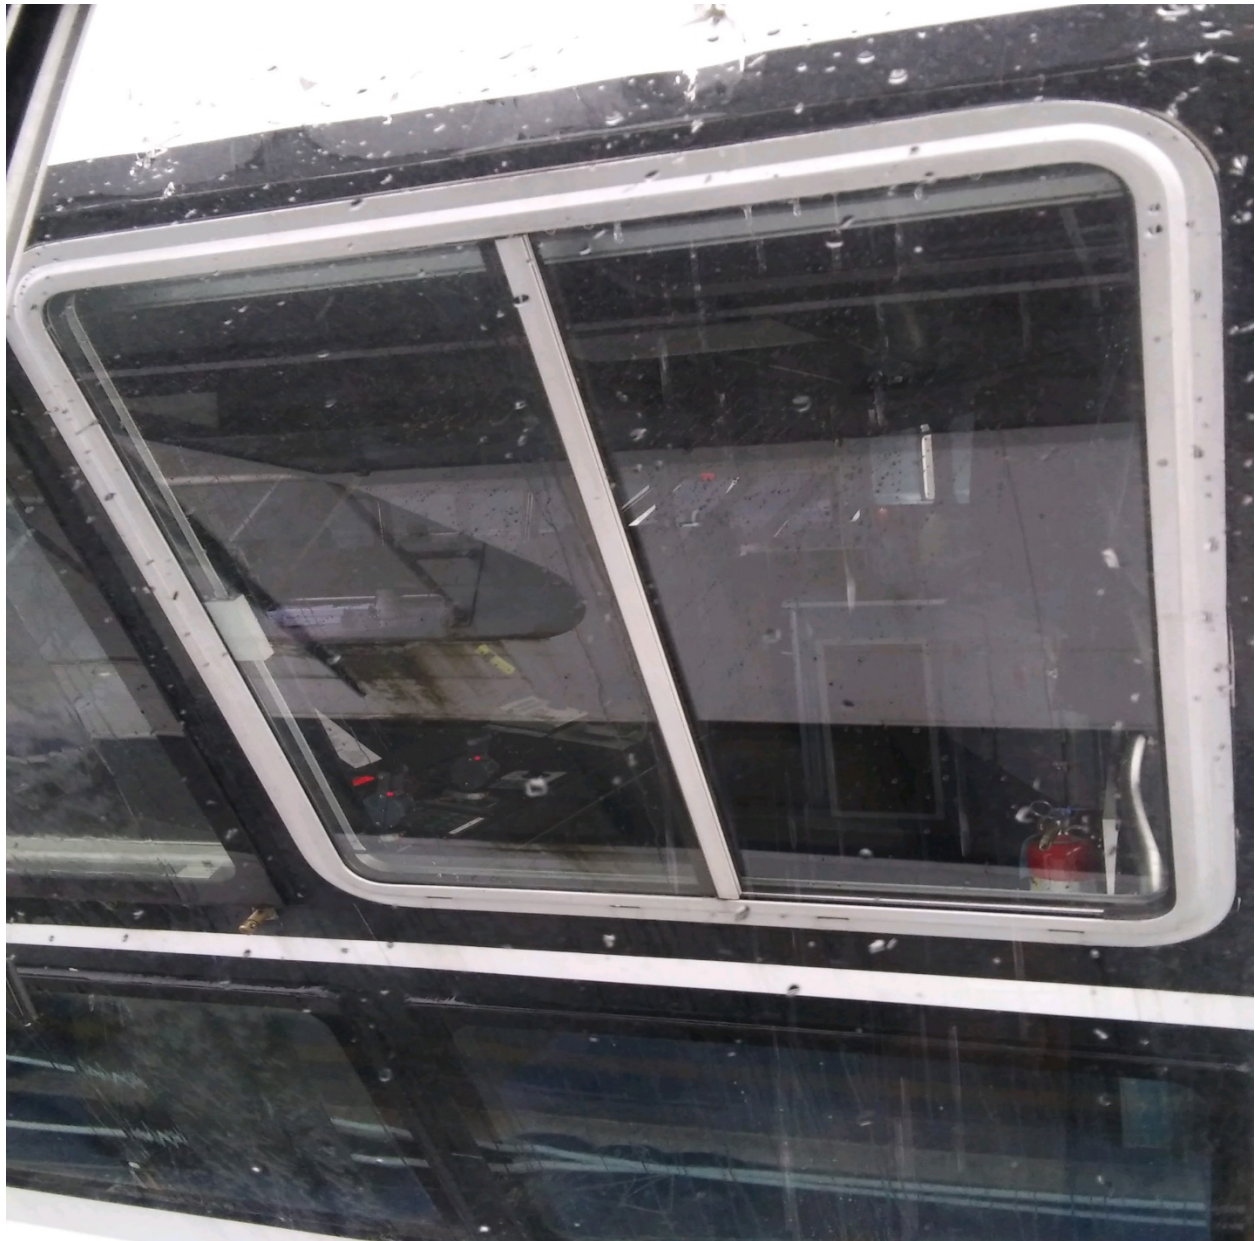
2. This picture is the FVF Fairweather Port Bridge area. While the window is intact, there is a tear or crack immediately above it and the wiper is smashed. There is water intrusion into the bridge area of the FVF Fairweather due to this damage. However, while tear or crack will not be repaired before the sale, the area has been sealed and the water intrusion has been halted.

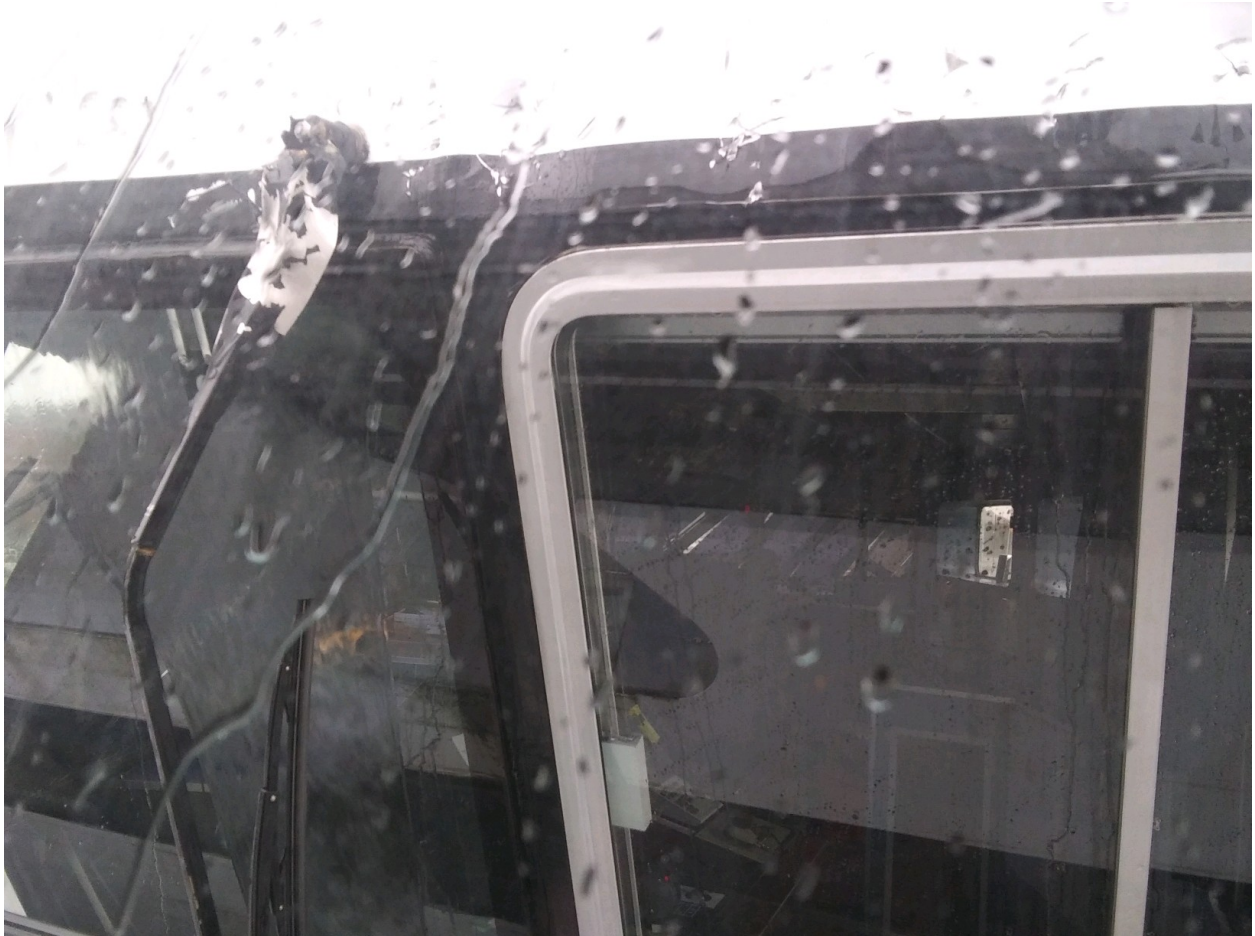
3. This picture is also of FVF Fairweather Port Bridge area. In this picture, the damage to the wiper is visible and there is water intrusion into the bridge area of the FVF Fairweather due to this damage. However, while wiper will not be repaired before the sale, the area has been sealed and the water intrusion has been halted.
