RE: Project Name: Statewide Roof Replacement Design & Contract
Services
Project Number: 20-19-02
Project Location: Statewide
RFP Opening Date and Time: September 27, 2018 @ 2:00 PM local time

Addendum # TWO (2)

ROOF INVESTIGATION REPORT
WILDWOOD CORRECTIONAL CENTER
BUILDING 8 ROOF REPLACEMENT

Kenai, Alaska

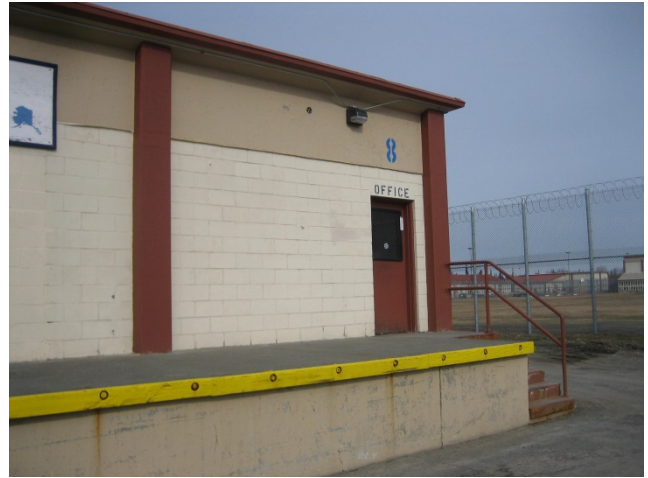
Photo 26: **Wildwood Bldg 8 – Personnel Door @ North End of Loading Dock**

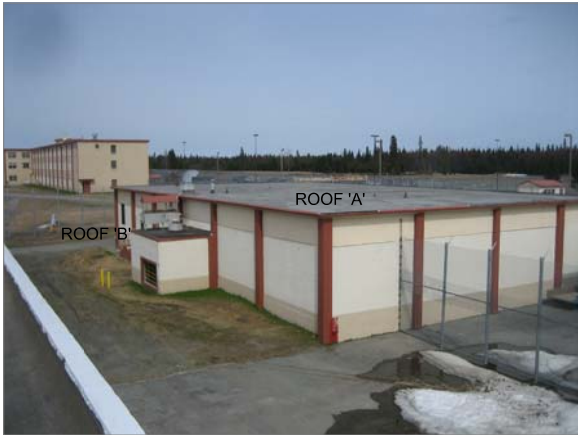
P1 - VIEW OF BLDG #8 FROM BLDG #6 ROOFTOP

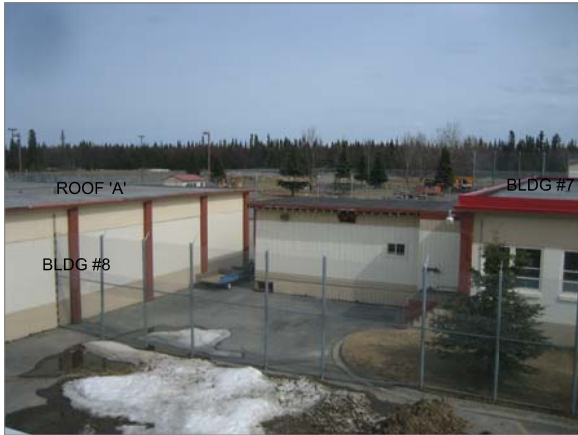
P2 - VIEW OF BLDG #8 & BLDG #7 FROM BLDG #6

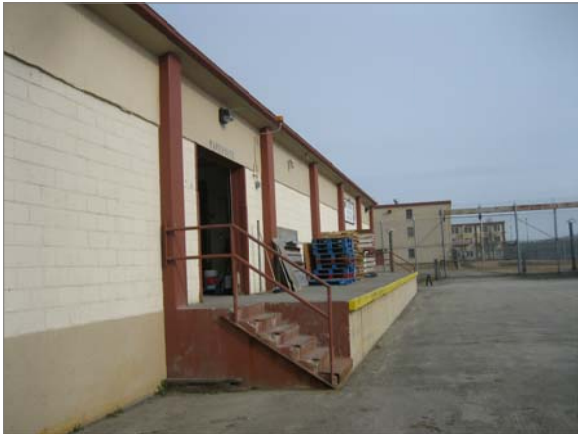
P3 - VIEW ALONG LOADING DOCK LOOKING NORTH

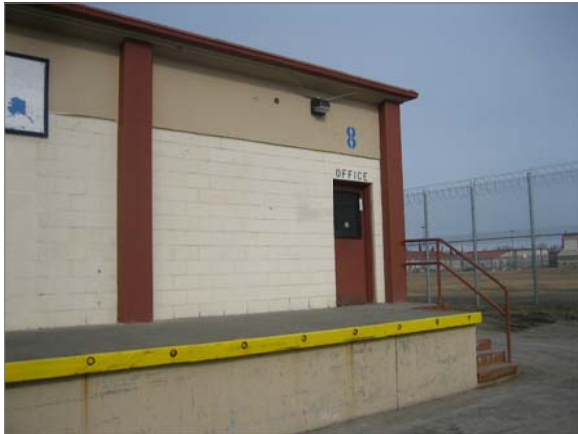
P4 - VIEW OF NORTH END OF LOADING DOCK

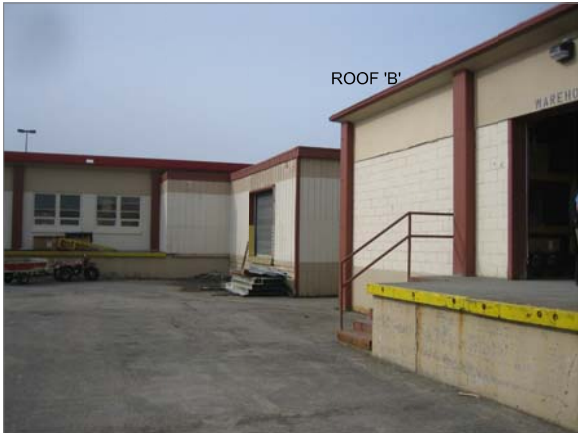
P5 - VIEW OF SOUTH END OF LOADING DOCK

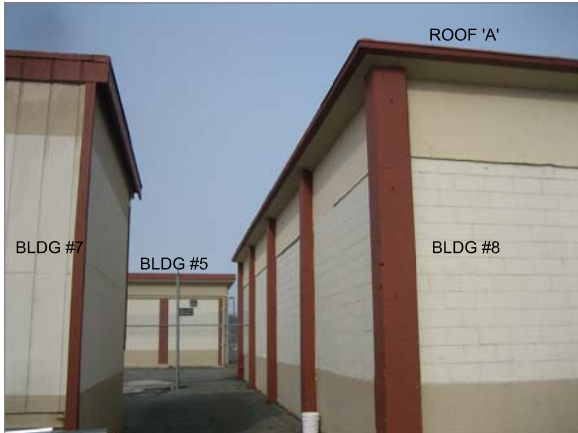
P6 - VIEW BETWEEN BLDG #7 & BLDG #8

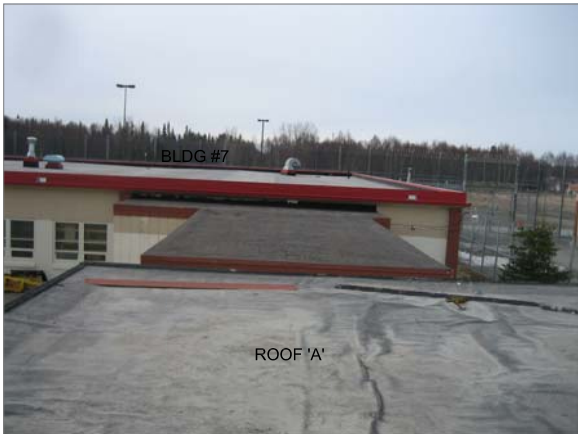
P9 - VIEW OF SOUTHEAST CORNER OF ROOF 'A'

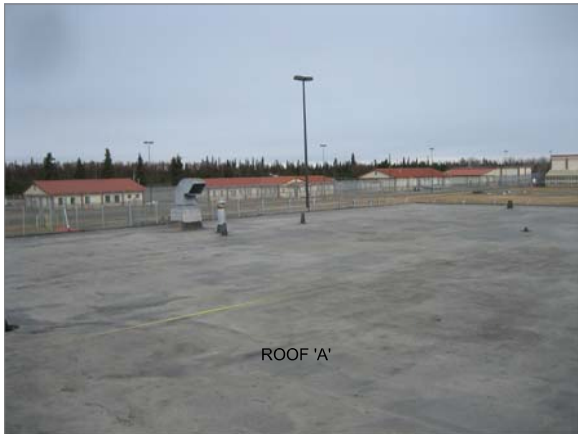
P10 - VIEW ACROSS ROOF 'A' LOOKING NORTHWEST

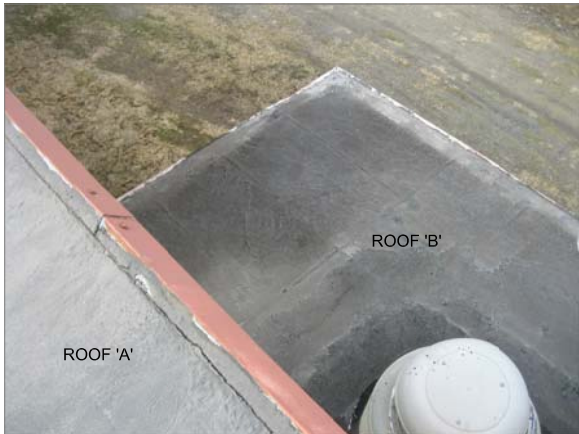
P11 - VIEW OF ROOF 'B' LOOKING DOWN FROM 'A'

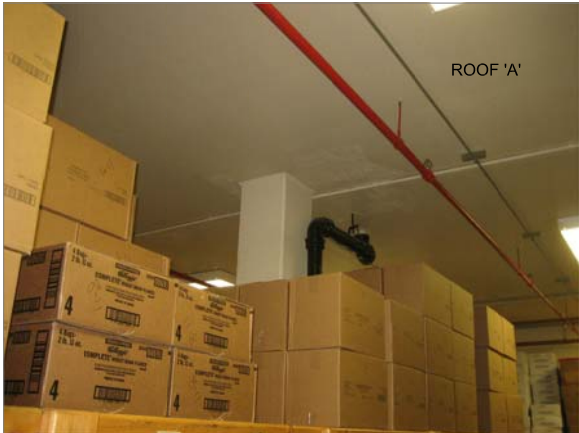
P8 - VIEW OF EXIST ROOF DRAIN & LEADER

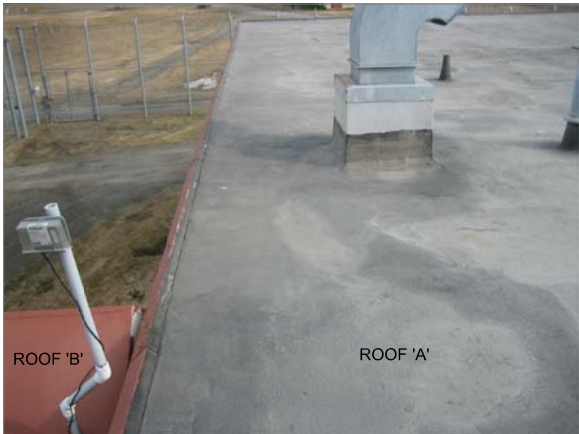
P12 - VIEW ALONG WEST EDGE OF ROOF 'A'

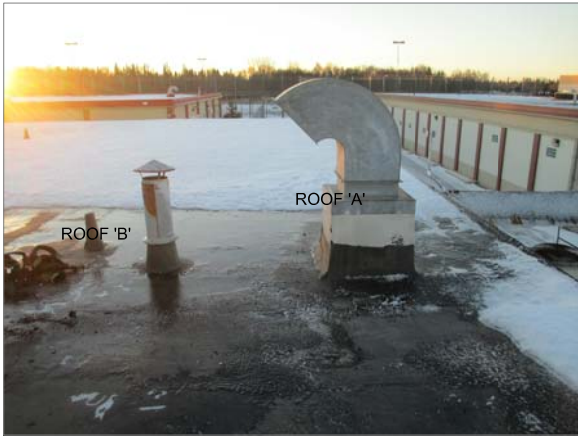
P1 - VIEW OF MECHANICAL PENETRATIONS

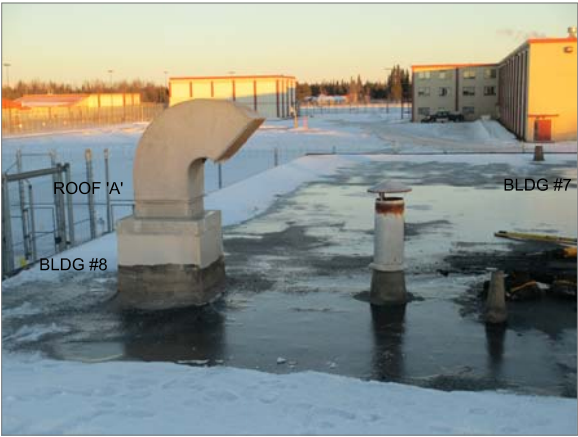
P2 - VIEW OF MECHANICAL PENETRATIONS

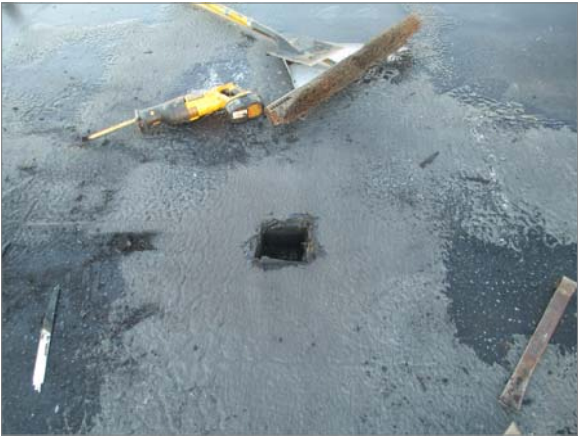
P4 - VIEW OF ROOF 'A' CORE CUT #1

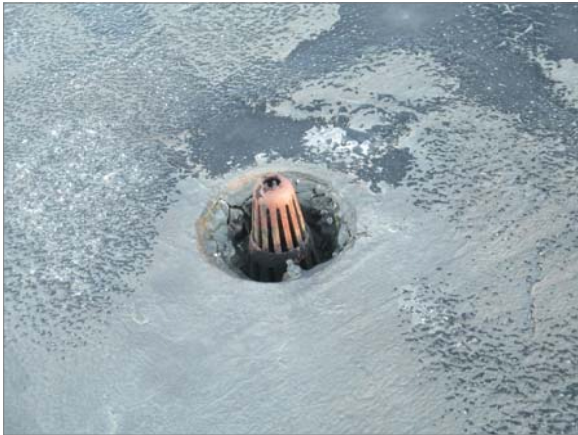
P5 - VIEW OF TYPICAL ROOF DRAIN

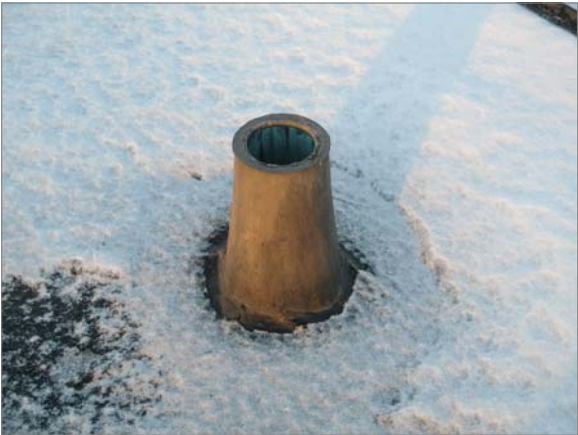
P6 - VIEW OF TYPICAL VTR W/ JACKET

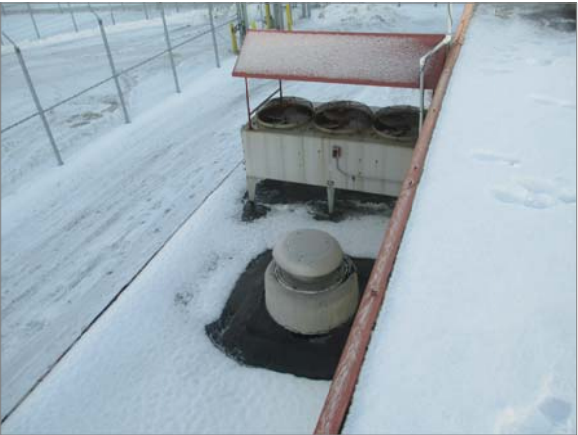
P7 - VIEW OF MECH EQUIPMENT ON ROOF 'B'

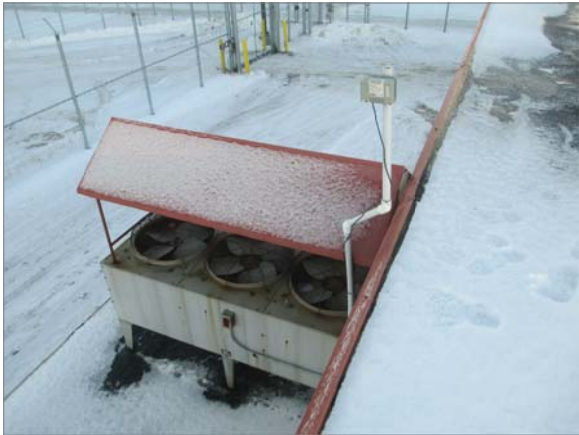
P8 - VIEW OF CONDENSER UNIT TO BE REMOVED

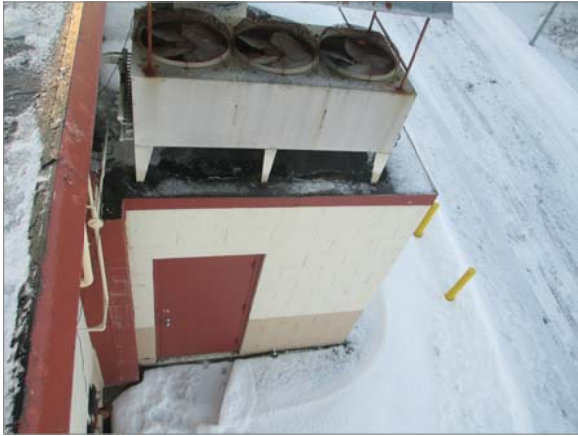
P9 - VIEW OF ROOF 'B' EQUIPMENT AND ACCESS

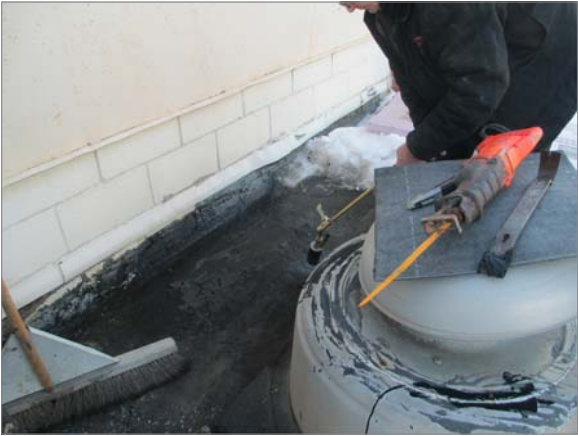
P10 - VIEW OF ROOF 'B' CORE CUT PREP

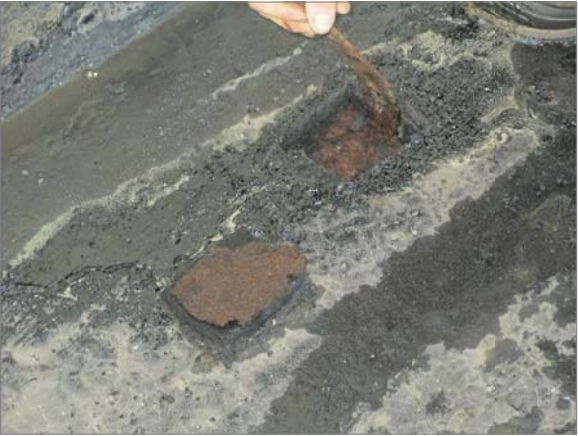
P11 - VIEW OF ROOF 'B' CORE CUT #2

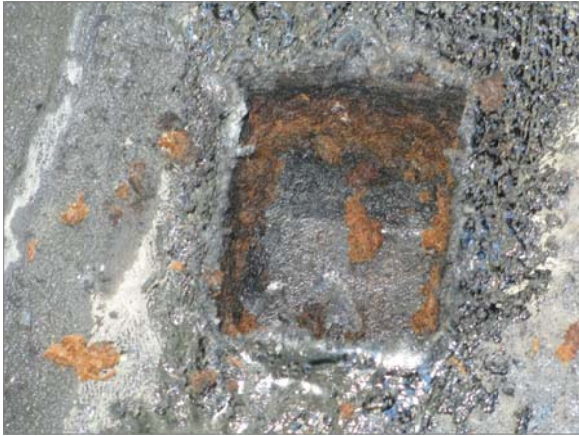
P12 - VIEW OF ROOF 'B' CORE CUT #2

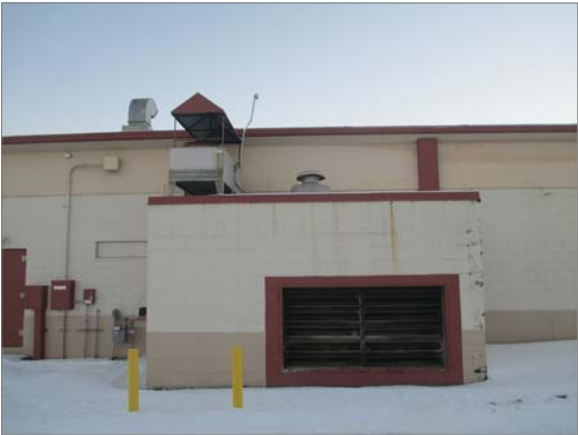
P6 - VIEW BETWEEN BLDG #7 & BLDG #8

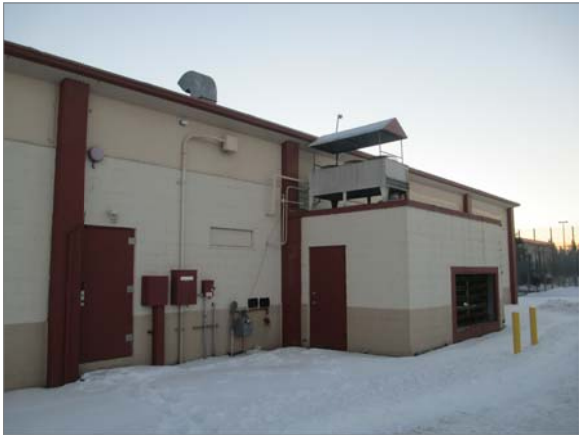
P8 - VIEW OF EXIST ROOF DRAIN & LEADER
